July 18, 2022 [*Revised March 22, 2023*]

ARBORIST REPORT
19 Mill Street East, Elora, Ontario

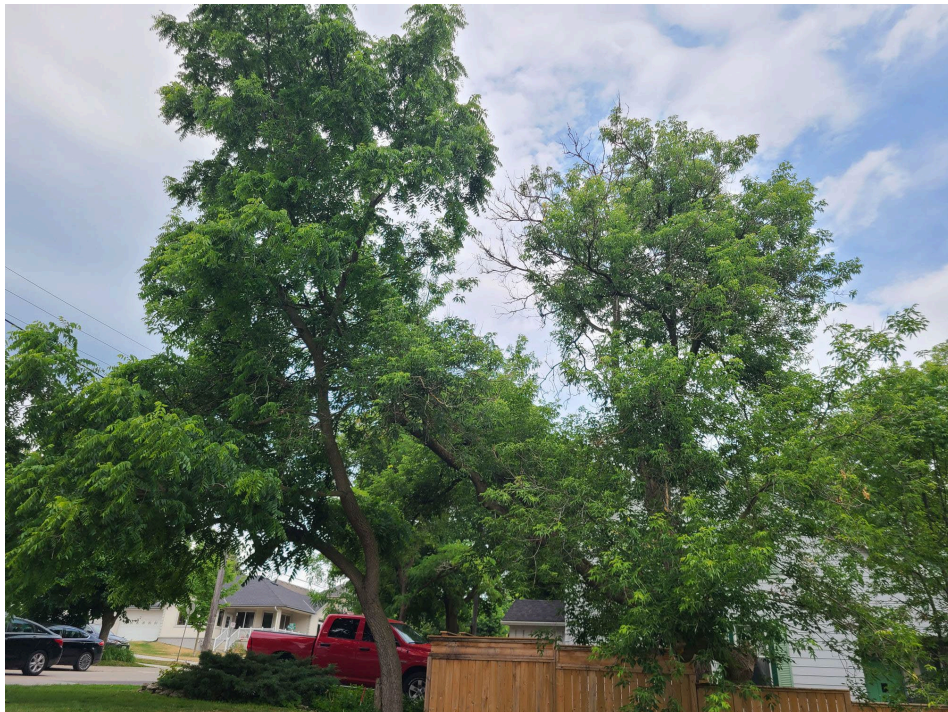
Trees 254 - 255

Trees #254 and 255 will sustain an injury to the root zone due to the proposed driveway. Given that these trees are located wholly on the neighbouring property, acknowledgement and permission from the neighbor shall be obtained prior to any work being completed. All work within the respective TPZs of these trees shall be completed by hand. Further, the driveway design shall consider the trees and should consider design that minimizes the need for compaction, and maximizes both air penetration and water percolation to the root zones.
