Fluvial Geomorphology Assessment and Erosion Mitigation Analysis

Nichol Drain
Elora, Ontario

Prepared for:
Elora Sands Development Inc.
2555 Meadowpine Blvd., Unit 3
Mississauga, Ontario L5N 6C3

GEO Morphix Project No. 25002

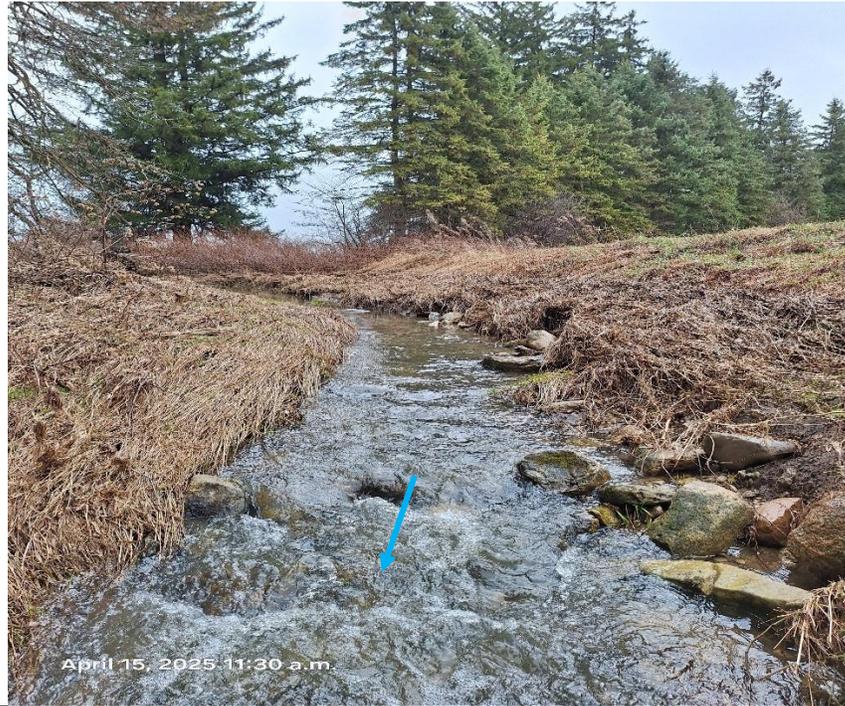
Photo 1

Photograph taken facing upstream from culvert at Sideroad 15. Note coarse, cobble substrate. Arrow denotes direction of flow.

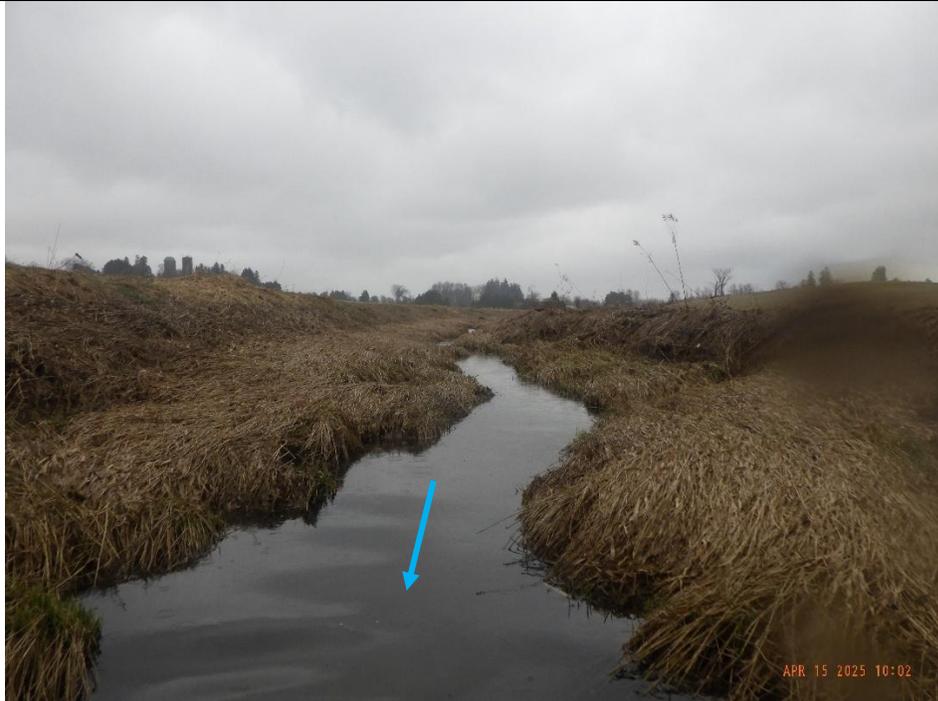
Photo 2

Photograph taken facing upstream. Agriculture fields extend close to channel edge on both sides of stream corridor. Arrow denotes direction of flow.

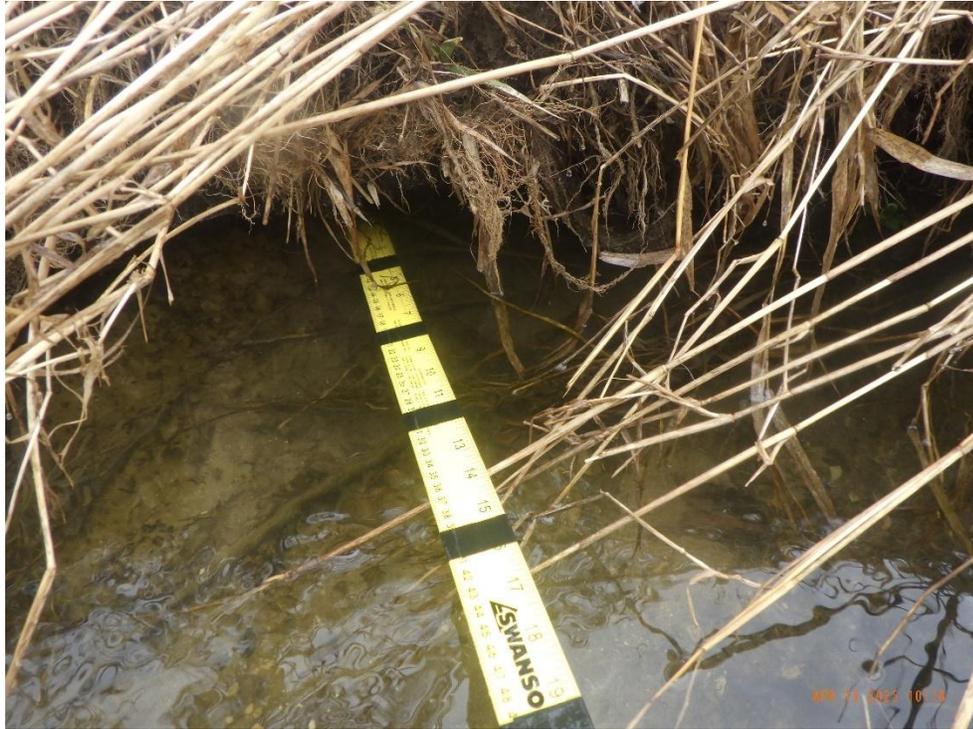
Photo 3

Reach R2a initiates at **Reach R2b** and flows northwest for approximately 315 m to Sideroad 15. The reach was historically straightened to function as a municipal drain, resulting in a linear planform. The riparian buffer was characterized as a continuous coverage of grasses spanning 4 to 10 channel widths. Riffles and runs were the predominant bed morphology observed with bed substrate comprised of sand, gravel and cobbles. Average bankfull width and depth ranged from 2.10 m to 4.50 m and 0.70 m to 0.85 m, respectively. Bank angles were moderately steep, ranging from 30° to 60°, and erosion was observed along 30% to 60% of the banks in the form of undercutting and scour.

Photograph taken of the edge of channel. Slight undercutting of 0.23m. Meterstick for scale.

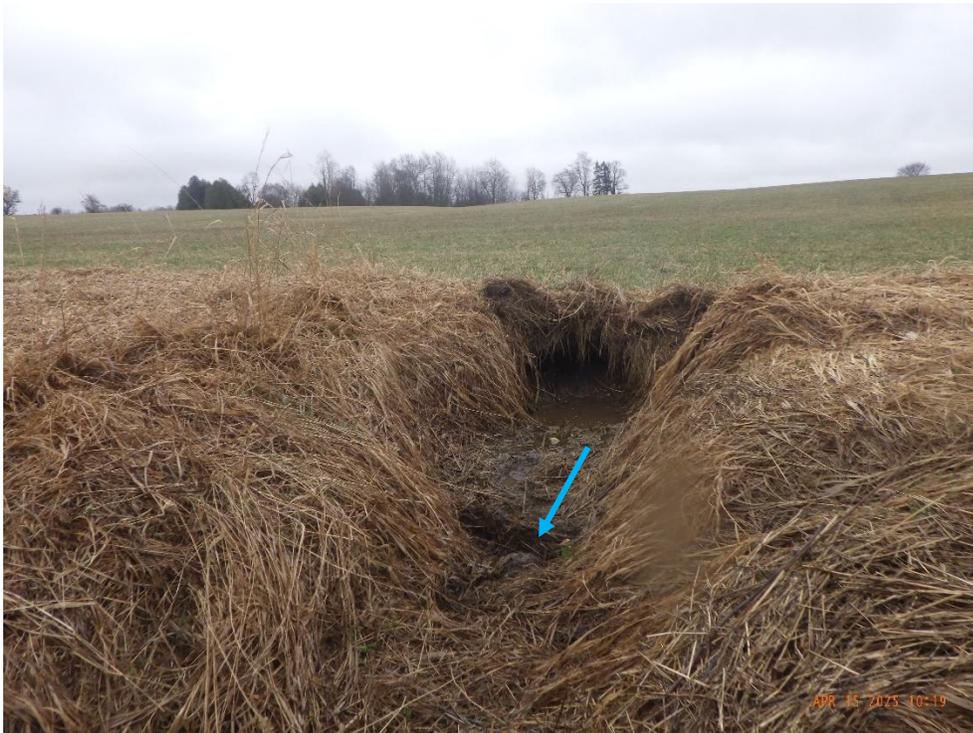
Photo 4

Photograph facing above the right bank highlighting a tile drain from adjacent agriculture field. The tile drain diameter was 0.14m.

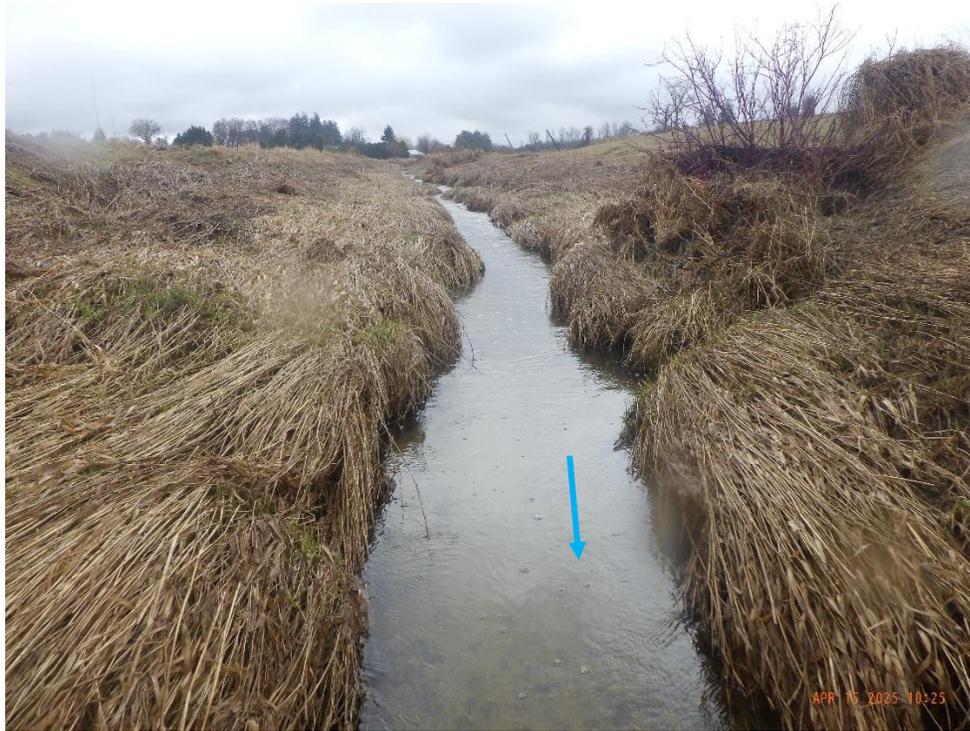
Photo 5

Photograph taken facing upstream. Note straight, uniform channel condition with dense grass vegetation adjacent to the channel.

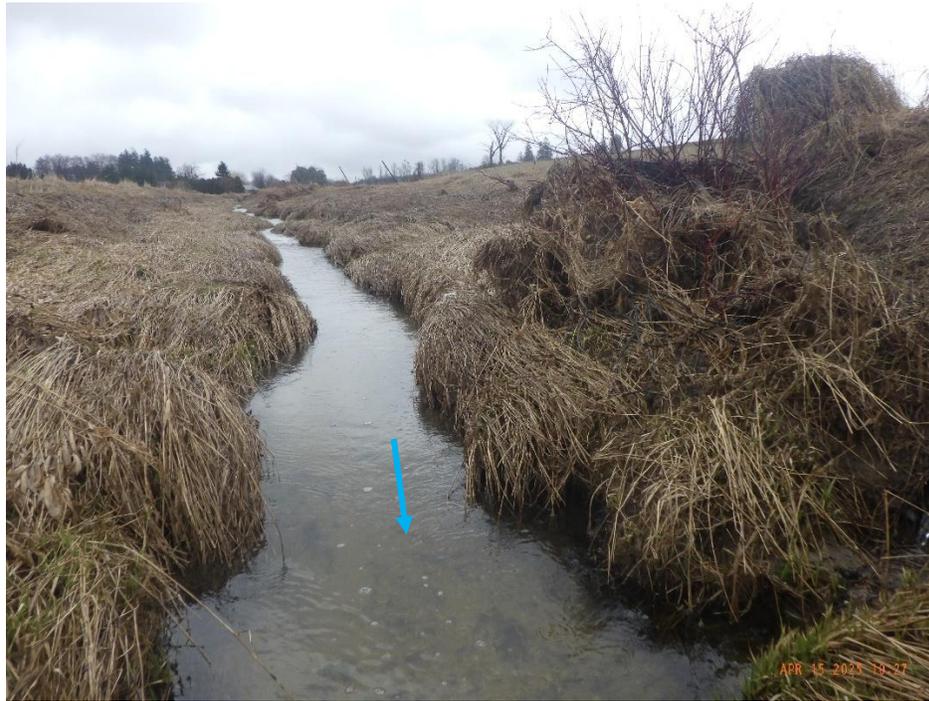
Photo 6
Irvine Street & Sideroad 15, Nichol Drain, Irvine Creek, R2B,
Elora, Ontario

Photograph taken facing upstream as R2A transitions to R2B. Heavy vegetation along the banks. Straight channel with open canopy. Arrow denotes direction of flow.

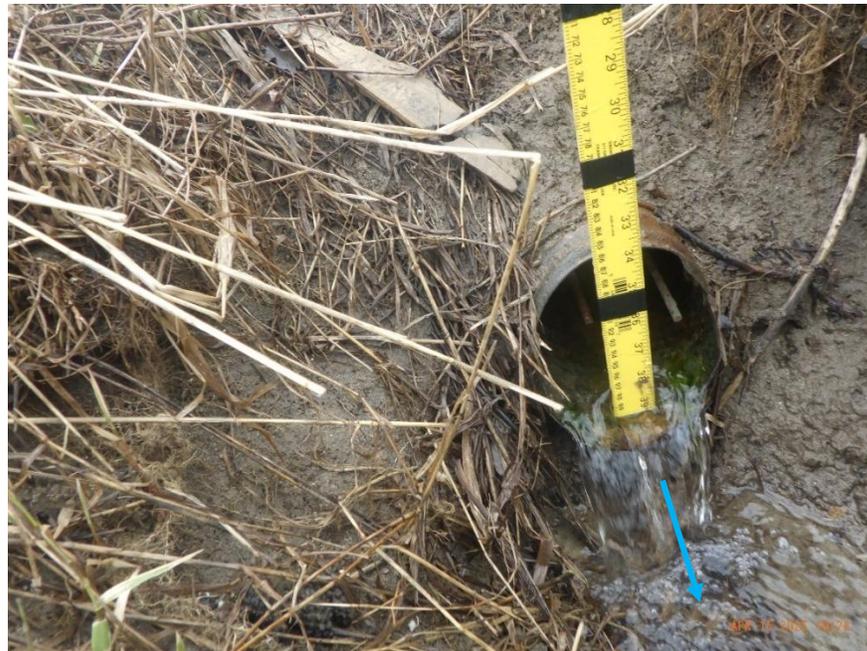
Photo 7
Irvine Street & Sideroad 15, Nichol Drain, Irvine Creek, R2B,
Elora, Ontario

Photograph facing the right bank flow from tile drain into channel. Tile drain diameter was 0.14m.

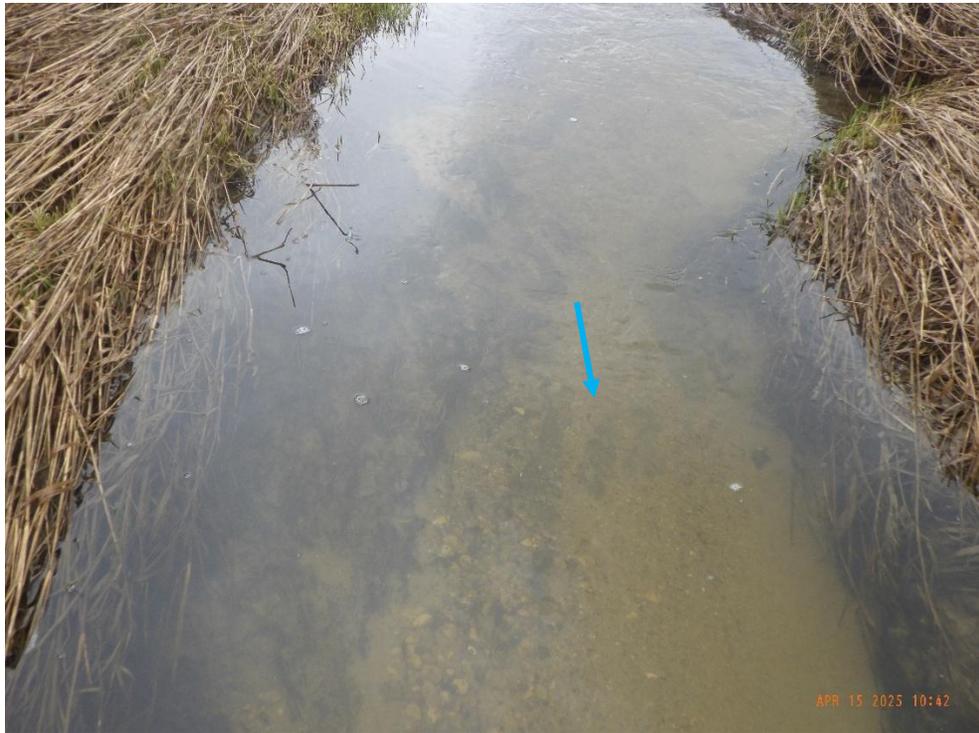
Photo 8

Photograph taken of bed substrate. Substrate ranges from sand, gravel and cobbles. Water has limited turbidity.
