Township Of Centre Wellington

ANNUAL PERFORMANCE REPORT FOR

2023

SEWAGE COLLECTION SYSTEM

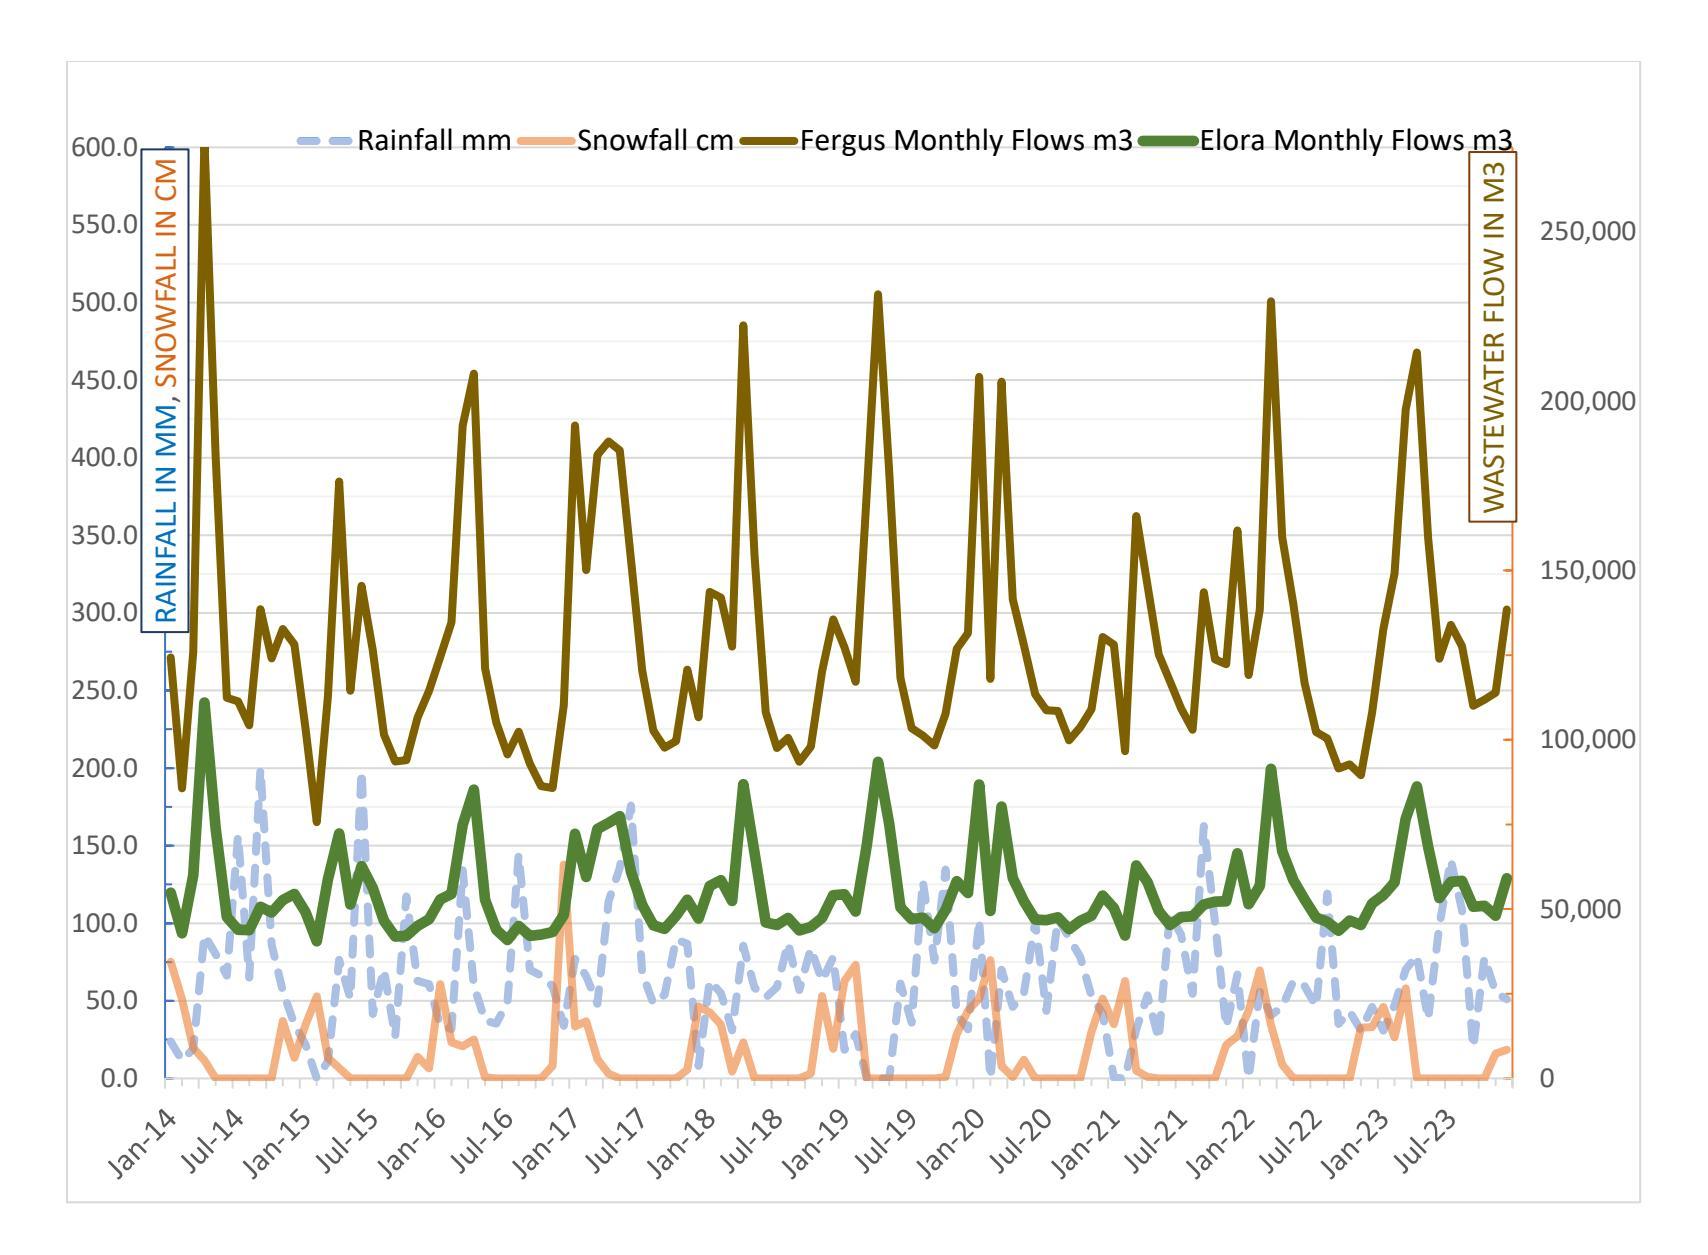
Figure 1: Weather Tracking vs. STP Flow

One identified trend is that a rain event exceeding 60 mm of rain in a short period of time, significantly increases the likelihood of a bypass event occurring at the Fergus STP.

Figure 1 shows a correlation between rain events and spiking STP flows from January 2014 – January 2024.

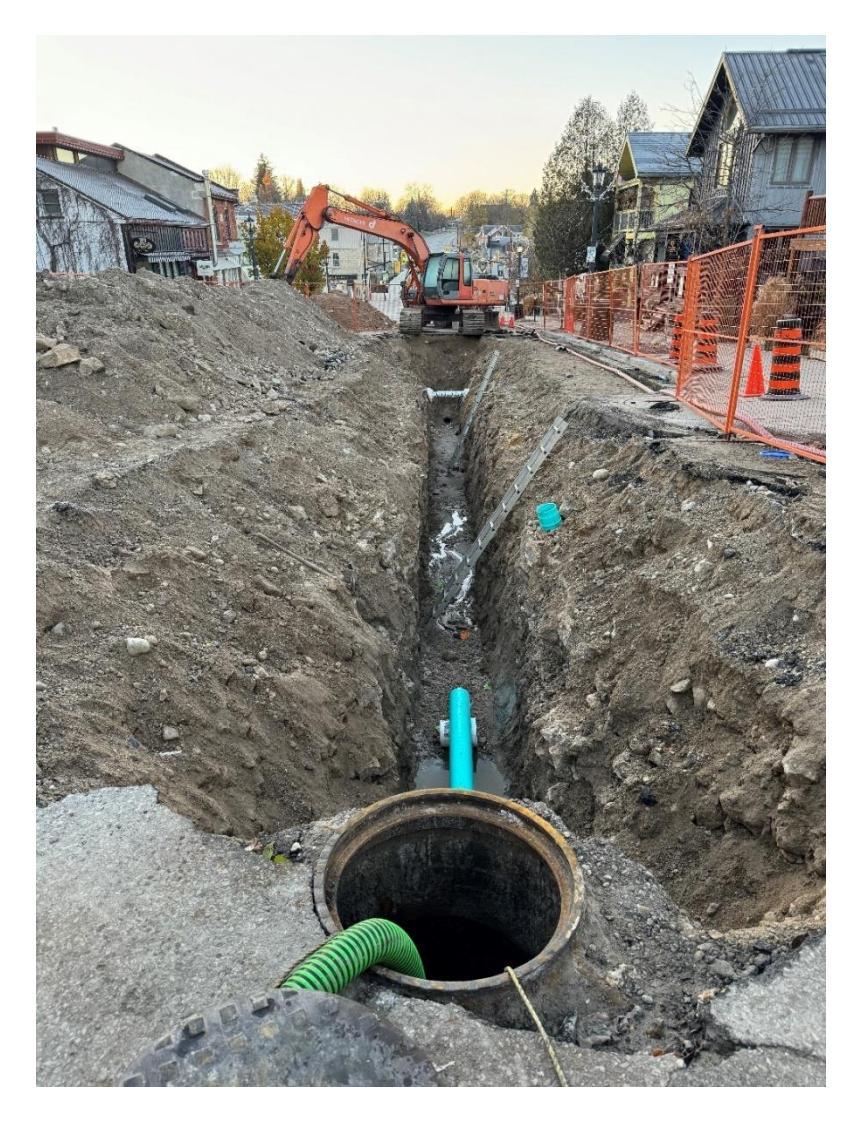
Figure 2: Metcalfe St. Sewer Main Repair

Location &	Actions Taken to Remediate Major Issue	
Major Issue		
Metcalfe Street	Description – Staff responded on November 15 th to what was	
8" Sewer Main	reported as a sewer backup into the basement of a business on	
Collapse.	Church St. W. ('Church'). Upon arrival staff discovered that the	
	sewer main on Metcalfe St. ('Metcalfe') was blocked.	
	Actions Taken – Operations staff attempted to clear the blockage	
	via flusher truck but remained unsuccessful.	
	Next steps were to excavate the road to expose the sewer and	
	determine the cause of the blockage. Staff identified that a section	
	of sanitary sewer pipe had collapsed on Metcalfe, between Church	
	and Mill St. ('Mill') in Elora.	
	A bypass pumping system around the collapsed section of sewer	
	was implemented for the duration of repairs.	
	A 30 m section of sanitary sewer pipe was deemed to be in very poor	
	Immediate replacement of the server main was required to eliminate

risk to public health & safety, and possible adverse environmental	
	impacts	
	Next Township staff completed CCTV condition assessment of the	
	sanitary sewers in the vicinity of the emergency repair. Based on this	
	assessment the Townshin identified a 6 m section of sanitary sewer	
	on Metcalfe between Church and James St. and a 70 m section of	
	sanitary sewer between Church and Mill that needed to be replaced	
	immediately due to their advanced state of deterioration Both	
	sections of sanitary sewer was completed were replaced completing	
	the repair	
	Background – The collapsed sections of sewer were constructed in	
	the 1960s and have been in-place for approximately 60 years. The	
	typical service life of for a concrete sanitary sewer is 80 years.	
	Township staff observed sections of the collapsed pipe crown with	
	only 3-5 mm of pipe thickness remaining (typical concrete pipe	
	thickness is 10-15 mm).

Based on analysis of the collapsed pipe segments and in discussions with experts in the concrete pipe industry, the likely cause of the premature pipe failure is a phenomenon called Microbial-Induced Concrete Corrosion ('MICC'). MICC occurs above the waterline in the presence of elevated concentrations of gaseous hydrogen sulfide and sulfuric acid build-up caused by bacteria coating the interior of the pipe.

Figure 2 shows the Metcalfe St. sewer main repair.

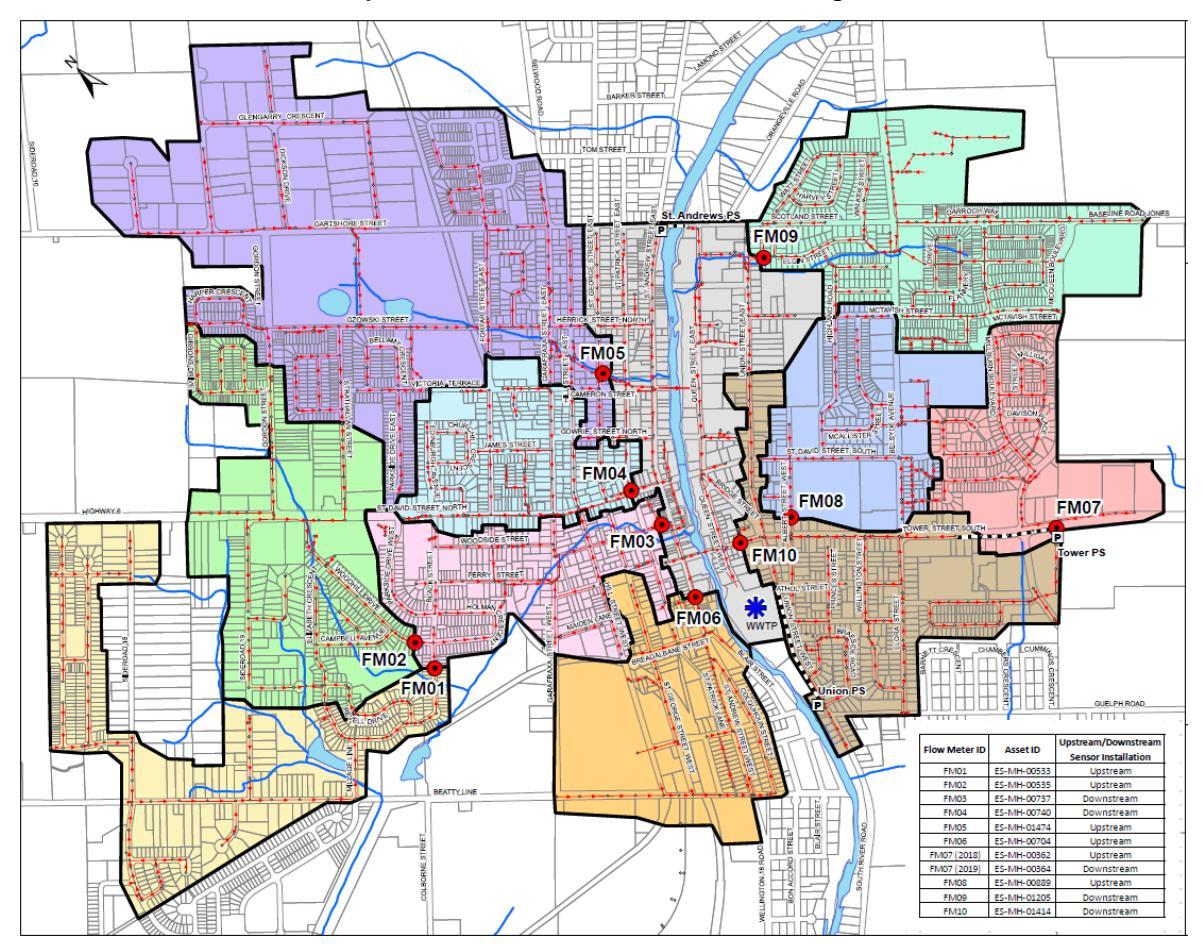
Figure 3: Fergus Sanitary Catchment Areas

In 2020, an Inflow and Infiltration study was completed by Cole Engineering. This study defined sanitary catchment areas for the urban systems of Fergus and Elora. Figure 3 below illustrates the sanitary catchment areas located in Fergus.

In 2022, the Sanitary Sewer and Storm Sewer CCTV Inspection, Assessment and Recommendation program selected areas FM09, FM03, FM04 (Figure 3) and the unmonitored grey section from the Cole Engineering Report for inspection as they were identified as the highest sources of inflow and infiltration.
