Tree Inventory and Preservation Plan

Ainley Subdivision, Township of Centre
Wellington, ON

Tree Inventory and Tree Preservation Plan

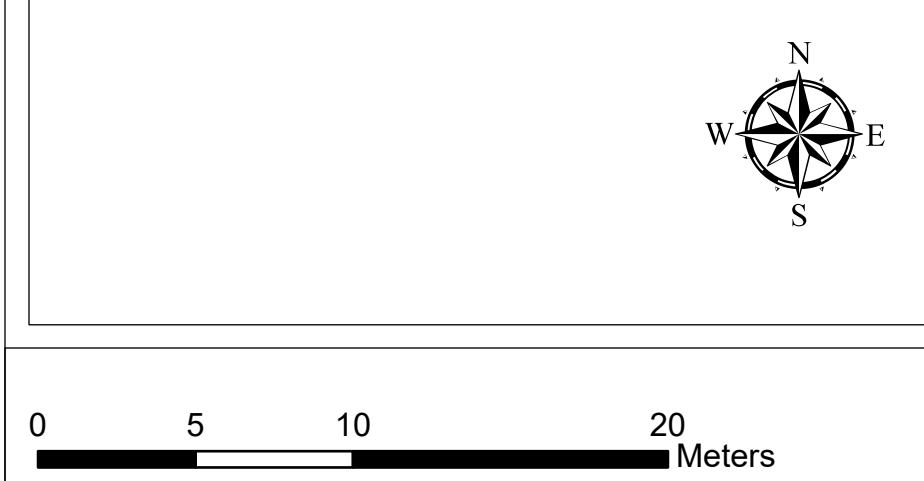
**Tree Protection Plan (A)
Ainley Subdivision**

- Legend**
- Subject Property
 - Proposed Development
 - Existing Lot Lines
 - Proposed Lot Lines
 - Proposed Streets
- Tree Inventory**
- Injure
 - Remove
 - Retain

Minimum TPZ distance from the base of the trunk

<10 cm DBH	1.2 m
11 - 19 cm DBH	1.8 m
20 - 40 cm DBH	2.4 m
41 - 50 cm DBH	3.0 m
51 - 60 cm DBH	3.6 m
61 - 70 cm DBH	4.2 m
71 - 80 cm DBH	4.8 m
81 - 90 cm DBH	5.4 m
91 - 100 cm DBH	6.0 m
>100 cm DBH	6cm / 1cm dia.

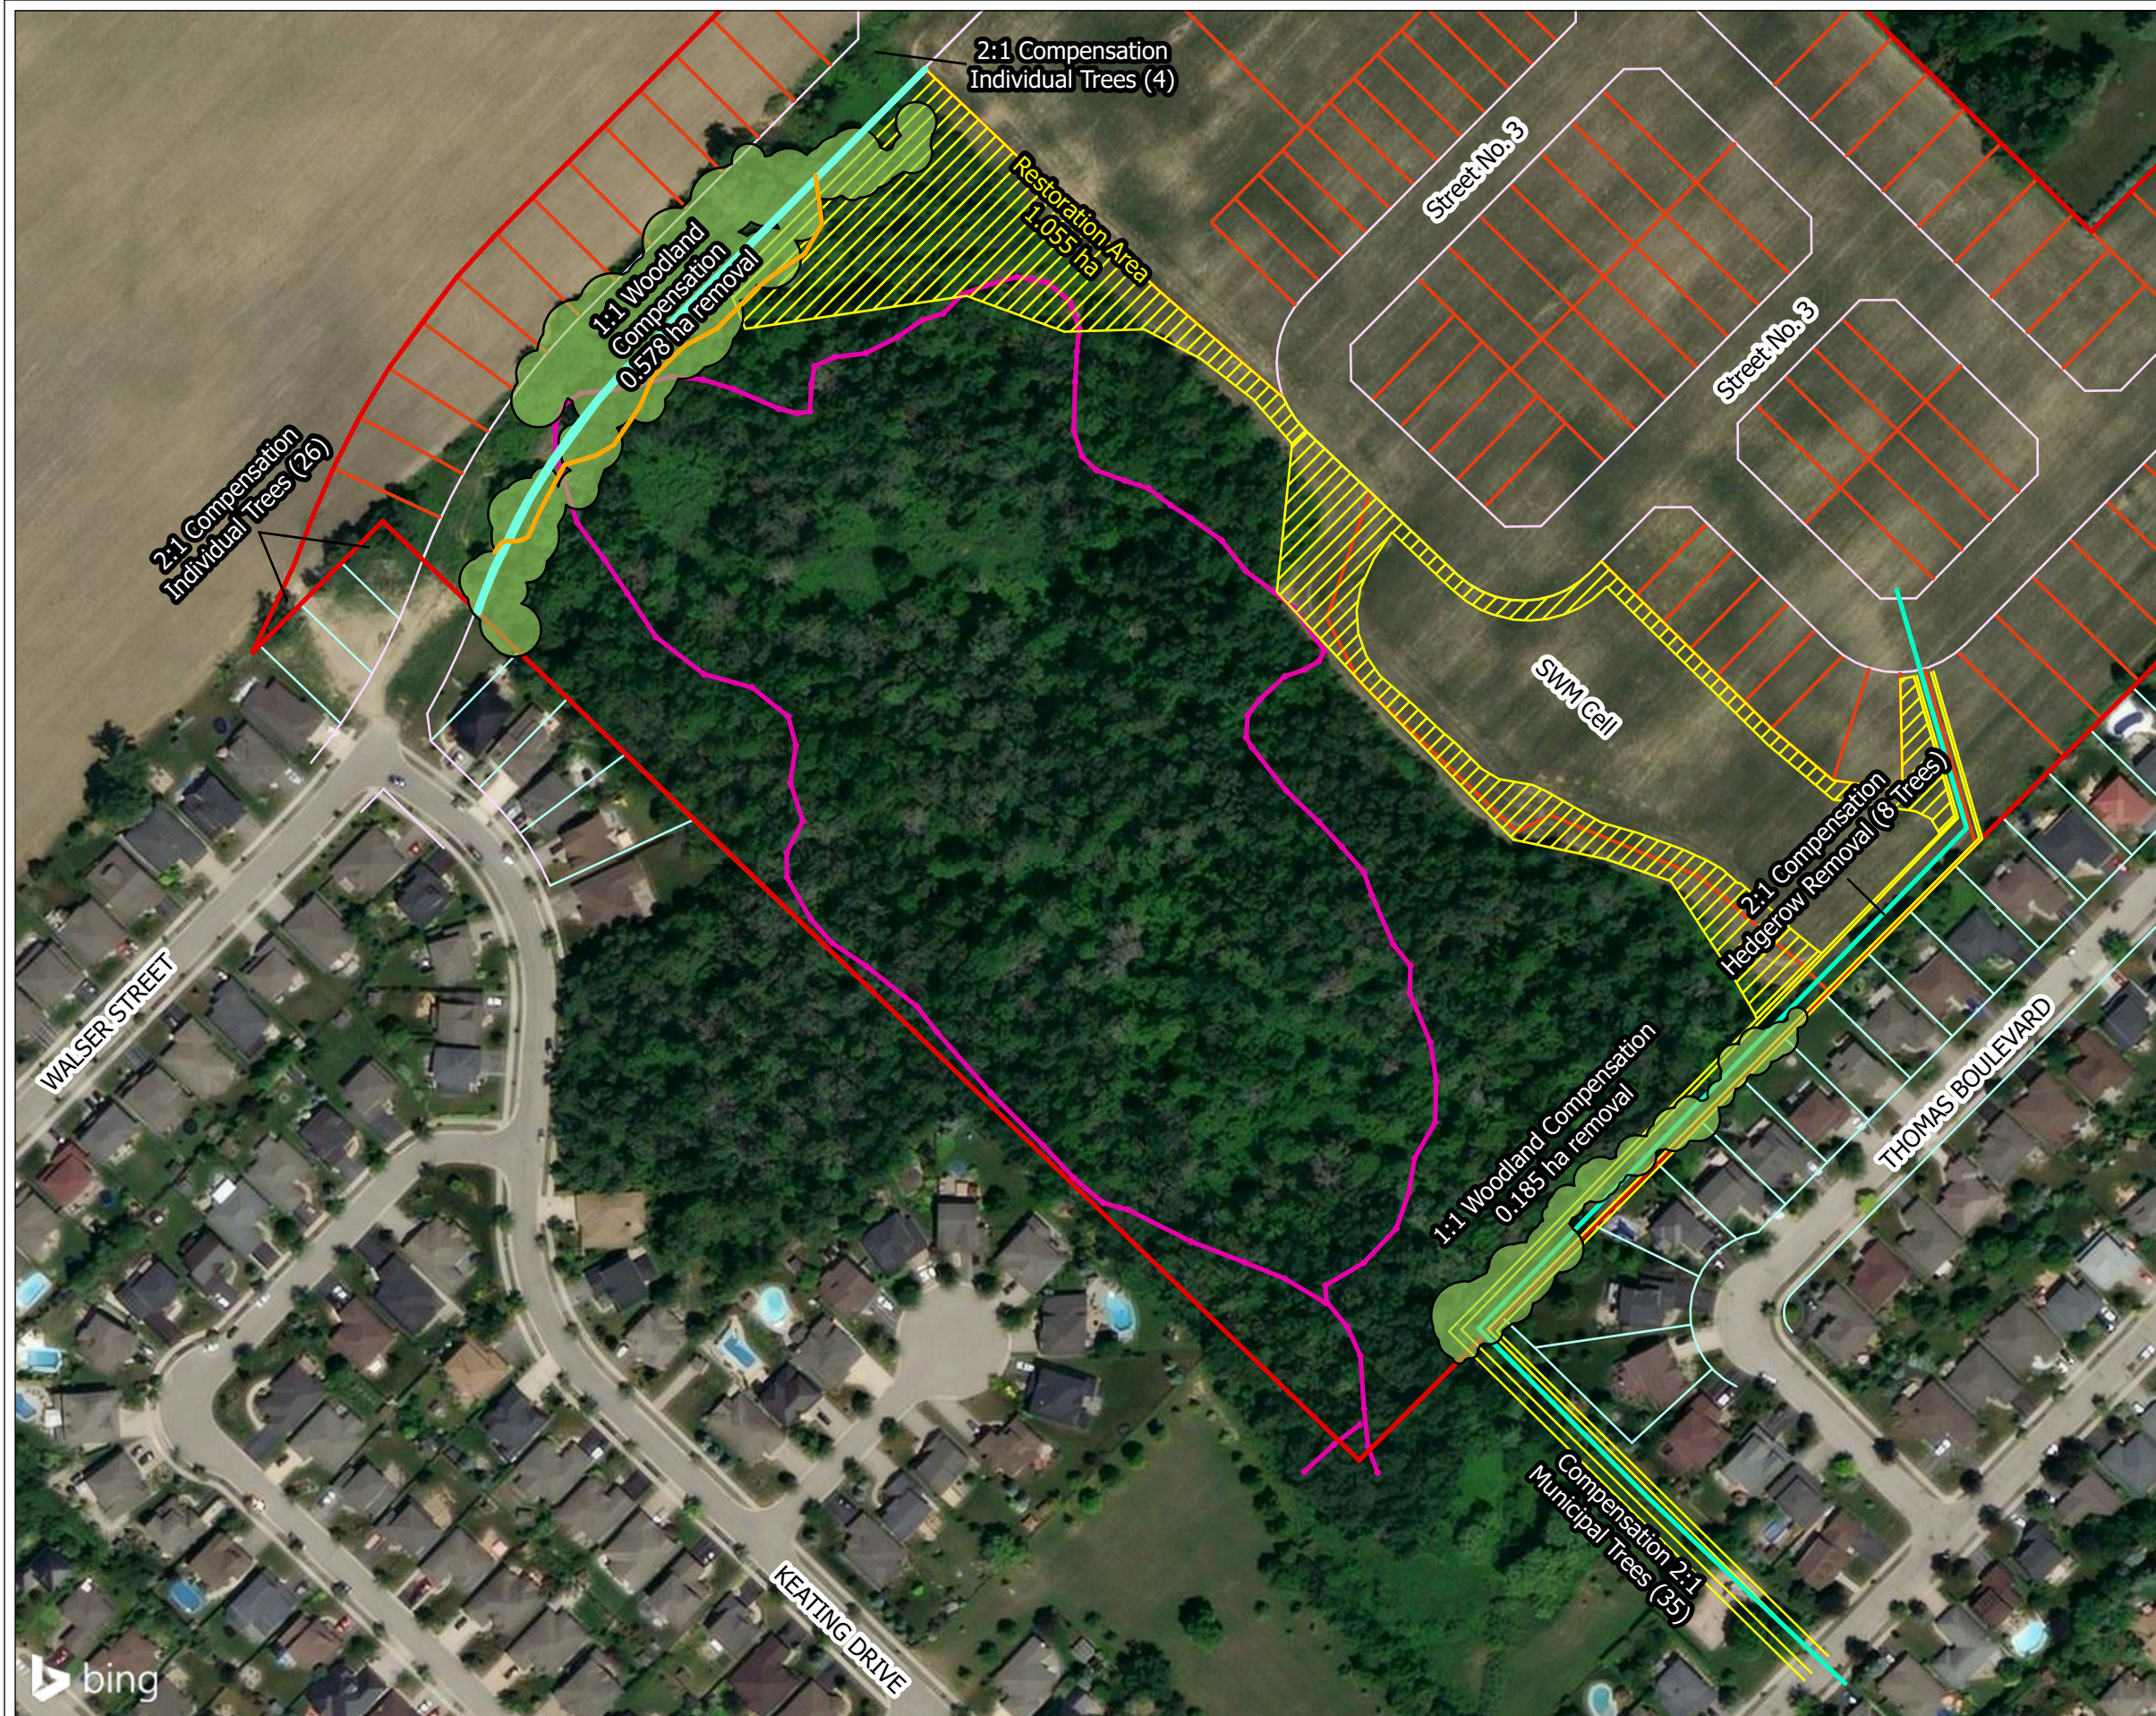
Figure 4 | Ainley Subdivision
Tree Removal Compensation Ratios

- Subject Property
- Limit of Disturbance for Road Construction
- Proposed Development**
- Existing Lot Lines
- Proposed Lot Lines
- Proposed Streets
- Proposed Pathway
- Proposed Sanitation Line
- Easement
- Compensation Area**
- Woodland Removal
- Recommended Restoration Areas
- Recommended Screening Vegetation

For trees removed within the Subject Property, it is believed the Subject Property is large enough in size to accommodate the replacement of trees directly on site. A map illustrating the available restoration area, equal to 1.055 ha, is provided within **Appendix 4**. Therefore, financial compensation is not considered a necessary means of fulfilling the required compensation recommendations. Compensation should be confirmed with the Township of Wellington. For trees removed outside of the Subject Property and owned by the municipality, discussion with the Township of Wellington is required to confirm the location of replacement trees.

For trees removed within the Subject Property (i.e., woodland, hedgerow/individual trees), replacement trees can be planted within the restoration area illustrated in **Appendix 4**. For trees removed outside of the Subject Property, owned by the municipality, discussion with the Township of Wellington is required to confirm the location of replacement trees.
