SCOPED HERITAGE IMPACT ASSESSMENT & CONSERVATION PLAN

7450 Middlebrook Road,
Elora, ON

November 21, 2022

Project No. 21161B

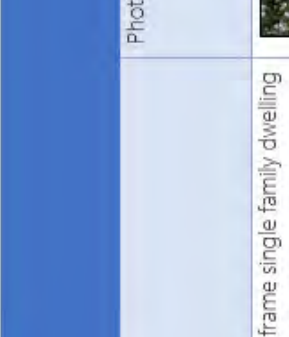
Building/ Structures	Description	Photograph
Farmhouse	Two storey, wood frame single family dwelling in the Georgian architectural style.

The farmhouse on the subject property is clad in stucco with the exception of the addition on the north elevation which is of a wood frame construction clad in siding. The farmhouse has a low-pitched open gable roof line with returning eaves and the addition has a medium-pitched open gabled roofline. The front (south) elevation contains 5 window openings and centred entry with a pediment portico. The west elevation includes an enclosed addition/ sunroom and two window openings that appear to have been altered. The rear (south) elevation includes the rear addition which is 'tucked' under the returning eave of the north elevation of the farmhouse.

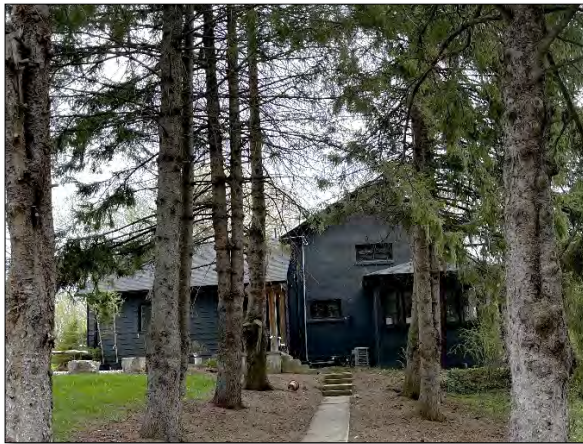
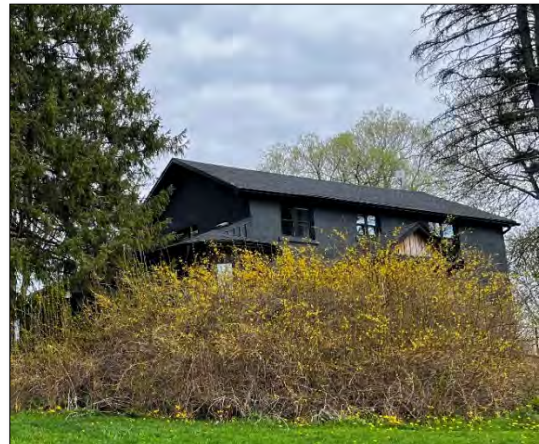
Figures 12 & 13- The front (southeast-facing) elevation of the dwelling (right) The left (southwest-facing) elevation of the house (Source: MHBC, 2022).

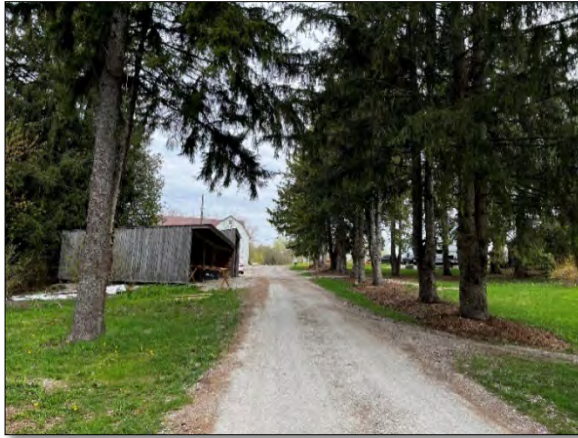
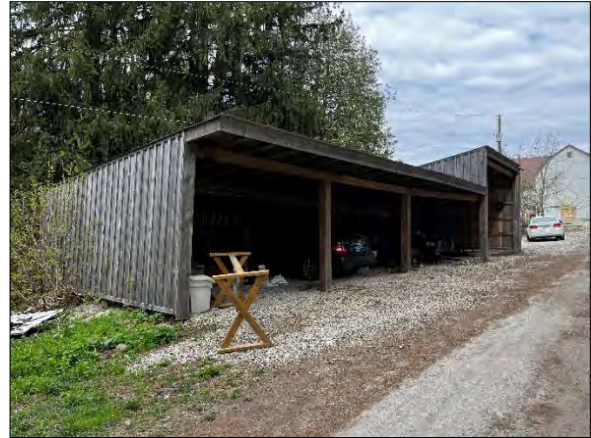
Figures 14 & 15- (left) A view of the shed looking northwest from the base of the driveway (right) A view of the front (east-facing) elevation of the shed (Source: MHBC, 2022).

There is a one storey wood frame shed / outbuilding with platform roofline. The building is along the west side of the main gravel driveway. This structure functions as a carport/ drive shed and has the capacity of approximately five vehicles.

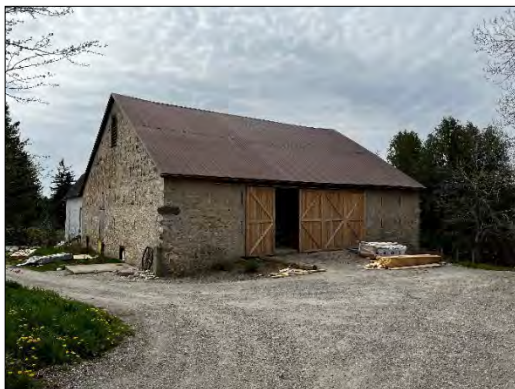
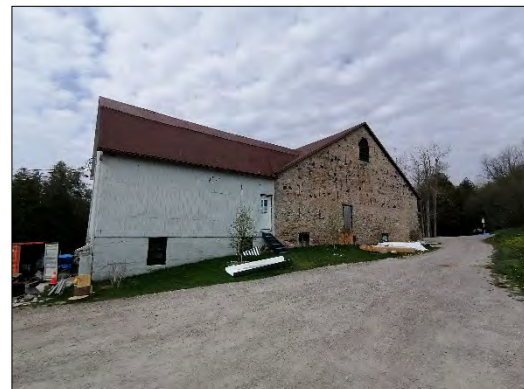
A three-storey field/ rubble stone banked slit barn located on the northwest portion of the subject property. The main barn has a rectangular footprint with an open gabled roof line constructed of metal sheathing and southern mid-century addition on the south with concrete foundation and wood frame construction with a gambrel roofline, also constructed of metal sheathing.

Figures 16 & 17- (left) The front (northwest-facing) elevation of the barn (right) A view of the east elevation with addition (Source: MHBC, 2022).

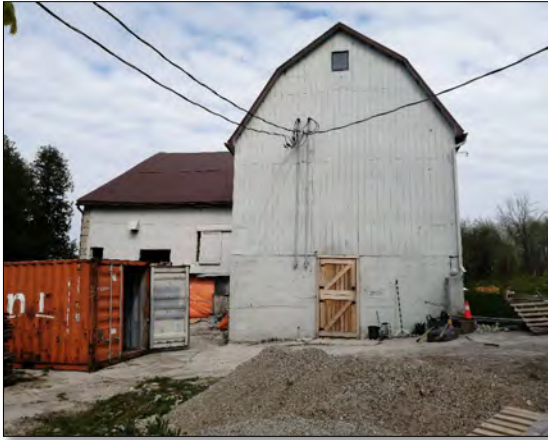
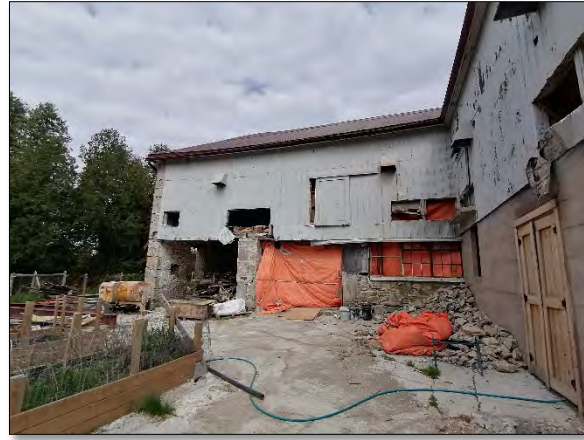
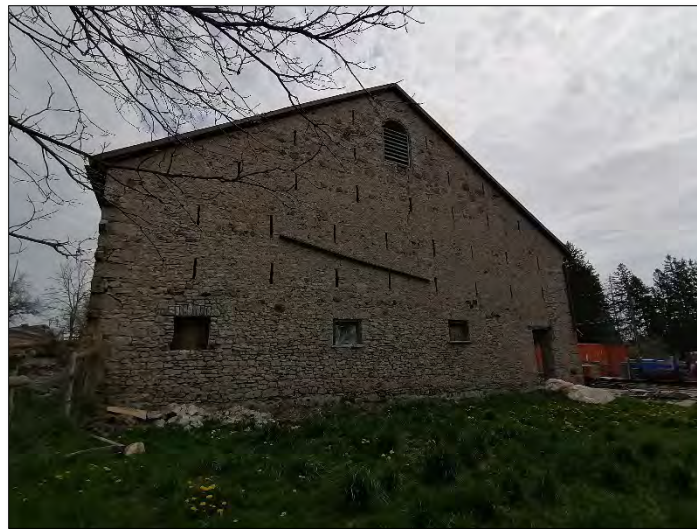
Figures 18-20- (left) The south elevation of the barn with gambrel barn addition (right) A view of the south elevation of main barn; (below centre) View of west elevation of main barn (Source: MHBC, 2022).

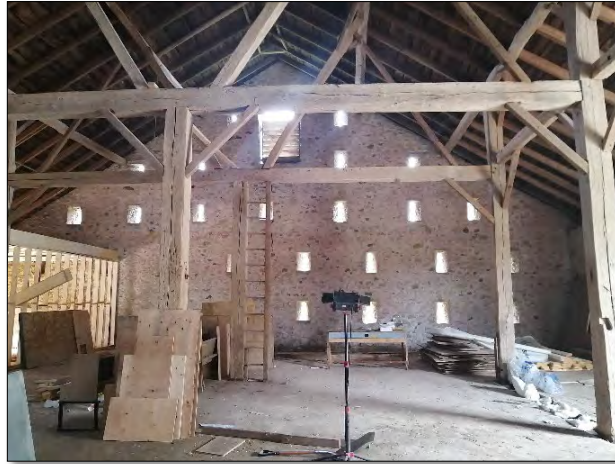
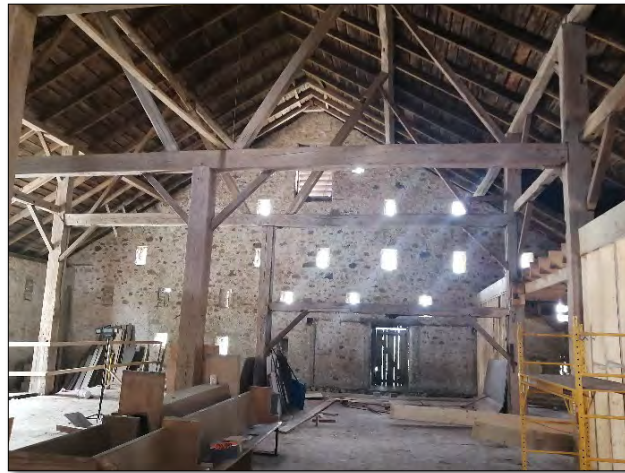
The main barn includes rows of narrow, slit openings and a centred window opening below the gable end. Some flooring and wood joists have been removed and replaced due to extreme deterioration. The mezzanine also was removed due to health and safety concerns and is planned to be reinstated.

Figures 21 & 22- (above) View of the interior of the west elevation; (below) View of the interior of the east elevation also showing interior of wood roof structure (Source: MHBC, 2022).

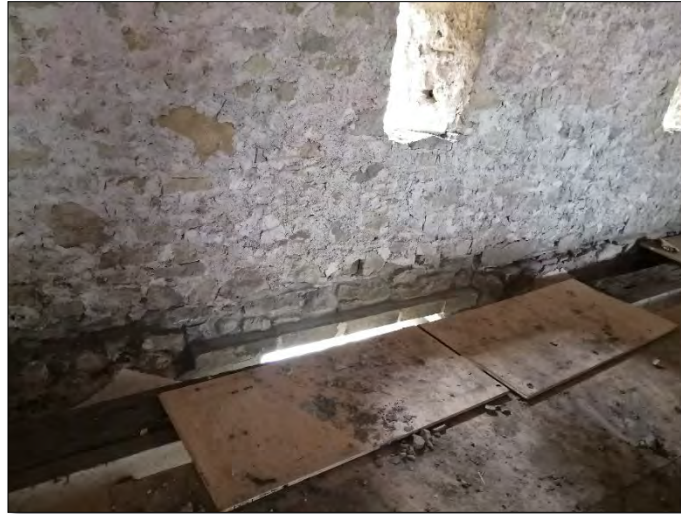
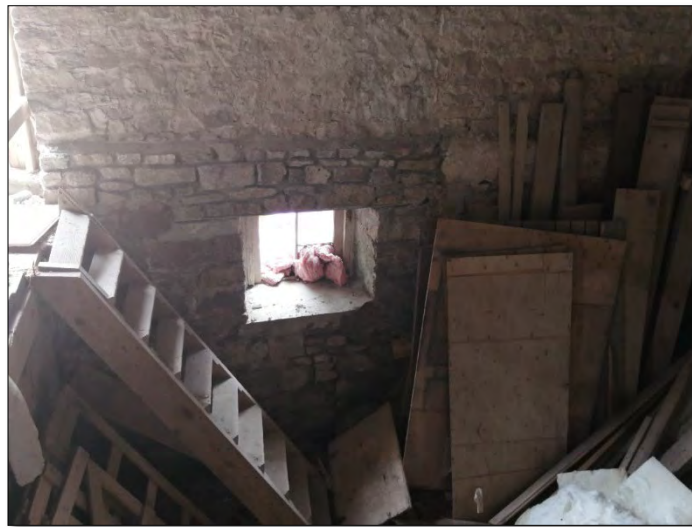
Work has commenced by masons to repair and repoint the existing masonry of the main barn structure; this process includes removing the existing mortar and replacing it with new lime based mortar.

Figures 23 & 24- (above) View of progress of repair to masonry on west elevation; ((below) View of progress of repair on lower level of south elevation (Source: MHBC, 2022).

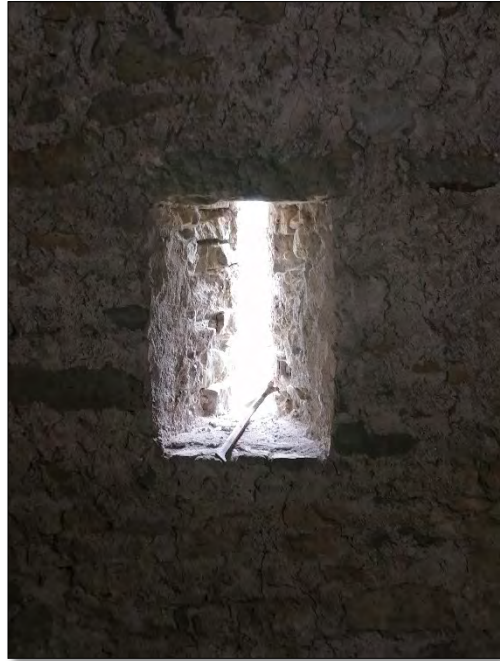
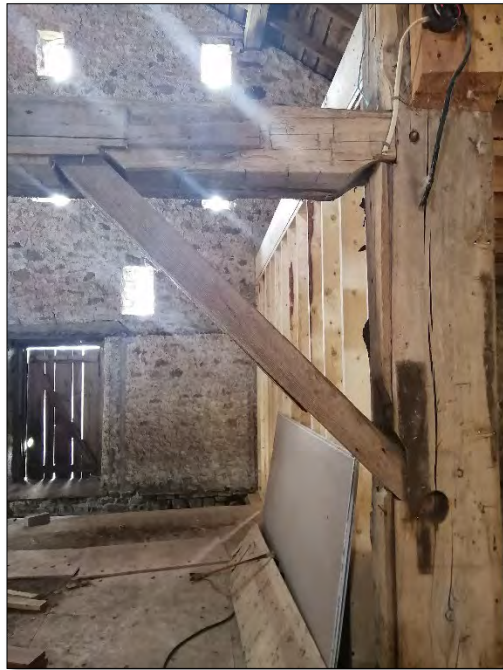
The vertical slots begin as a larger rectangular opening in the interior and gradually narrow to the vertical 'slit' that is visible from the exterior of the building (Figure 22). The barn also includes mortise and tenon construction which is visible in Figure 23.

Figures 25 & 26- (above) Detailed view of stone slit opening construction from interior; (below) View of mortise and tenon construction in the interior of the barn (Source: MHBC, 2022).

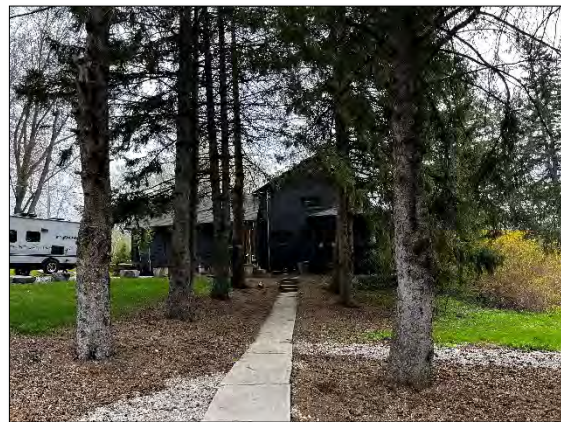
Figures 27 & 28- (above) View of tree-lined driveway; (below) View of tree-lined pathway to farmhouse (Source: MHBC, 2022).

The property includes a tree-lined driveway leading northwards from Middlebrook Road and a tree-lined path eastward towards the house from the main driveway.

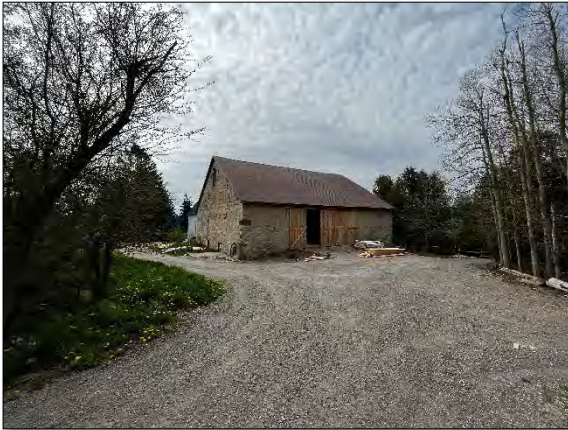
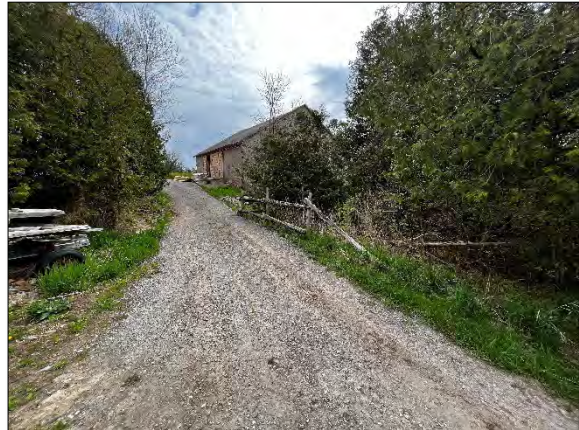
Figures 29 & 30- (left) View looking southwards of immediate context/ setting of slit barn; (right) View looking eastwards towards slit-barn showing some split rail fencing (Source: MHBC, 2022).

The east and north elevation of the barn is surrounded by gravel, however, the west elevation includes a natural open space followed by a wooded area to the west. There is some split rail

fencing along the lane that runs parallel to the barn. The property includes some wooded areas and open agricultural fields.

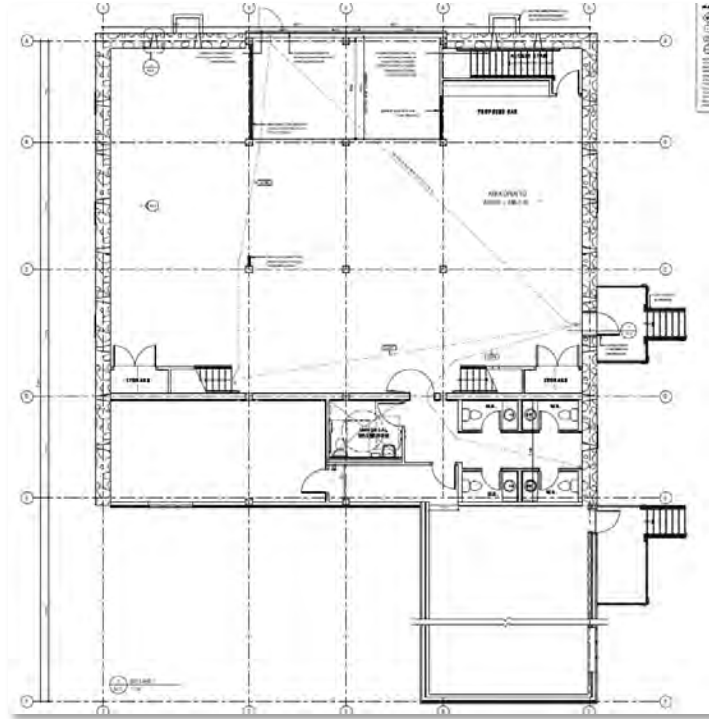
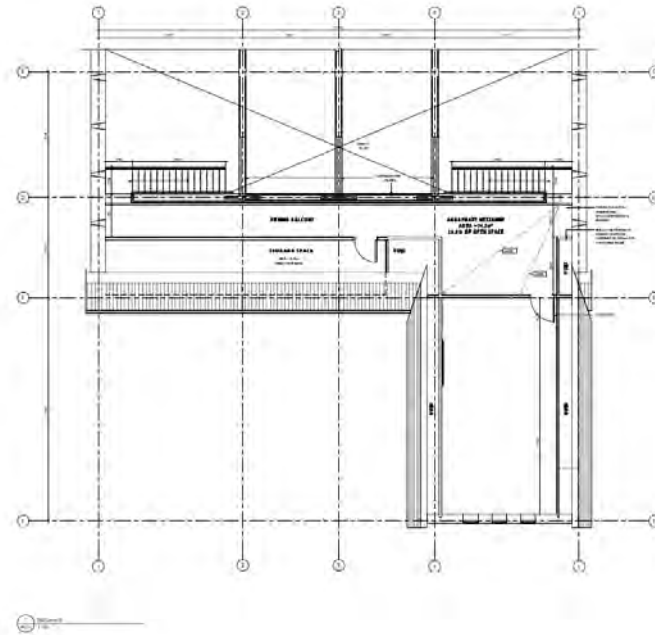
- Repair and repointing of fieldstone masonry with lime based mortar;
- Installation of wood flooring (European Larch) and replace or reinforce deteriorated joists in the original barn;
- Rebuild mezzanine in the interior;
- Replace louvered window inserts with stained glass;
- Install new electrical system;
- Partition walls for shop space and washrooms on south side of barn;
- Roof repair/ replacement with like material;
- Install new window frames to replace rotten window frames at basement level;
- Replace main barn slider doors and human door entries with similar, new doors; and
- Concrete flooring in basement.

Figures 32 & 33- (above) Proposed main floorplan of the slit barn post rehabilitation; (below) Proposed second floor plan (Source: Fryett Turner Architects Inc.).

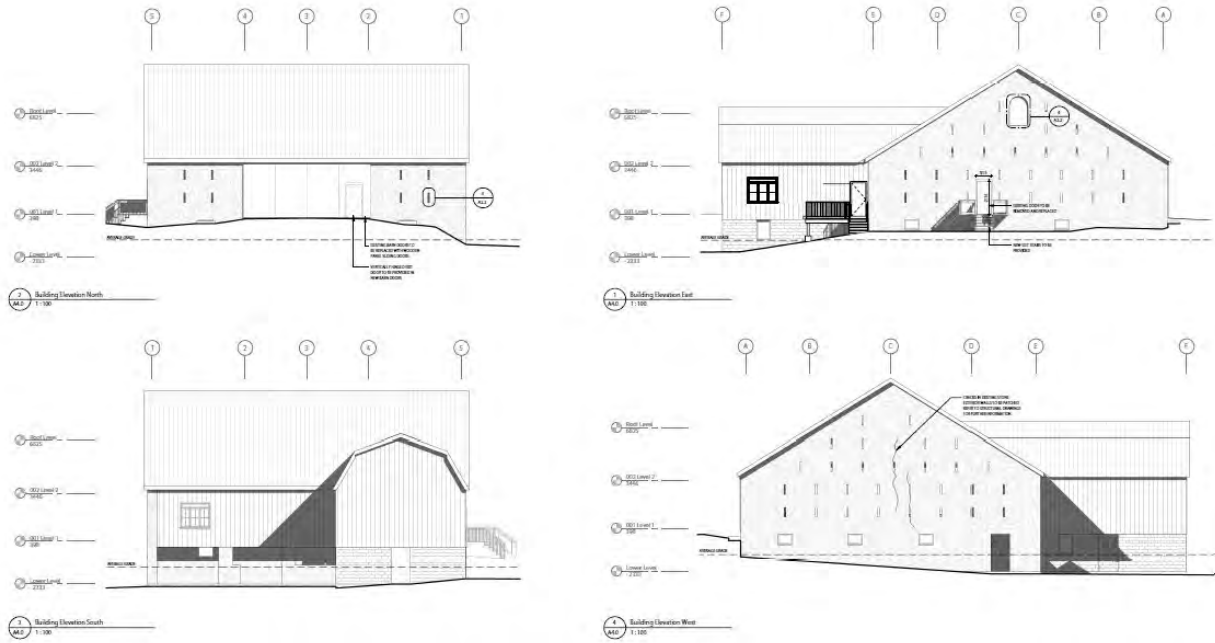
Figure 34- Proposed elevations of slit barn rehabilitation (Source: Fryett Turner Architects Inc.).

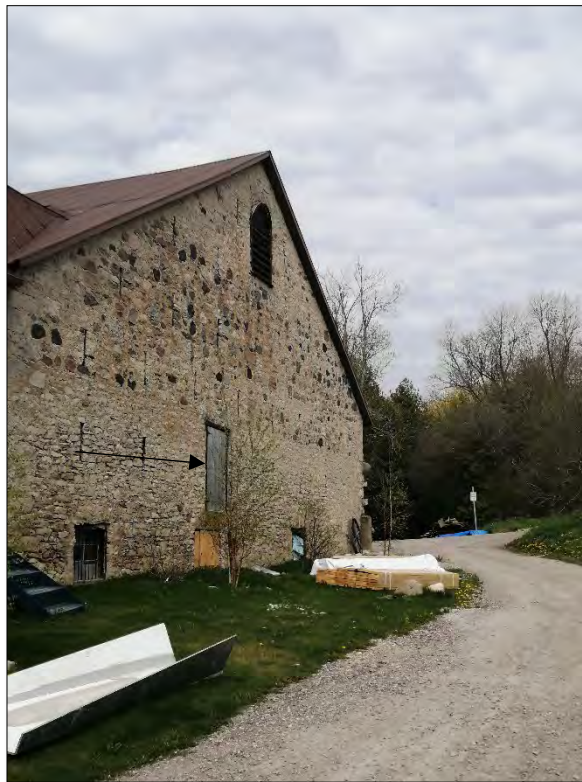
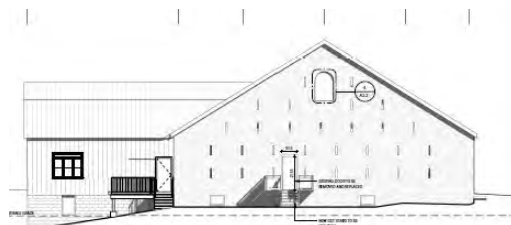
The building will be used for commercial purposes including a local market and entertainment venue. These uses require minimal changes that are relevant to the Ontario Building Code to ensure health, safety and barrier free access.

Figures 35 & 36- (above) Doorway that will be minimally altered to allow for barrier free access (Source: MHBC 2022) (below) Proposed elevation (Source: Fryett Turner Architects Inc., 2022).

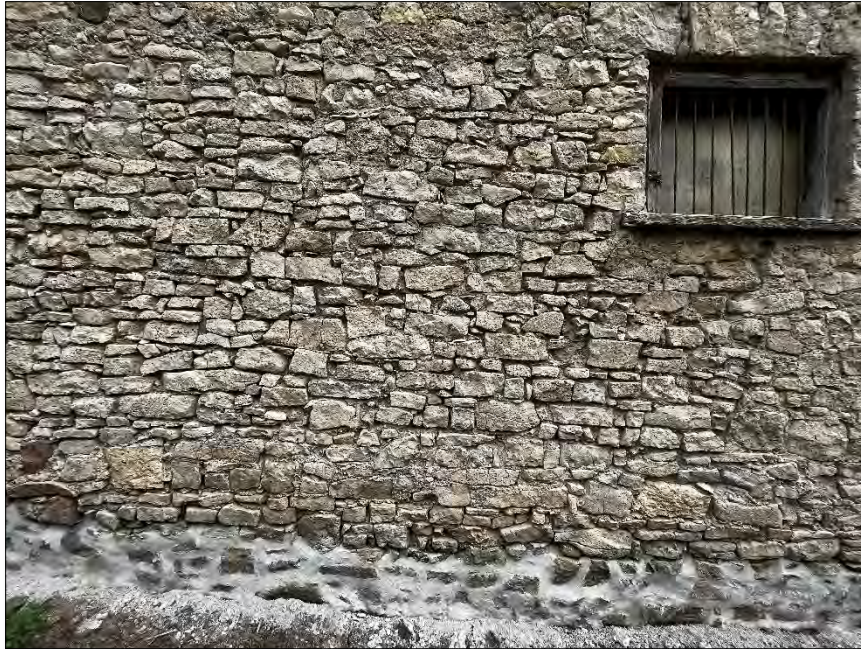
The heritage buildings are in good condition. Repair and repointing of masonry for the barn has already commenced, although the repair is not required to stabilize the structure. There are no archaeological resources perceived to be or identified on either the current site of the heritage building.

Figure 37- Detailed view of rubble stone facade (Source: MHBC 2022).

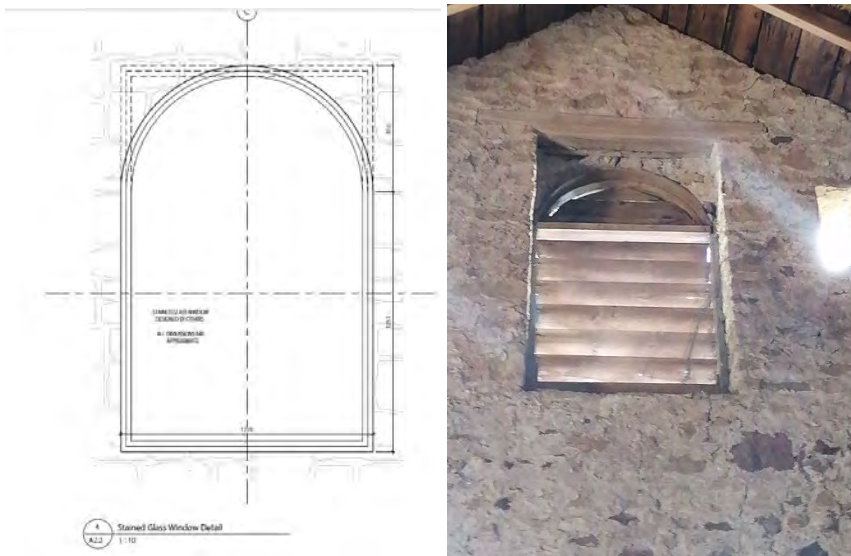
The majority of the character-defining elements are in good condition and do not require replacement. If replacement is required, there is sufficient physical evidence to replace them with new elements that match the forms, materials and detailing of sound versions of the same elements. The louvered window insert will be replaced with stained glass to better insulate the interior and to allow for more light for the venue.

Figures 38 & 39- (above) Sketch of semi-arched window opening which is on the west and east elevation of the original barn (Source: Fryett Turner Architects Inc., 2022); (below) Photograph of semi-arched window opening of the slit-barn (Source: MHBC, 2022).

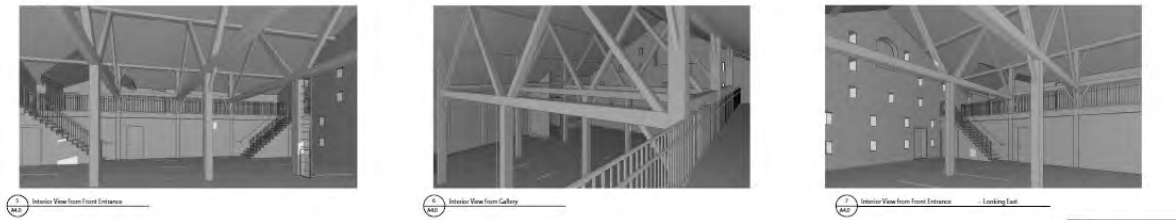
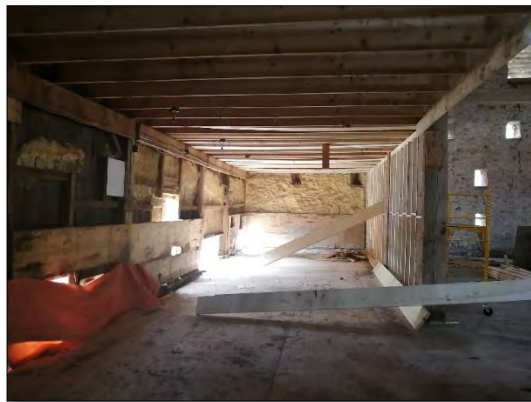
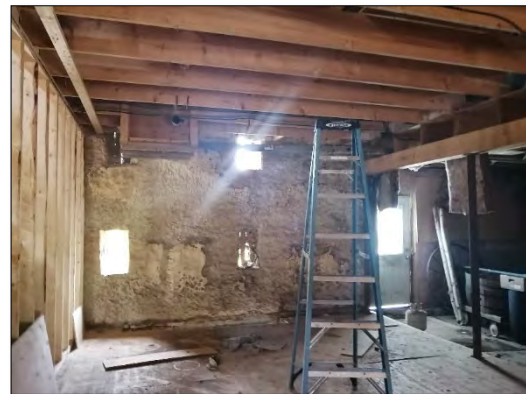
The proposed new construction, which would include some partition walls in the later addition to facilitate washrooms (etc.) are intended to be physically and visually compatible to the historic barn.

Figures 40-42- (above) Proposed 3D renderings of the interior construction of the slit-barn (Source: Fryett Turner Architects Inc., 2022); (below left) View of south end of original barn installation of updated wood framing and joists; (below right) View of east end of southern portion of original barn transitioning to the south addition (Source: MHBC., 2022).

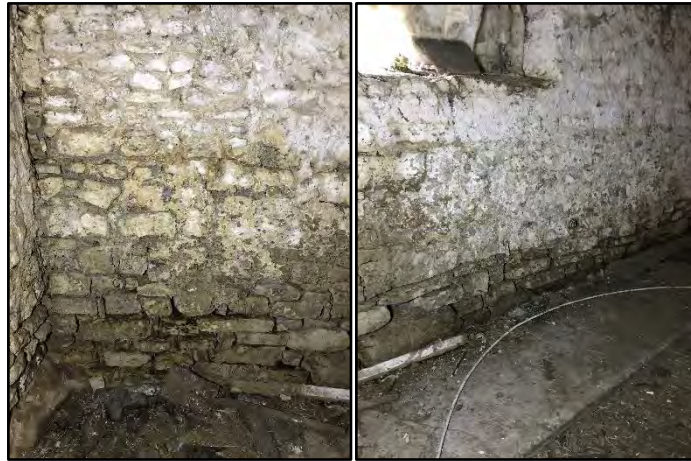
Figure 1a,b: Mortar deterioration of foundation walls

- **Short Term (12 months) Remedial Action:** repair both the exterior masonry with a lime-based mortar and deterioration below windows with a compatible product.
- **Medium Term (24 months) Remedial Action:** replace or reinforce deteriorated joists in the original barn.
- **Items Requiring Routine Maintenance:** monitoring both drainage systems for the barn and the condition of the floor joists for potential insect damage.

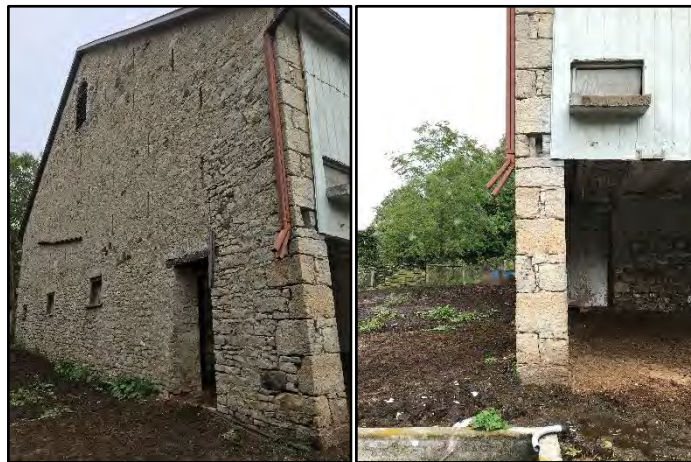
Figure 2: Mortar deterioration on exterior face of gable end wall

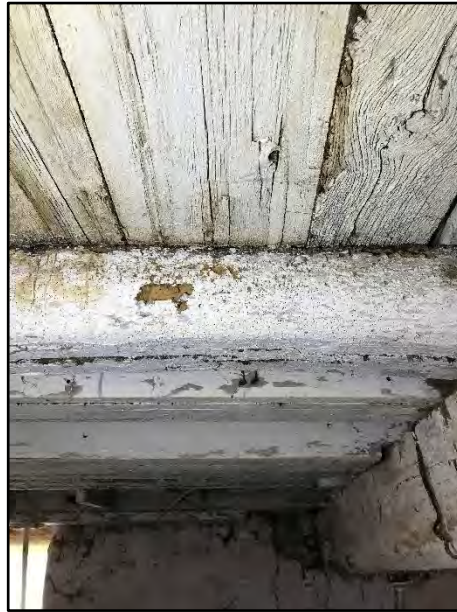
Figure 3: Joist deterioration in main floor framing

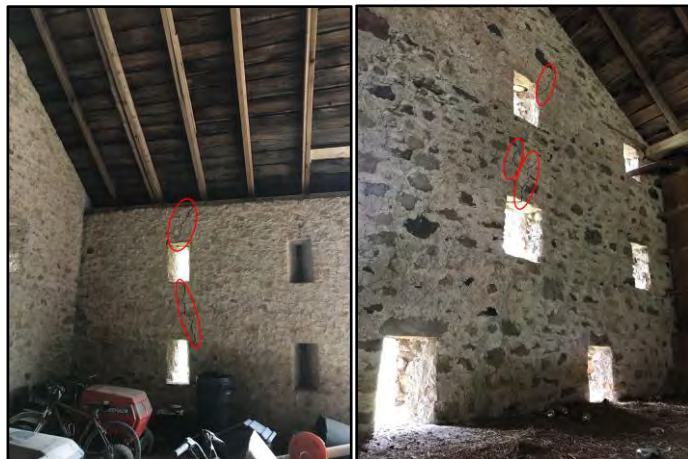
Figure 4: Cracking around openings on masonry walls

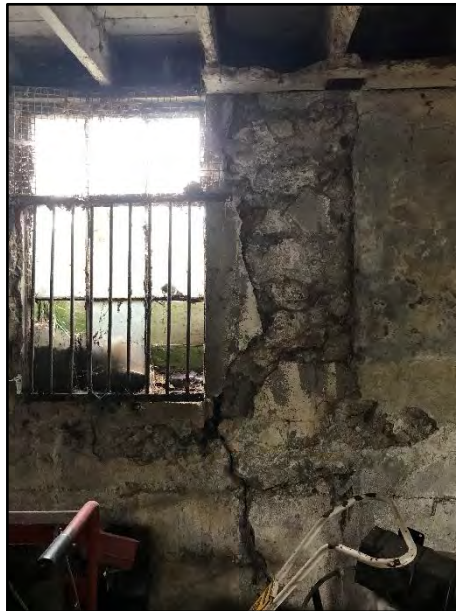
Figure 5: Foundation wall deterioration
