April 5, 2022

Ainley Farm Environmental Impact Study

Addendum # 2

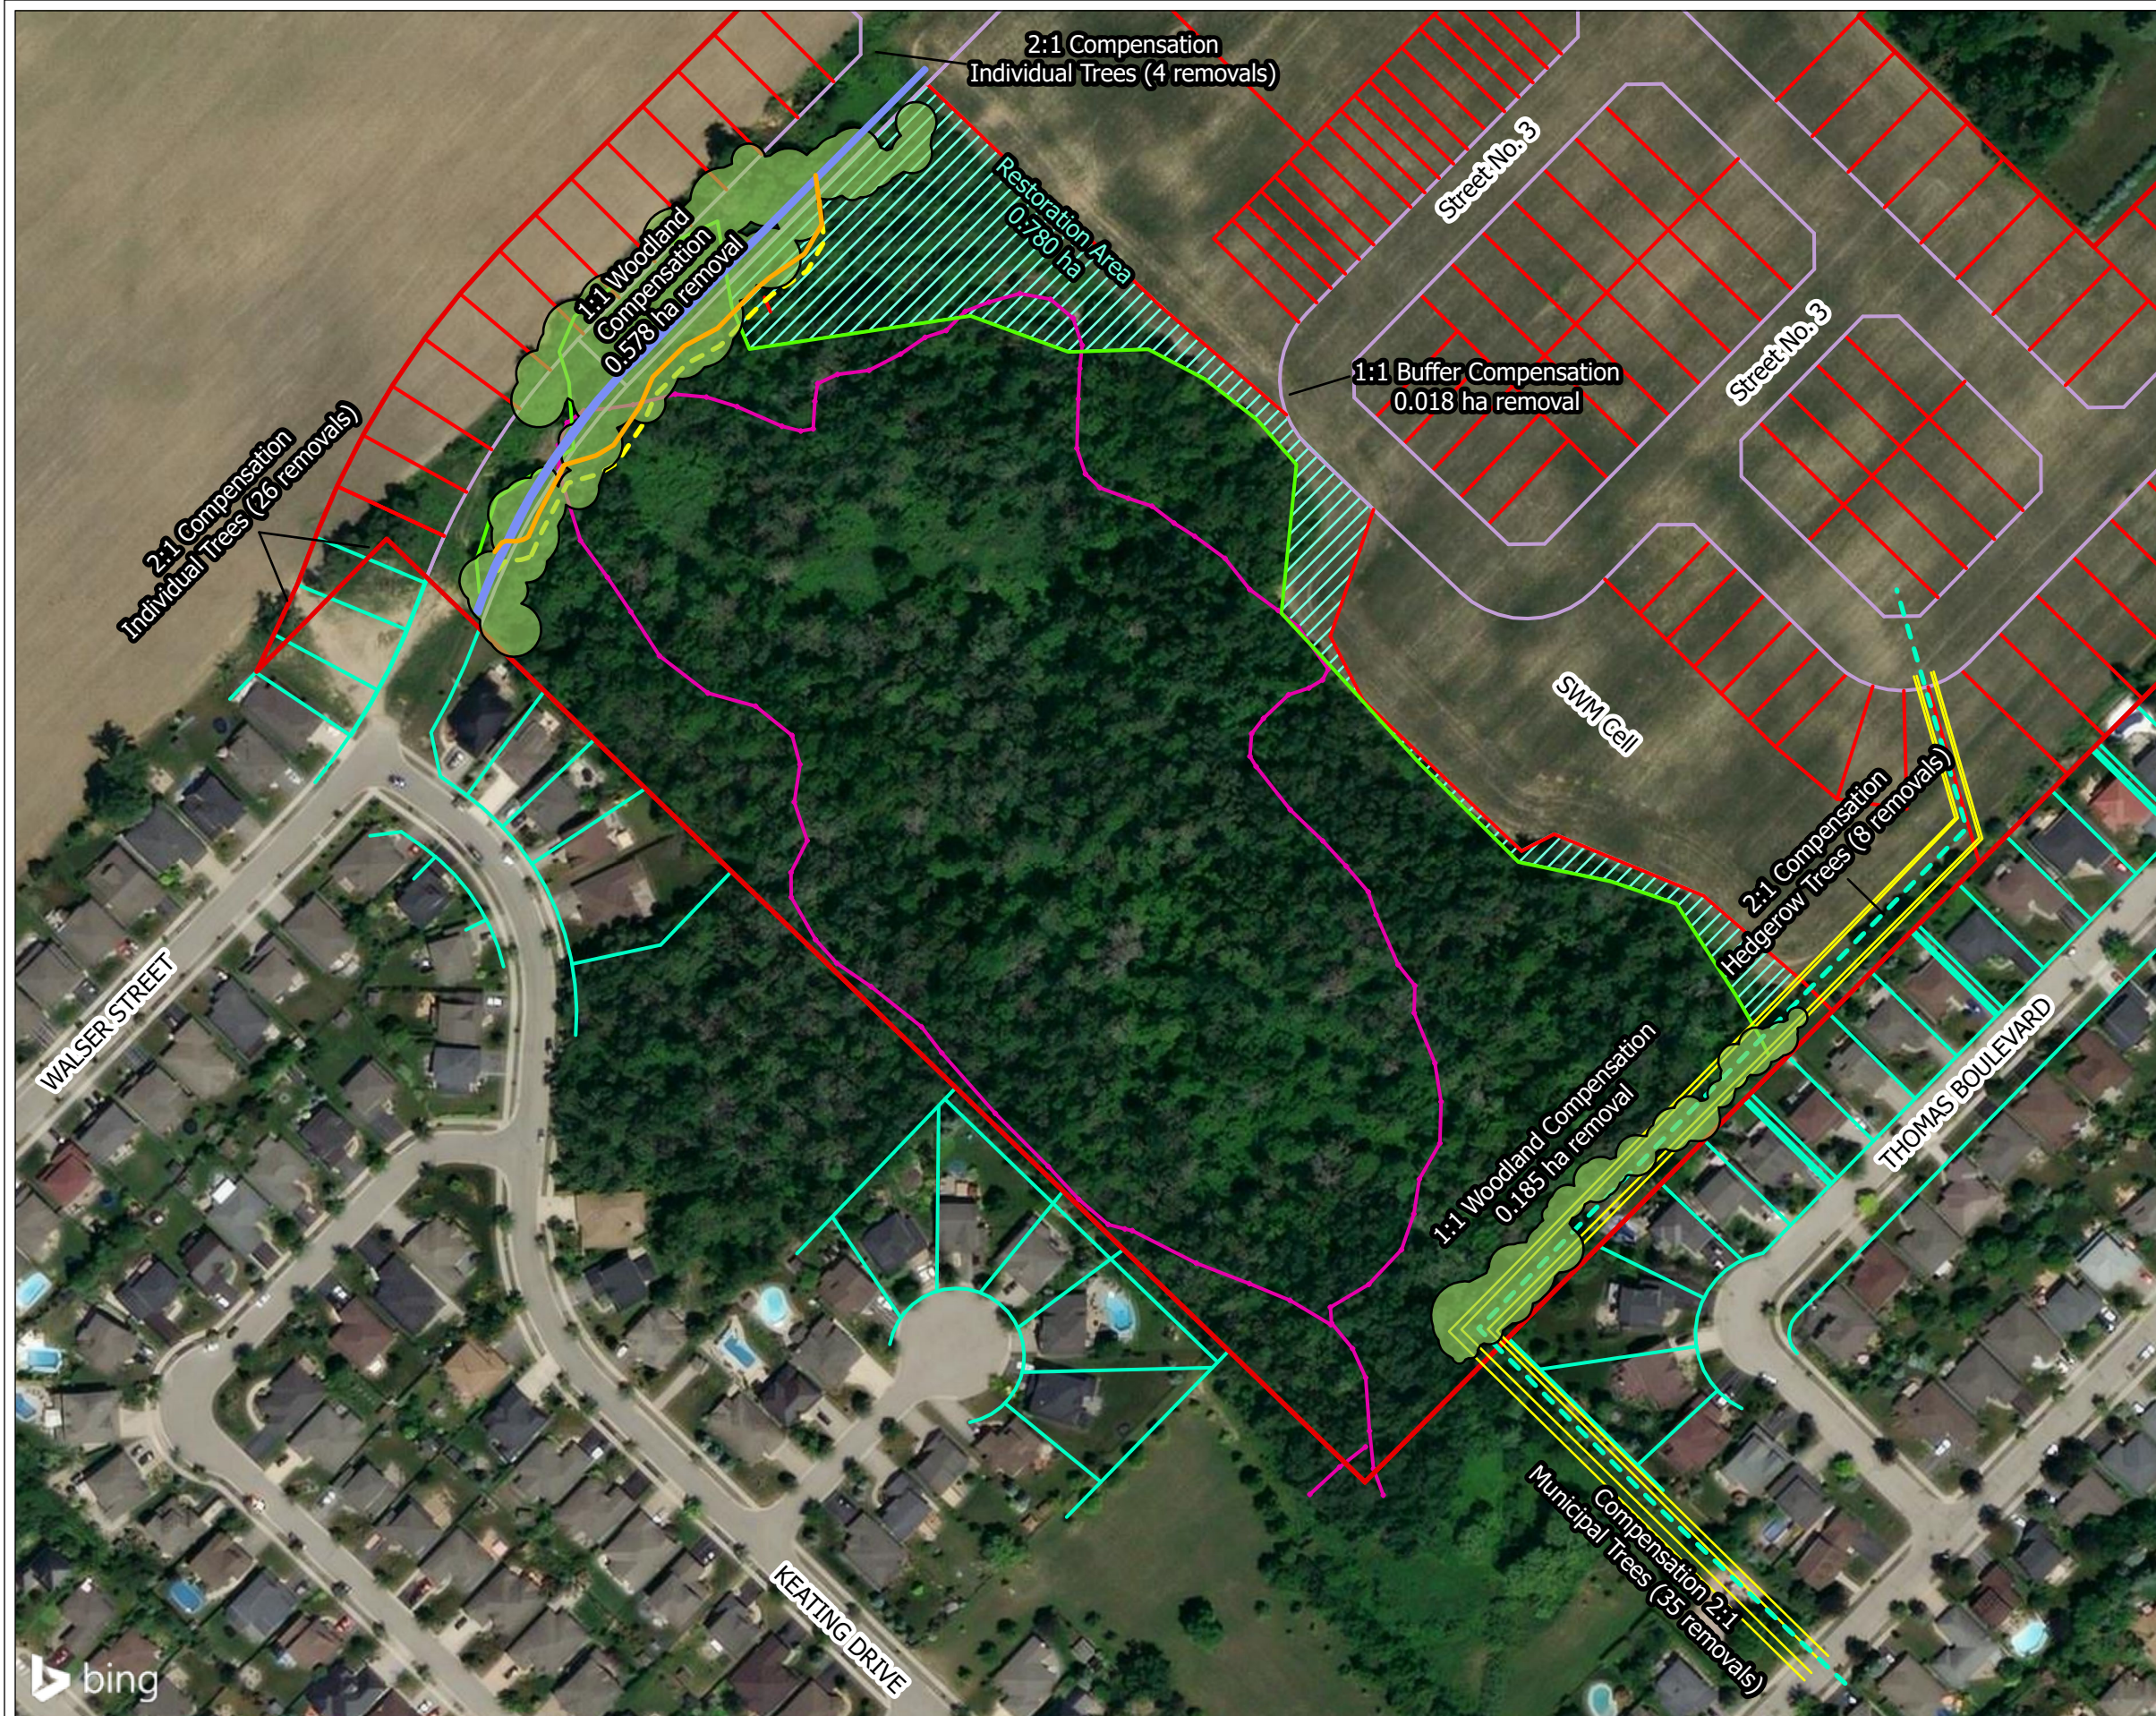
Figure 2 | Ainley Subdivision
Tree Removal Compensation Ratios

NRSI requested that tree planting occur at density of 1200 trees per hectare of any size. The proposed development plan will result in the removal of 0.771 ha of woodland trees. Based on the area proposed for removal, 925 trees of any size (e.g., whips, 50-100 cm height) will be planted for compensation. This is based on the calculation of $(0.771)(1200) = 925$ trees. If tree planting of larger caliper species is proposed within the development envelope, the density/numbers of trees per hectare will be adjusted consistent with the Forestry Act (e.g., 750 over 5 cm diameter per hectare). Planted trees shall come with a 2-year warranty period and monitoring will be conducted during this period to determine numbers of replacement trees.

It should be noted that a total of 7.223 ha of woodland area is being preserved on the Subject Property. The number of trees within the preserved woodland area is estimated to be 3100 trees \geq 10 cm DBH (calculations are shown in the Tree Protection Plan). This estimate is likely conservative. The areas of woodland proposed to be removed for the Walser Street Extension (0.578 ha) and the sanitary sewer on the south side of the woodland (0.185 ha) total 0.763 ha. An additional area of 0.008 ha of woodland buffer is proposed to be removed for Street 3, bringing the total to 0.771 ha. The area of woodland proposed for removal will be compensated at a 1:1 ratio in order to maintain tree canopy cover. A total of 0.780 ha (slightly larger than the area lost) is identified for compensation purposes adjacent to the woodland as it was assumed that the density of planted trees within the compensation areas may have to be adjusted in minor locations because of requirements for stormwater treatment facilities, presence of existing tree roots, etc. Restoration areas are shown in

A trail is proposed to follow the existing informal trail alignment (**Figure 2**). It is recommended that the trail be retained as informal, but surfaced with fine granular material. Signage should be used to warn people that dumping, off-trail encroachment and movement of soils and vegetation have high impacts and are not permitted.

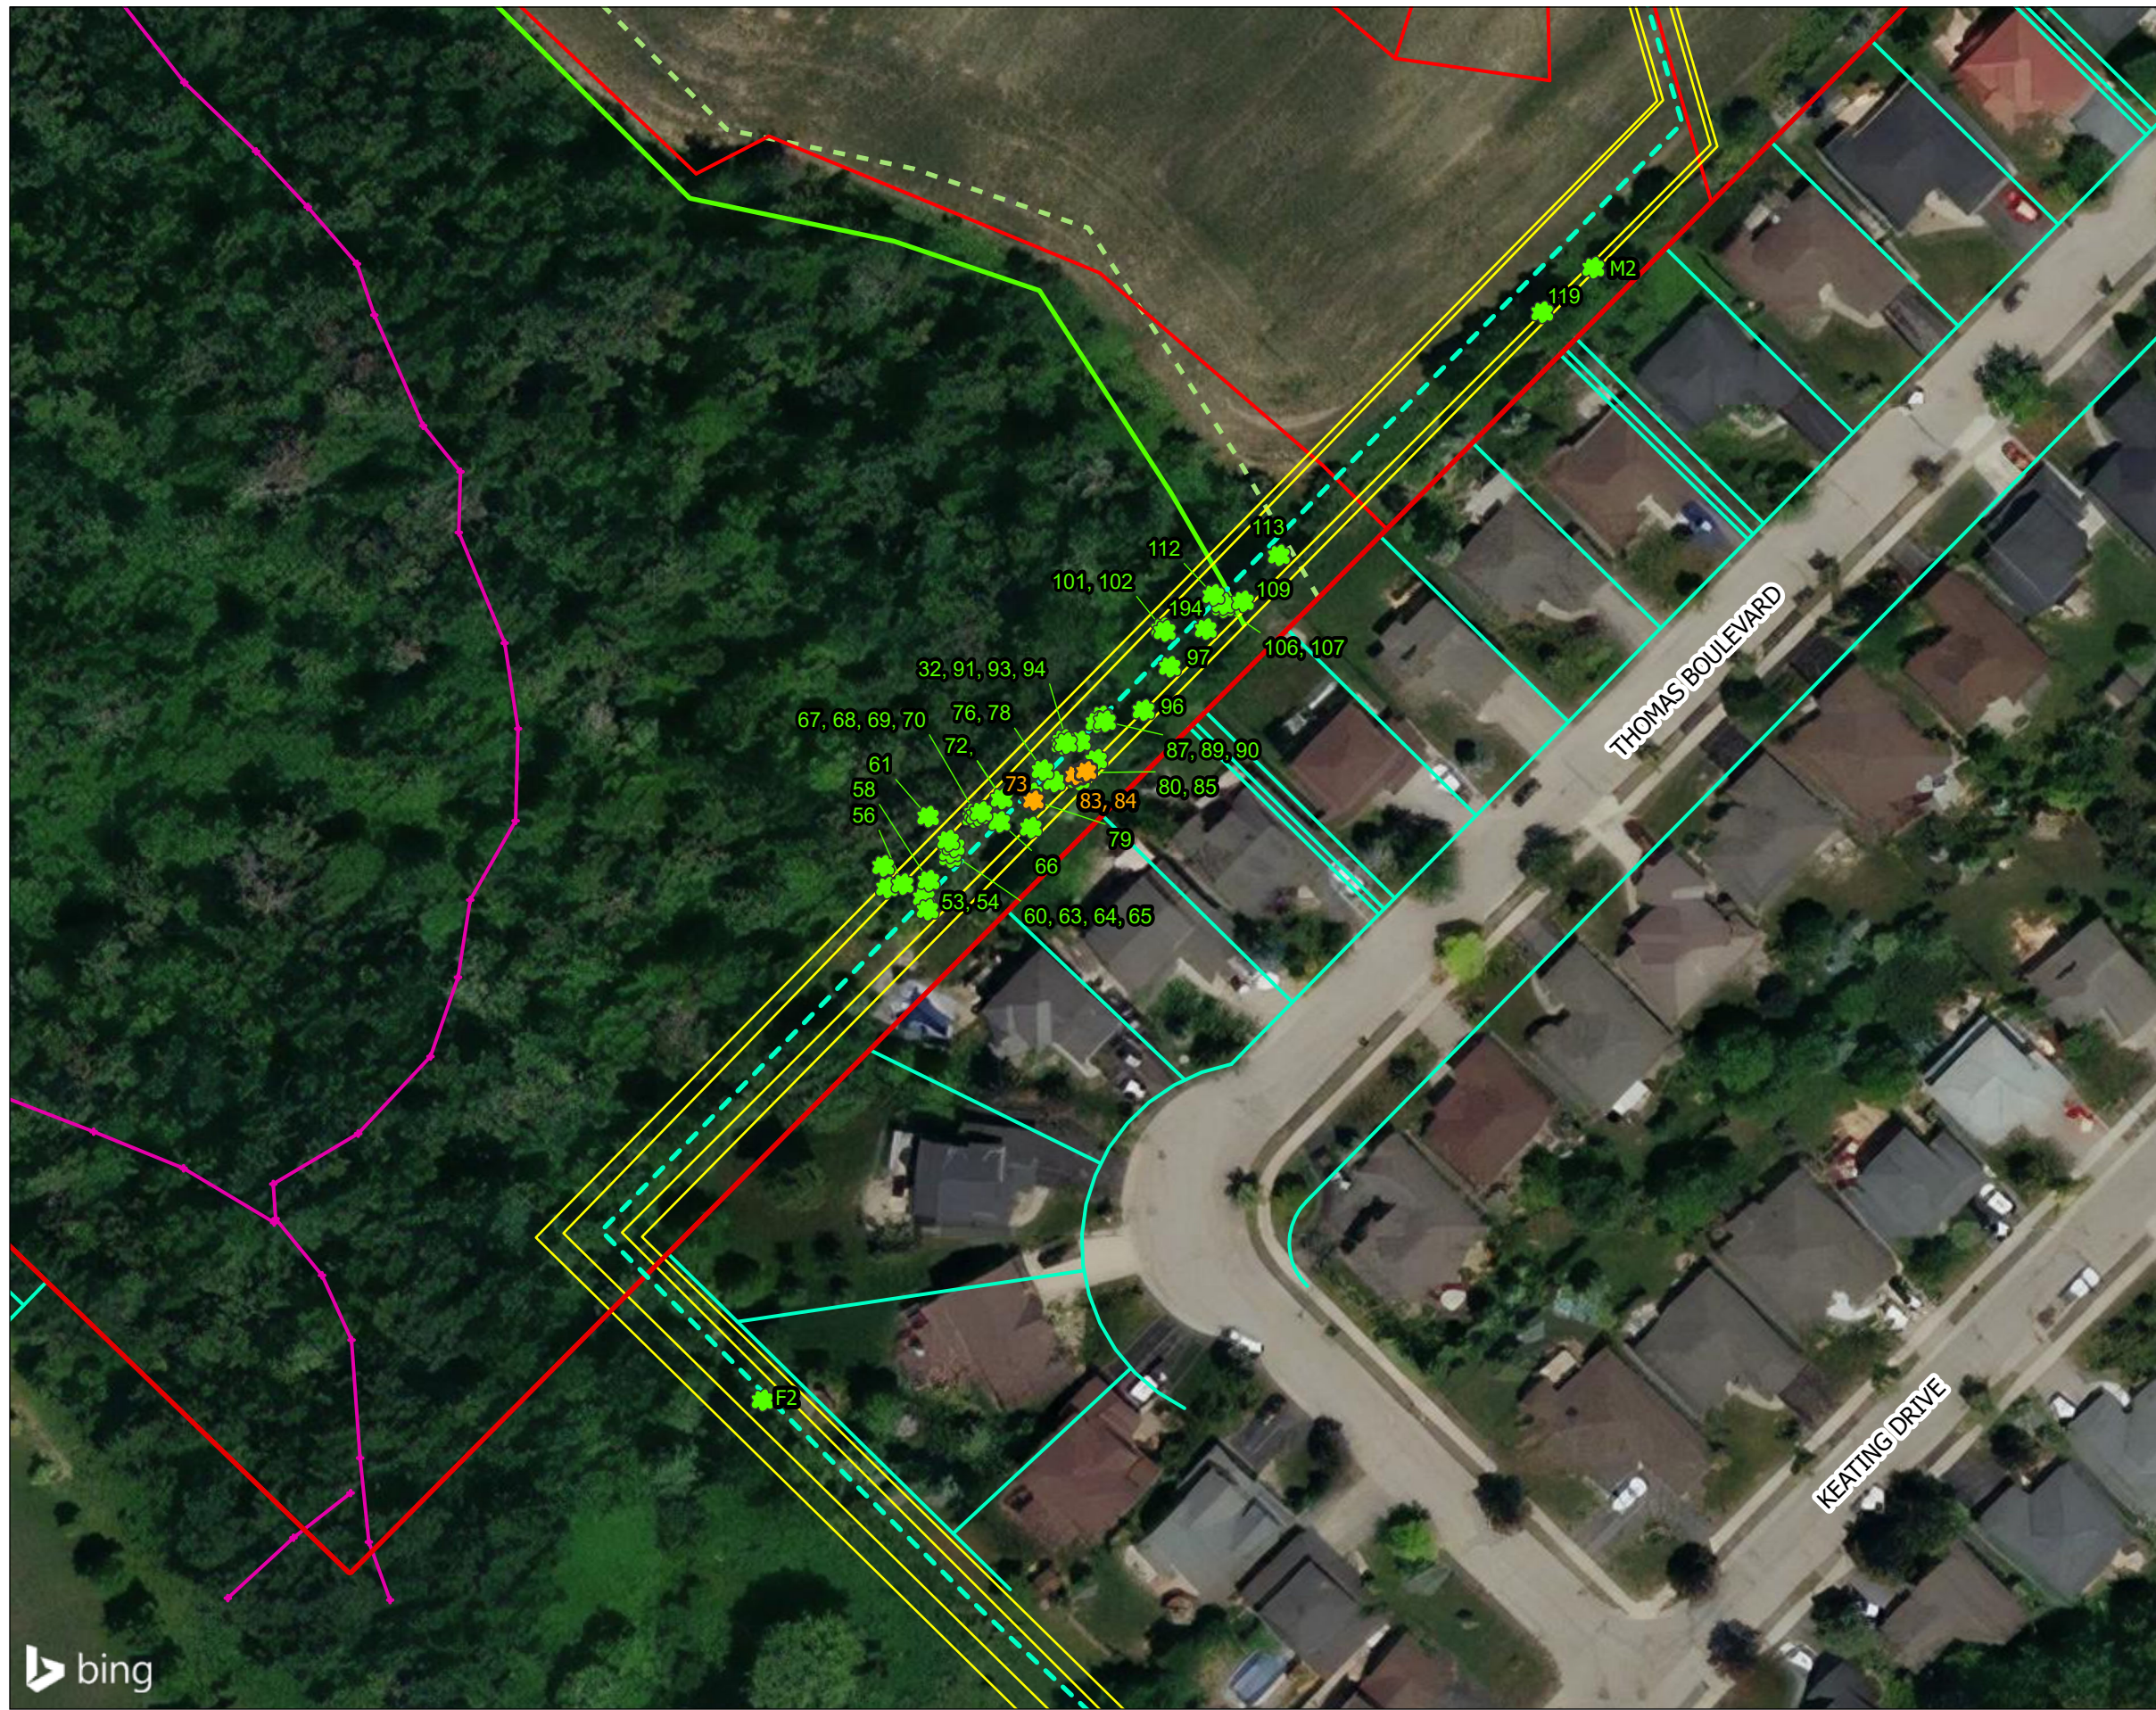
Proposed Development

- Existing Lot Lines
- Proposed Lots
- Proposed Streets
- Proposed Pathway
- Top of Slope
- - - Proposed Sanitation Line
- Easement

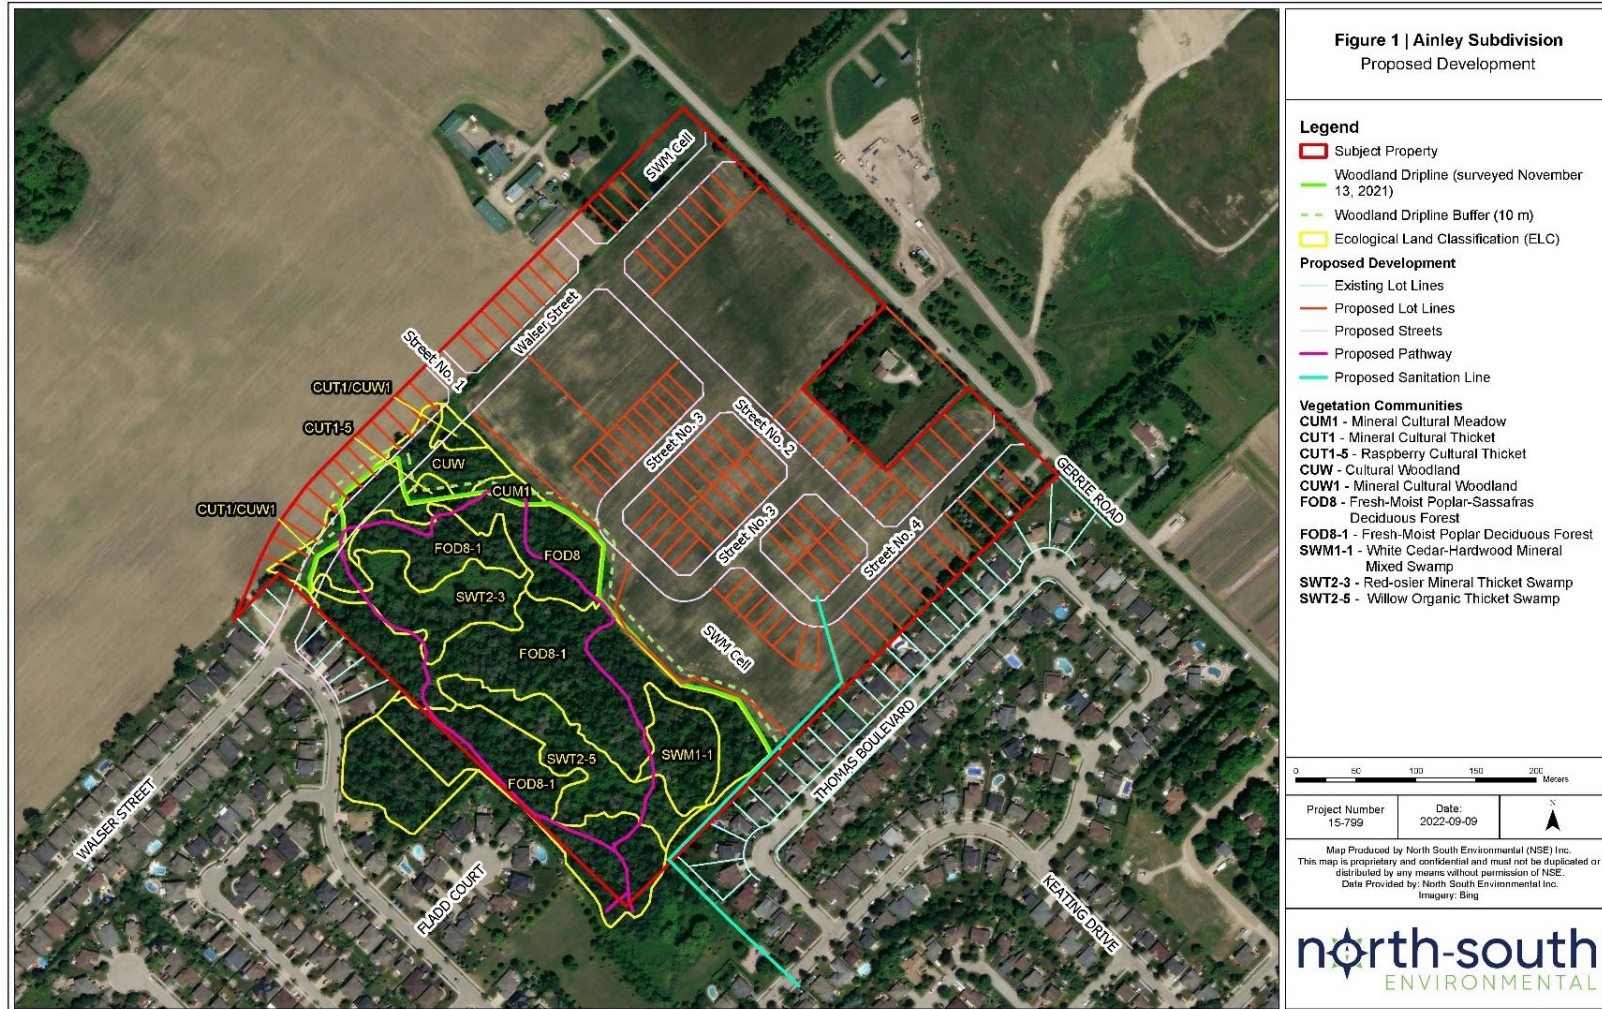
Figure 1. The Subject Property and ELC at Lots 17 and 18, Concession 12, Township of Centre Wellington (Geographic Township of Nichol), County of Wellington

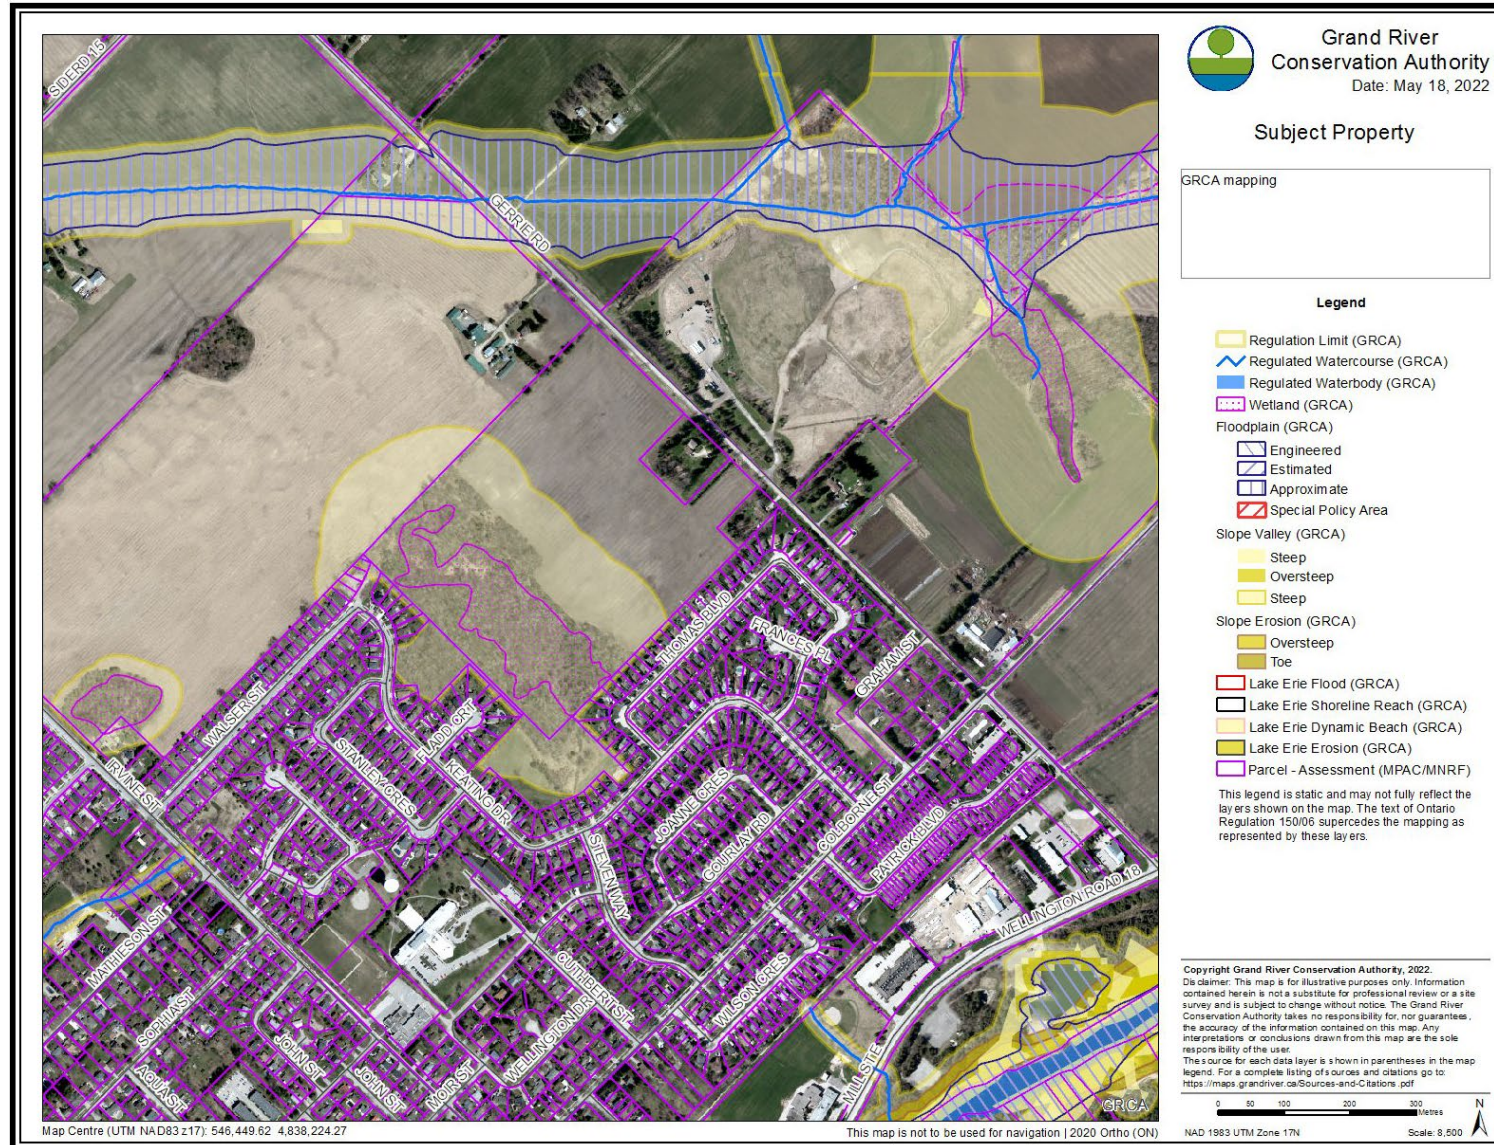
GRCA (2018) Regulation Mapping (**Figure 2**) illustrates a non-provincially significant wetland within the wooded area on the western portion of the Subject Property. The extent of the “Regulated Area” on the Subject Property is mapped as 120 m from the boundary of the wetland mapped by GRCA.

Figure 2. GRCA (2022) mapping illustrating aerial mapping of wetland (purple) and regulated area (yellow)

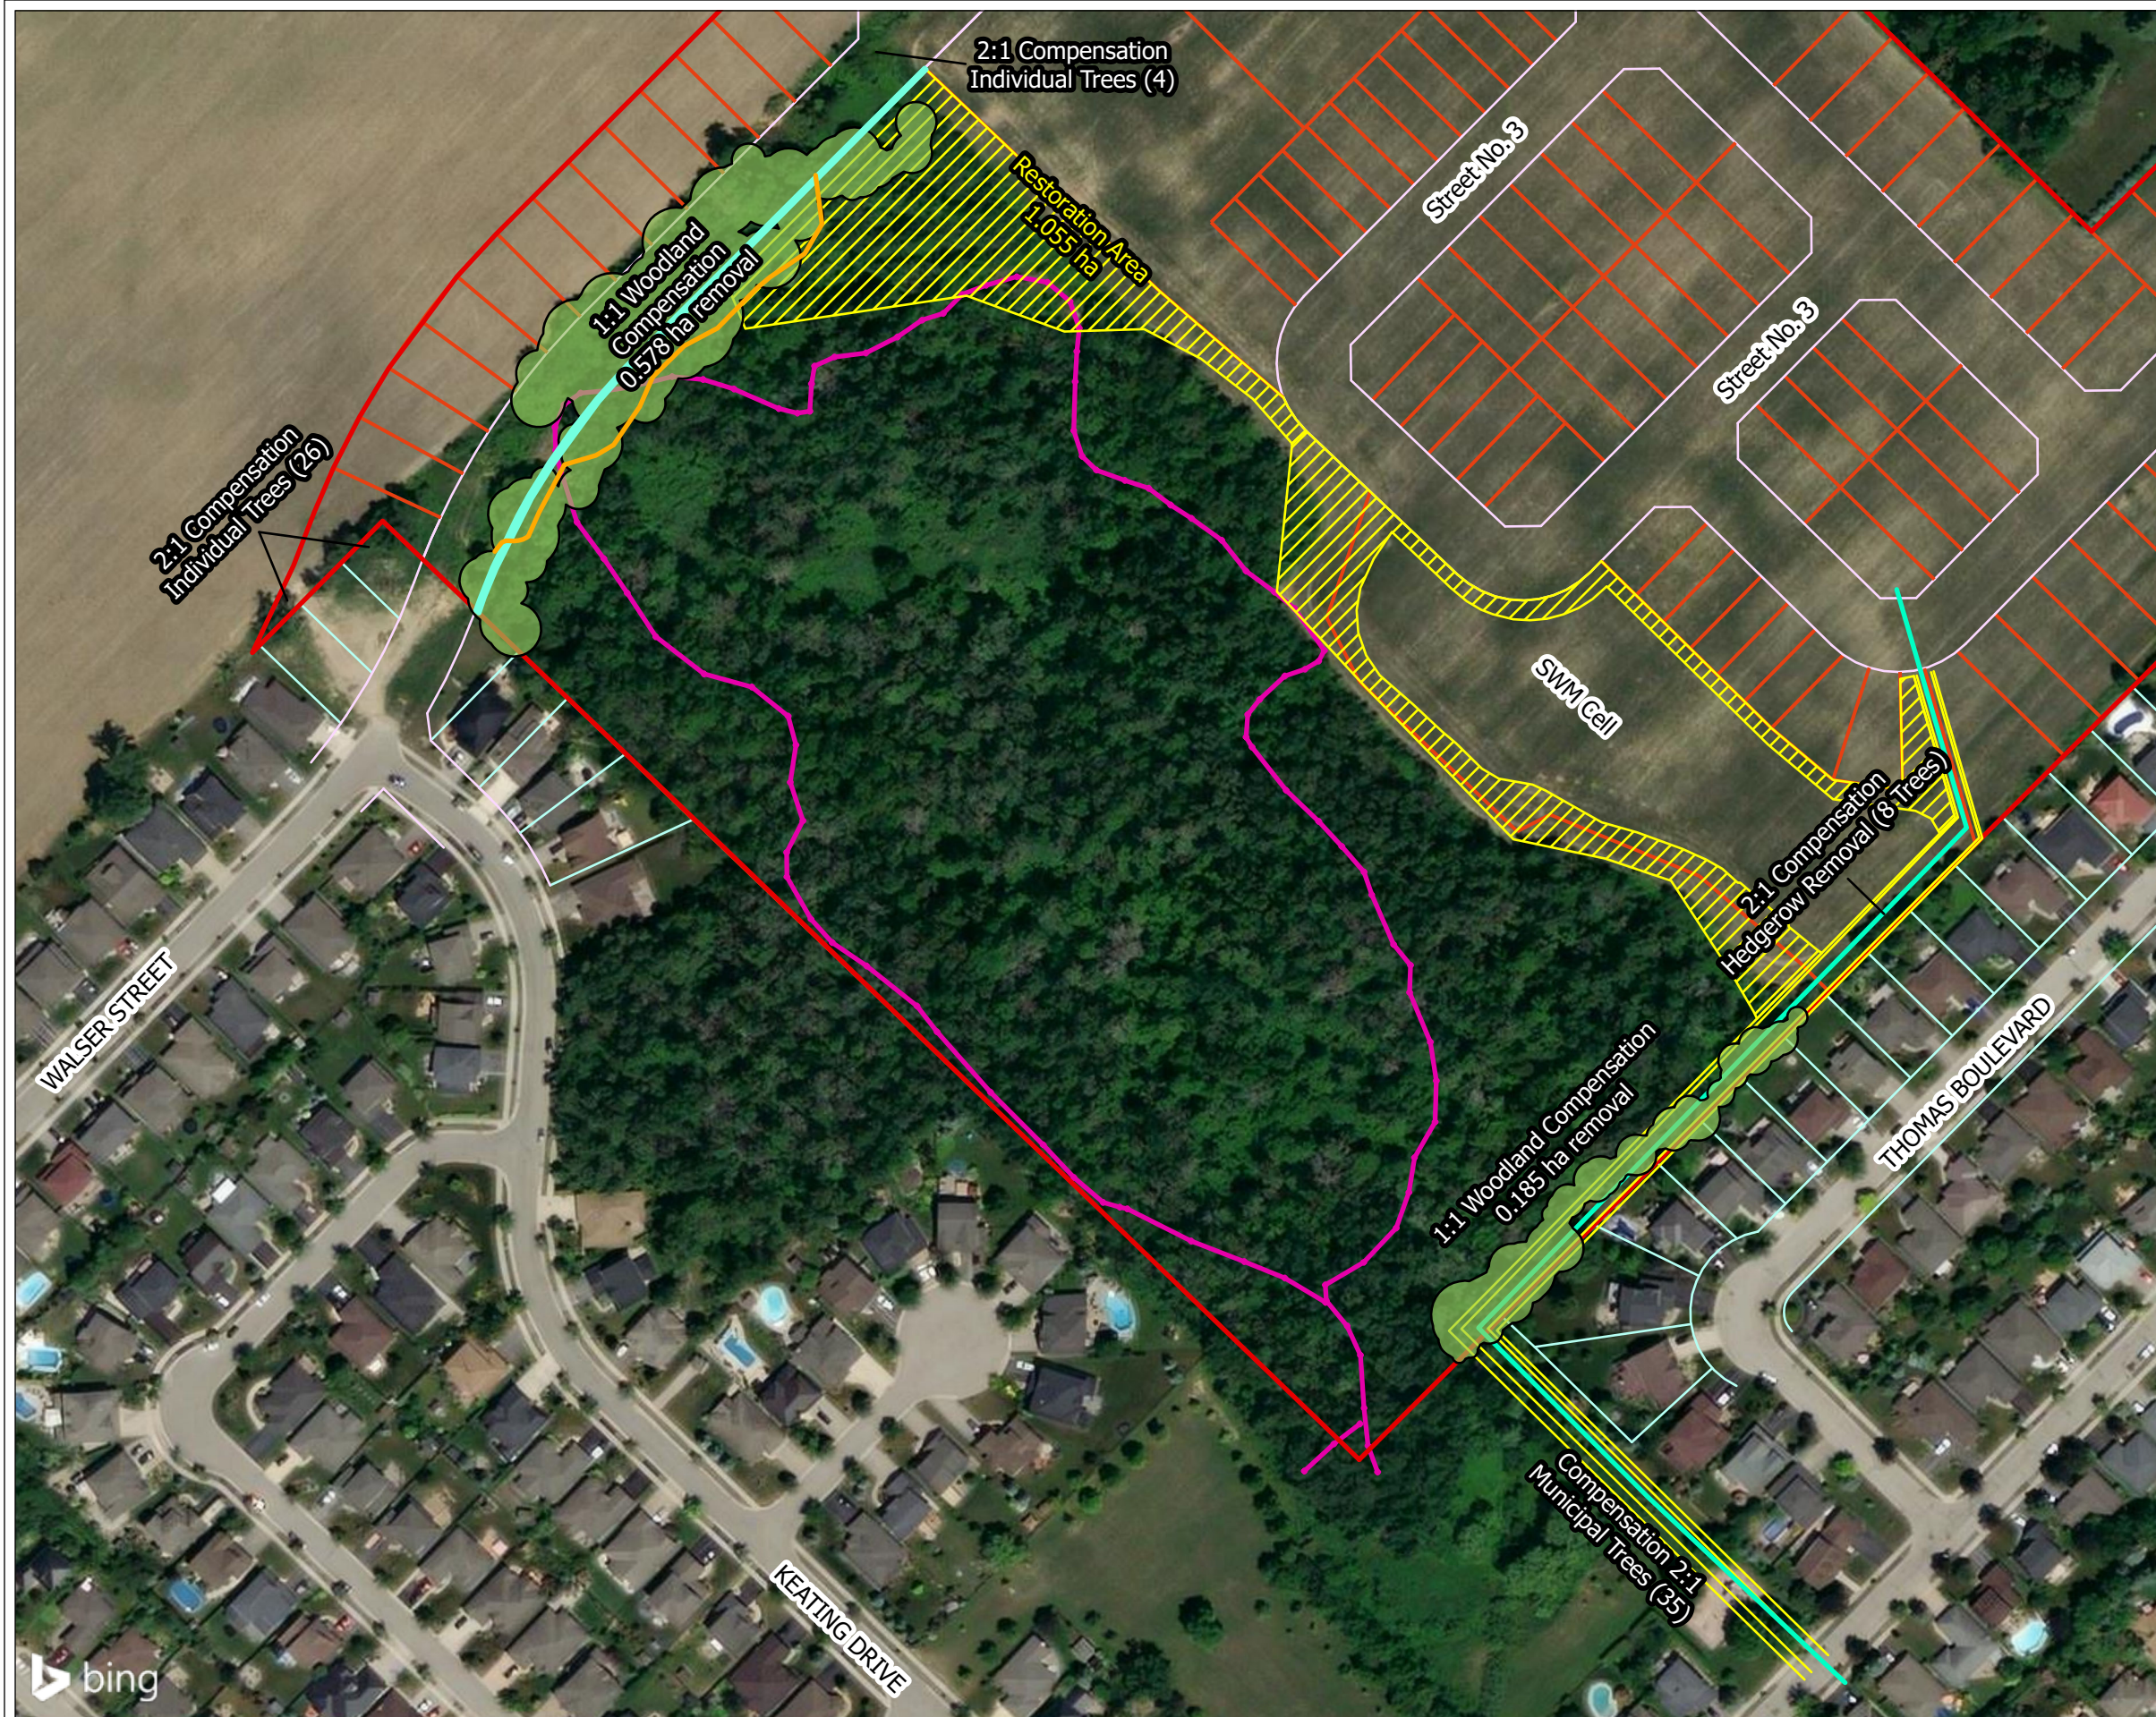
Figure 4 | Ainley Subdivision
Tree Removal Compensation Ratios

For trees removed within the Subject Property, it is believed the Subject Property is large enough in size to accommodate the replacement of trees directly on site. A map illustrating the available restoration area, equal to 1.055 ha, is provided within **Appendix 4**. Therefore, financial compensation is not considered a necessary means of fulfilling the required compensation recommendations. Compensation should be confirmed with the Township of Wellington. For trees removed outside of the Subject Property and owned by the municipality, discussion with the Township of Wellington is required to confirm the location of replacement trees.

The County of Wellington Conservation and Sustainable Use of Woodlands Tree By-law (5115-09) does not state specific details on tree compensation. Recommendations for tree compensation has been determined by Madison Postma, Registered Professional Forester from Natural Resource Solutions Inc. (NRSI) and approved by Mariana Iglesias, Senior Planner and Mat Alain, Urban Forestry Project Manager from the Township of Wellington (**Appendix 5**). A map illustrating the breakdown of tree compensation ratios by area is provided in **Appendix 4**.
