MIDDLEBROOK PLACE BRIDGES

Schedule C Phase 2 Consultation
Municipal Class Environmental Assessment
Public Consultation Centre
Township of Woolwich and Centre Wellington

Schedule C – Phase 2 Consultation Municipal Class Environmental Assessment

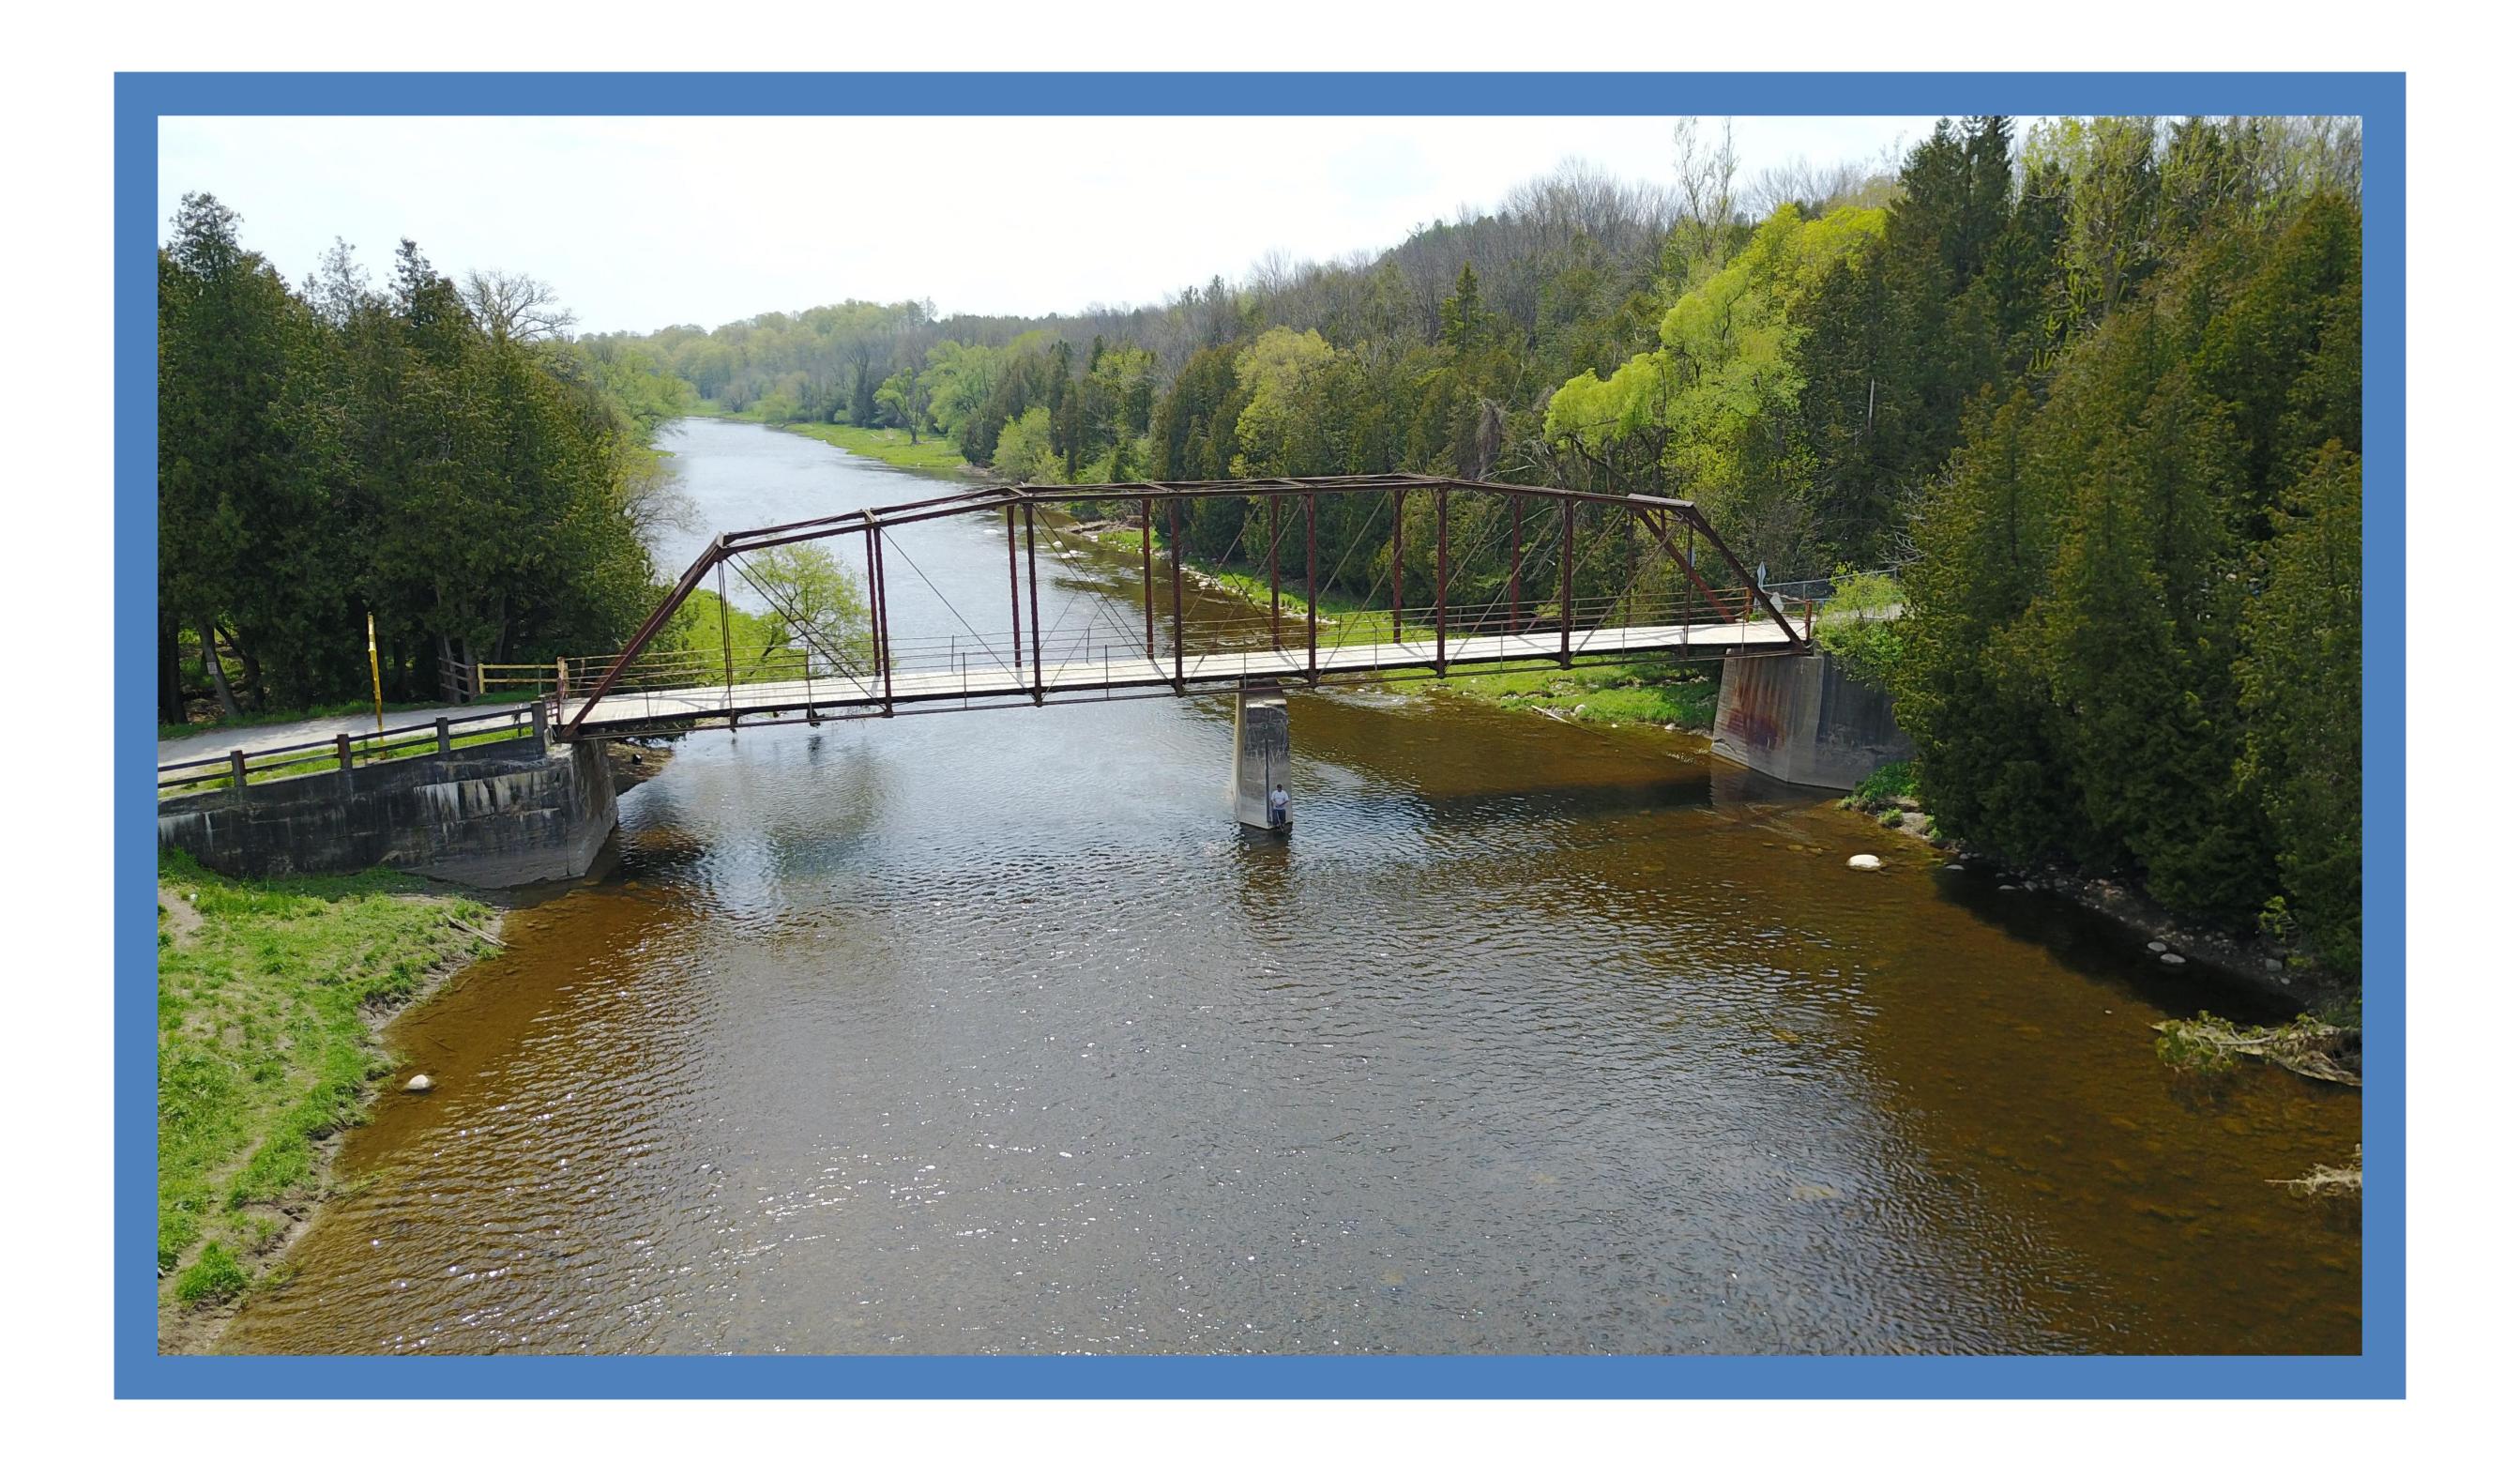
- The Middlebrook Truss Bridge was found to have heritage significance due to the following:
 - One of four remaining Pratt camelback through truss bridges located in the Region of Waterloo;
 - > Single-lane construction;
 - > Truss members connected by pins;
 - > Steel double-span truss configuration with nine panels;
 - > Location on Middlebrook Place, spanning the Grand River;
 - Views to the bridge from the approaches; and,
 - ➤ Views from the bridge of the surrounding rural landscape and the Grand River.

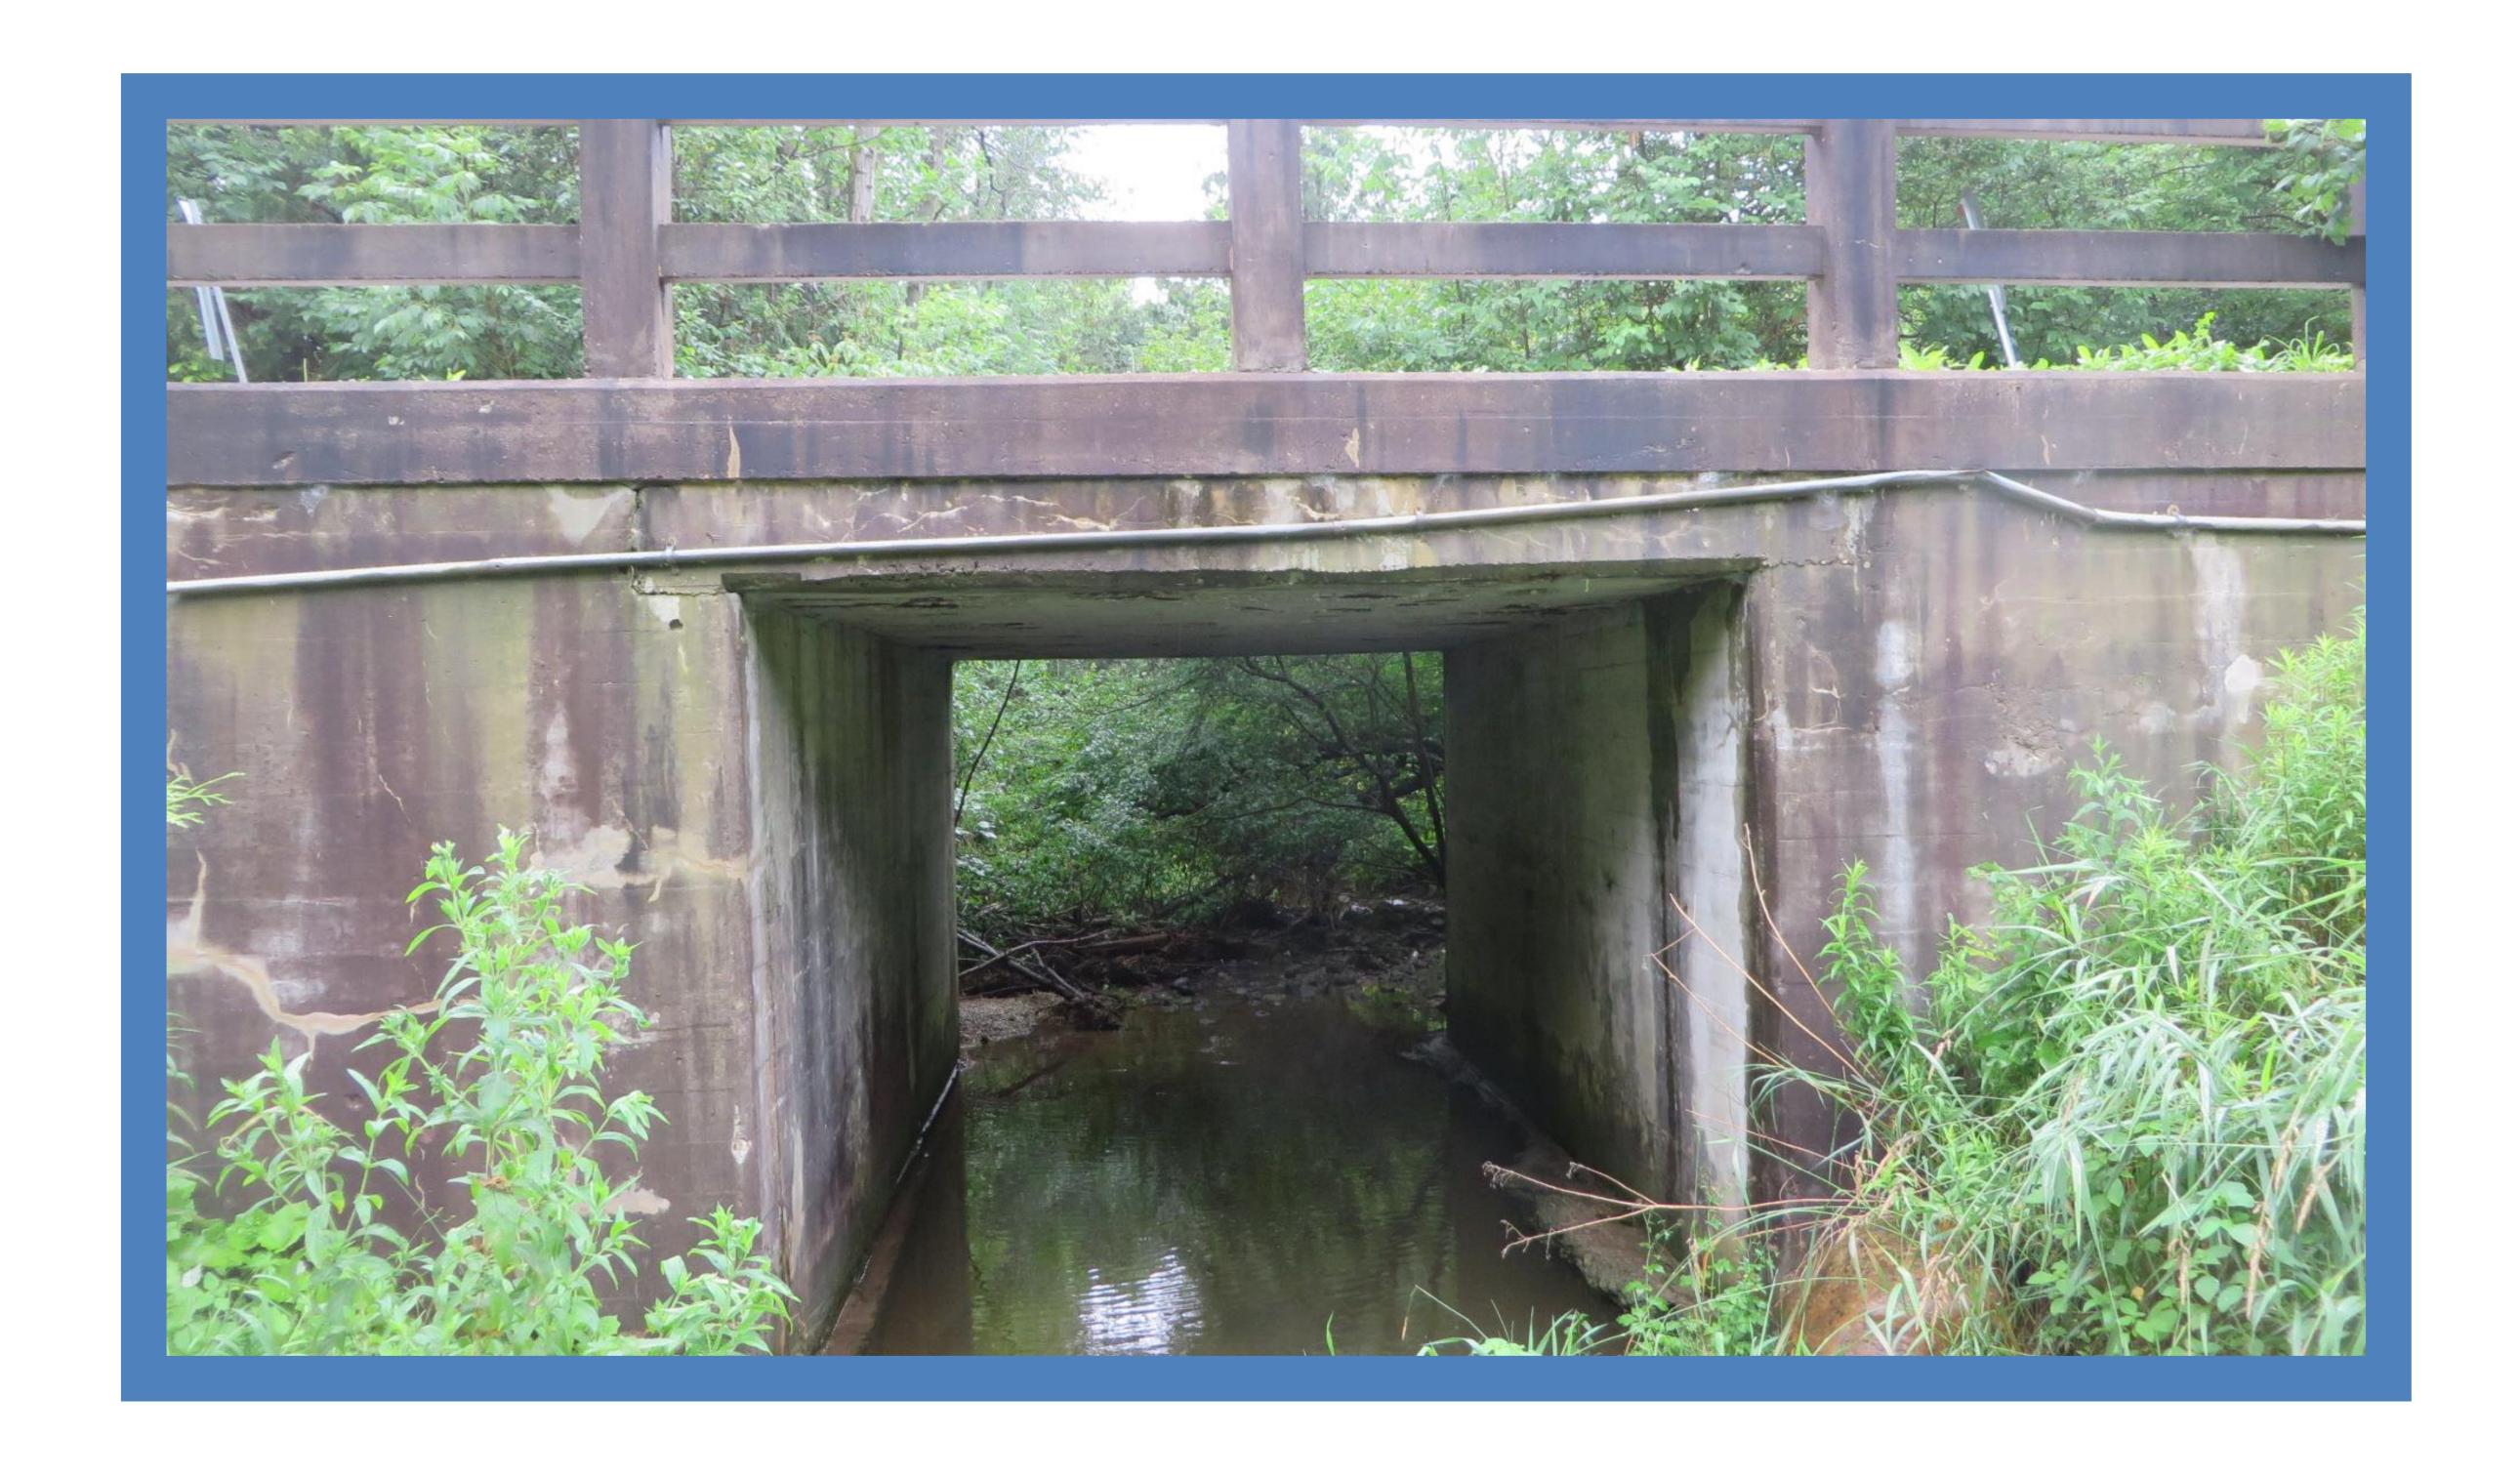
- ➤ The Middlebrook Concrete Bridge was found to have heritage significance due to the following:
 - > Single-lane construction;
 - ➤ Early example of a cast-in-place concrete rigid frame with a box design in the Region of Waterloo; and,
 - > Simple concrete railing system which gives the bridge a distinctive appearance and affords the bridge a degree of aesthetic appeal.
