**Centre Wellington Bridge and
Transportation Network Study for
Bridges
2-WG, 3-E, 5-E, and 7-E Natural Heritage
Report**

**Township of Centre Wellington
1 MacDonald Square
Elora ON N0B 1S0**

**R.J. Burnside & Associates Limited
292 Speedvale Avenue West Unit 20
Guelph ON N1H 1C4 CANADA**

**November 2024
300058117.0000**

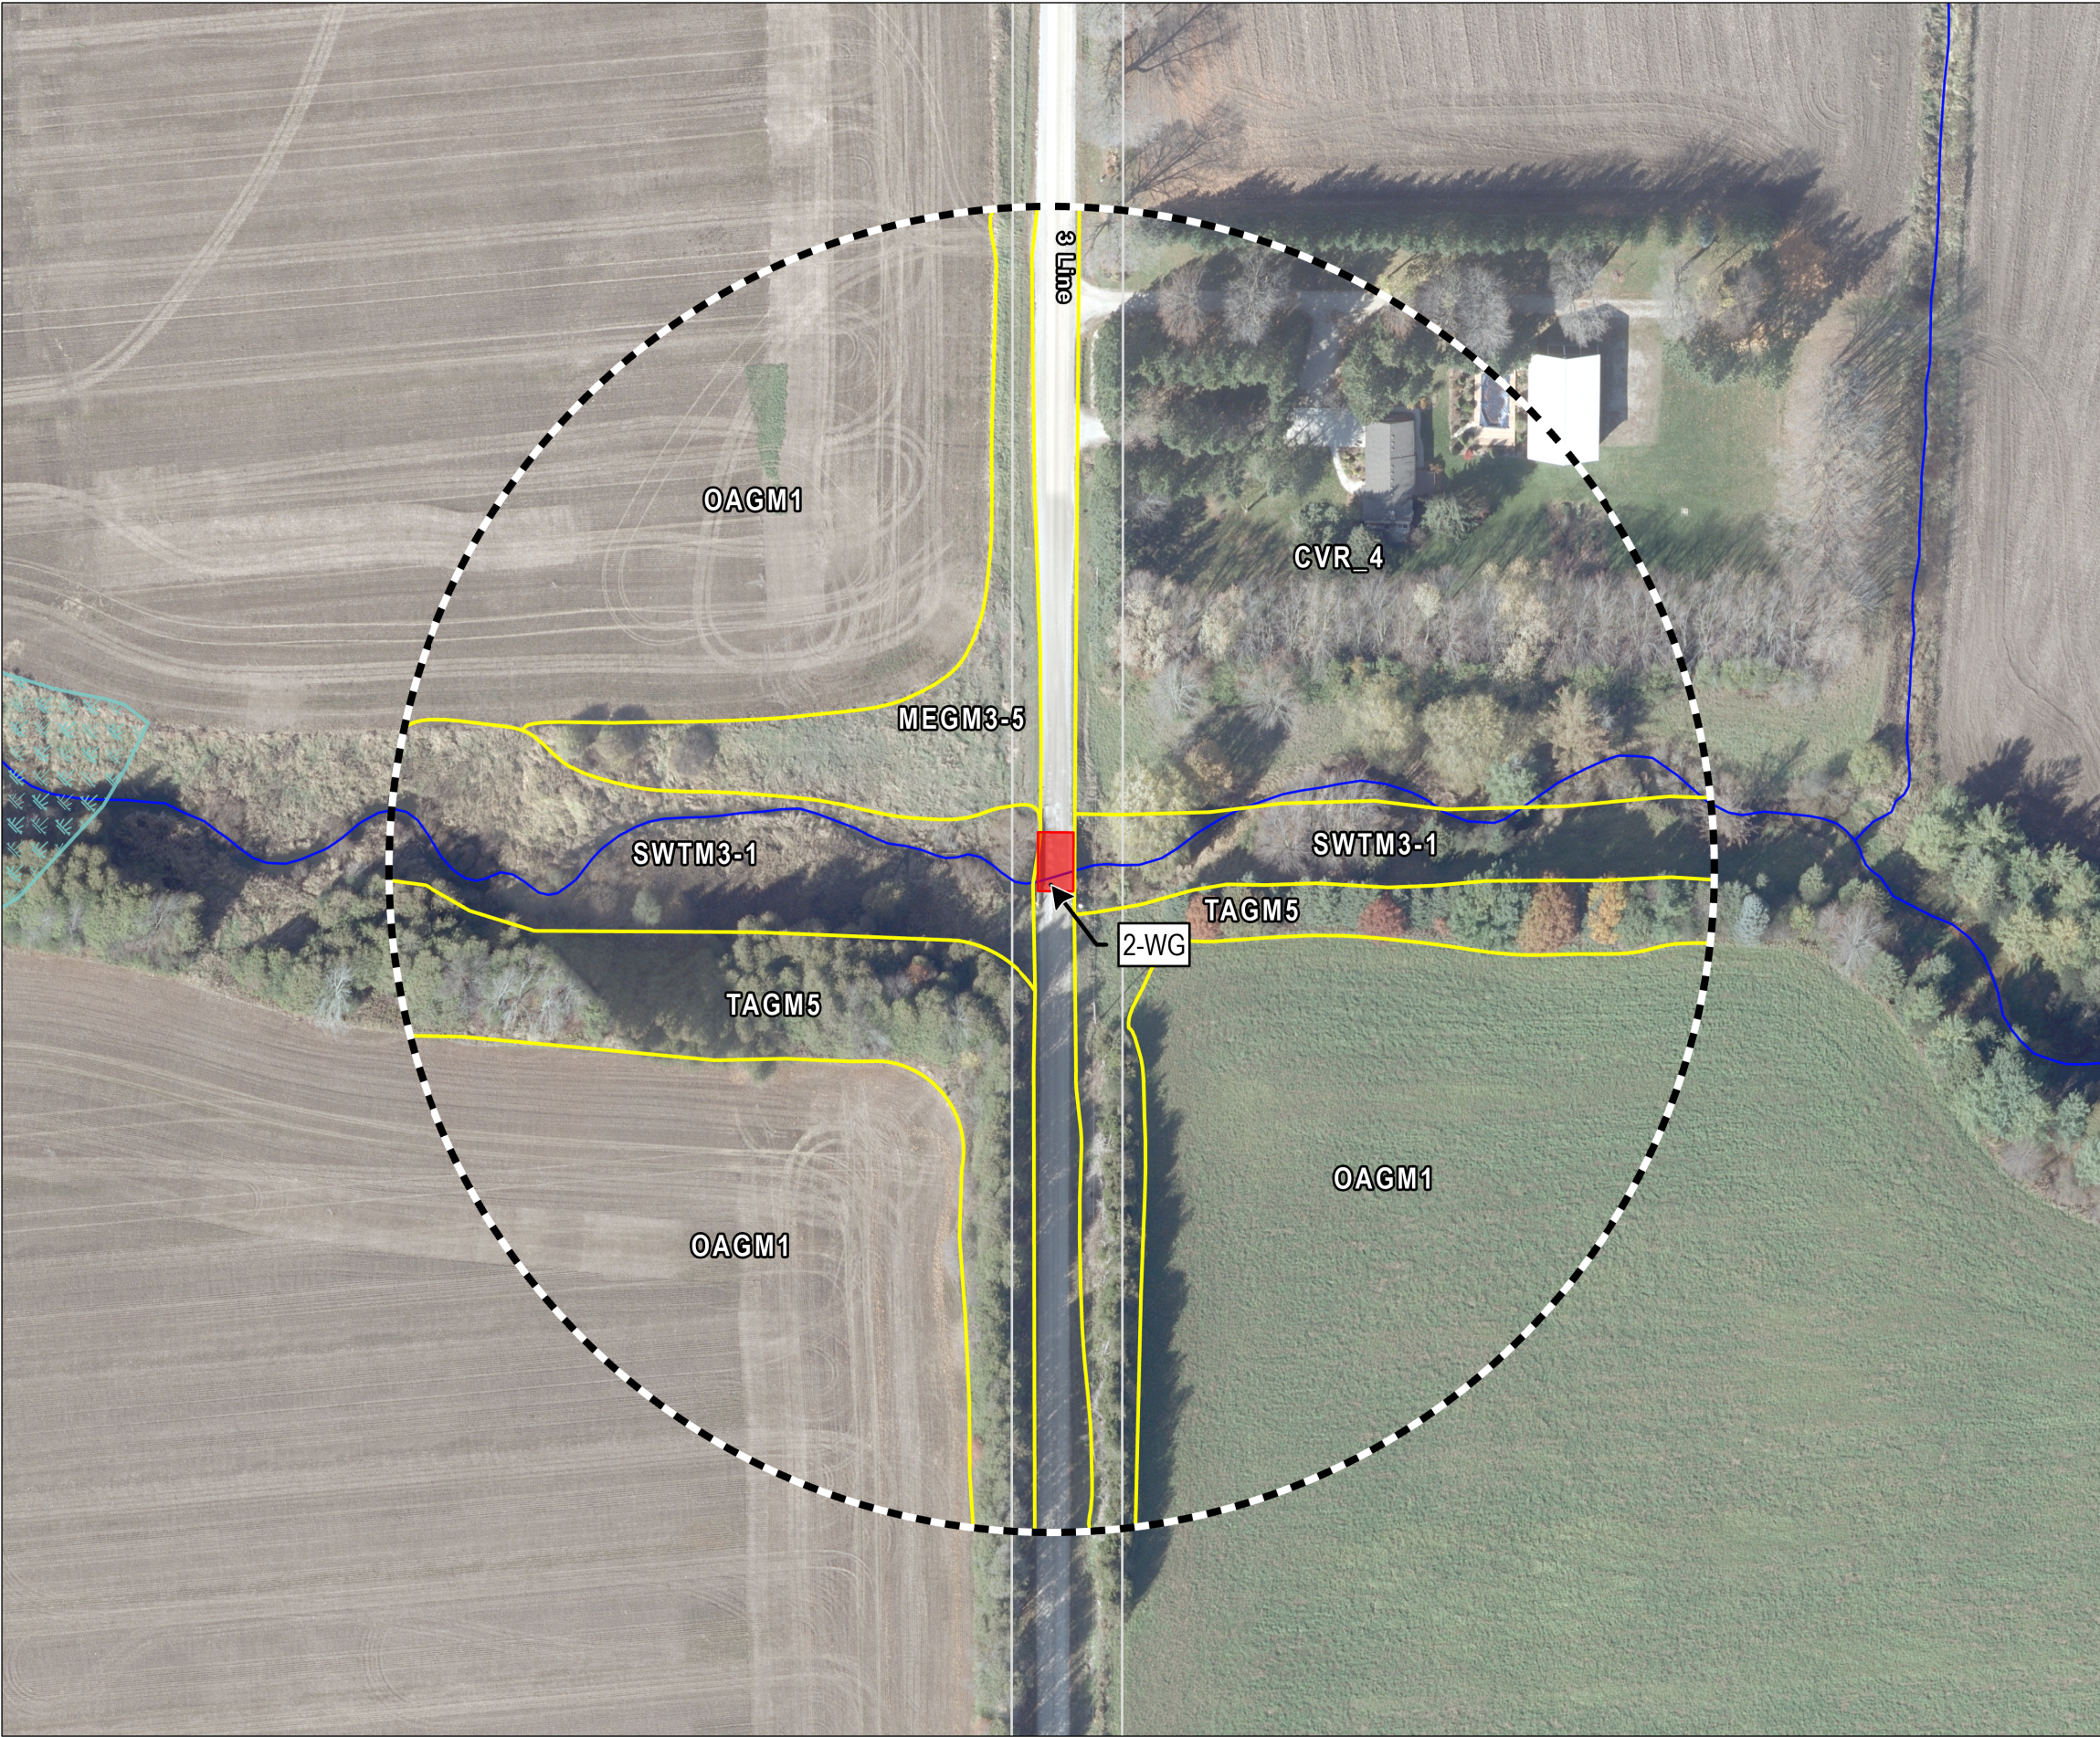
The natural heritage system adjacent to this structure is narrow, with hedgerows separating the watercourse from the agricultural lands. The northwest portion has a swamp feature, not identified on GRCA mapping that extends westward along the riparian edge. Open grown trees and hedgerows associated with the rural property are found at the northeast portion of the structure.

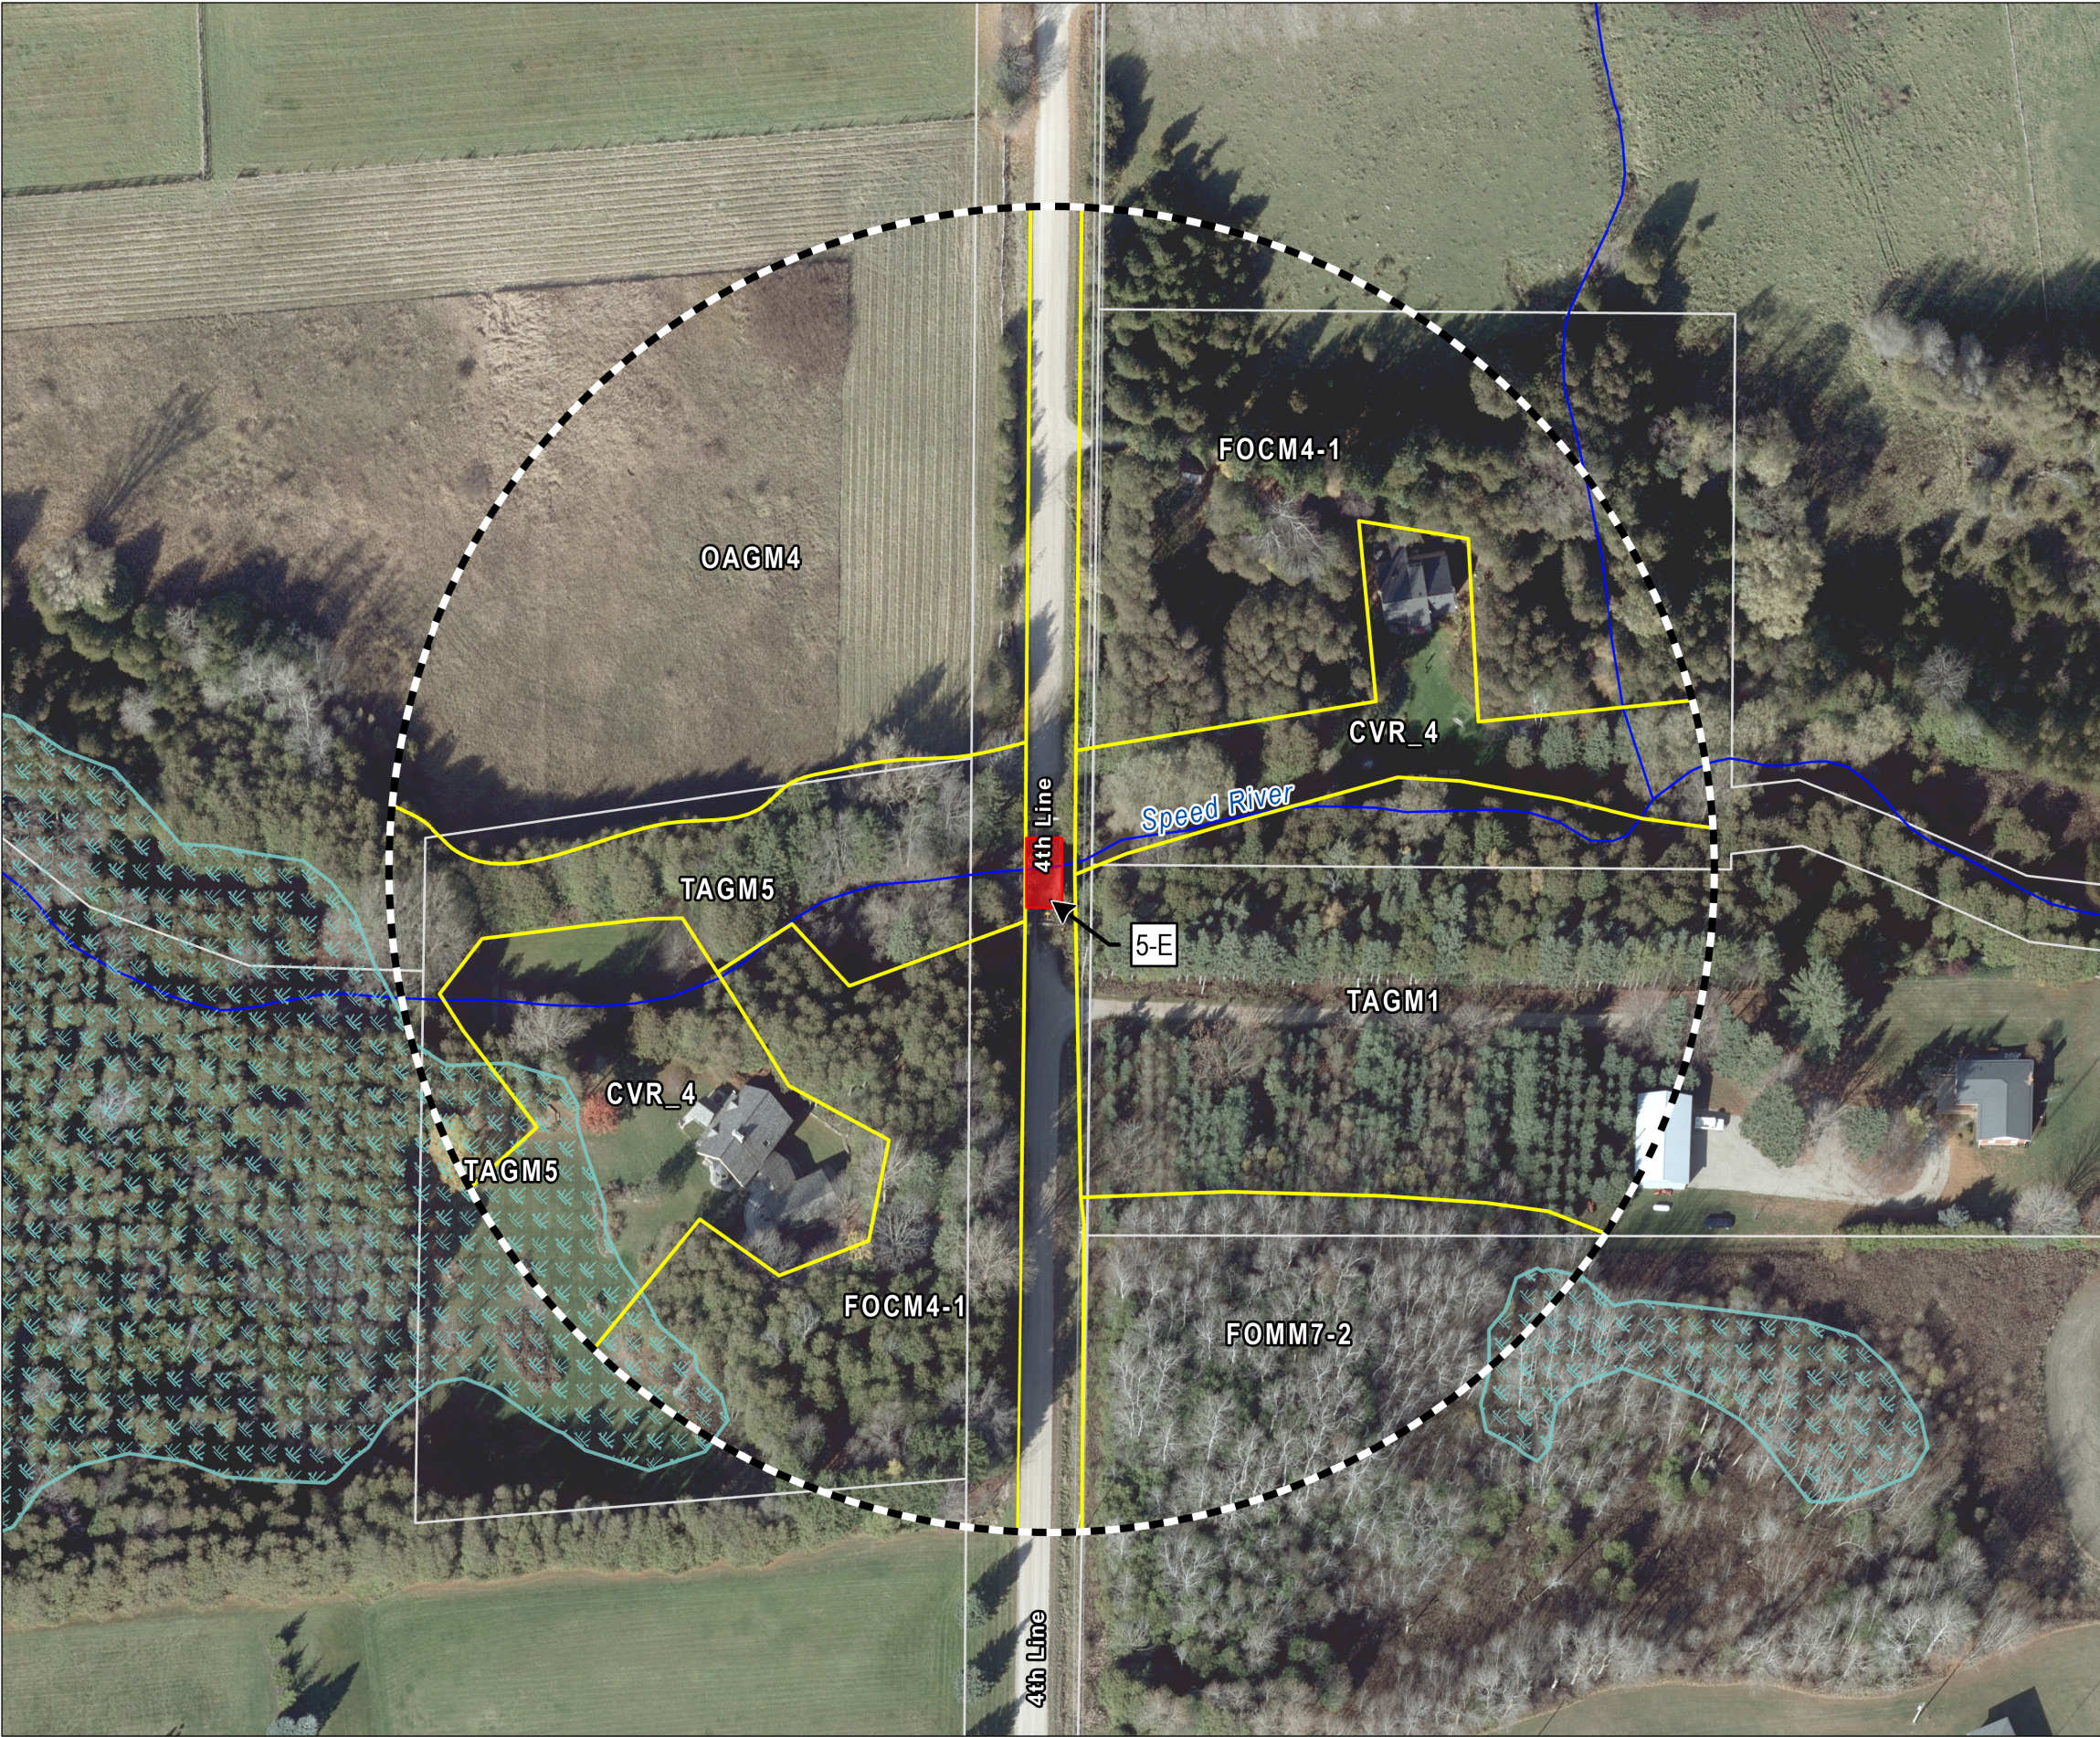
The adjacent lands at this crossing are varied and include forest communities, plantation, rural residential, hedgerows and pasture / hayfield. The plantation found southeast of the crossing is dominated by Norway spruce (*Picea abies*). There are two Fresh-Moist White Cedar forest communities identified at the southwest and northeast portions of the Study Area, adjacent to the two rural property lands. The rural properties only have a small area being managed as manicured turf for amenity space but are otherwise densely treed. The pasture / hayfield is dominated by cool season grasses with abundant Goldenrod, Wild Carrot and meadow forbs. A mature hedgerow of White Cedar is found between the watercourse and the pasture. A Fresh-Moist White Cedar - Hardwood Mixed Forest is found at the southeast corner of the Study Area that contains wetland immediately beyond the Study Area limit, as identified by GRCA mapping.

ELC Descriptions
CVR_4: Rural Property
FOCM4-1: Fresh - Moist White Cedar Coniferous Forest
FOMM7-2: Fresh - Moist White Cedar - Hardwood Mixed Forest
OAGM4: Open Pasture
TAGM1: Coniferous Plantation
TAGM5: Fencerow

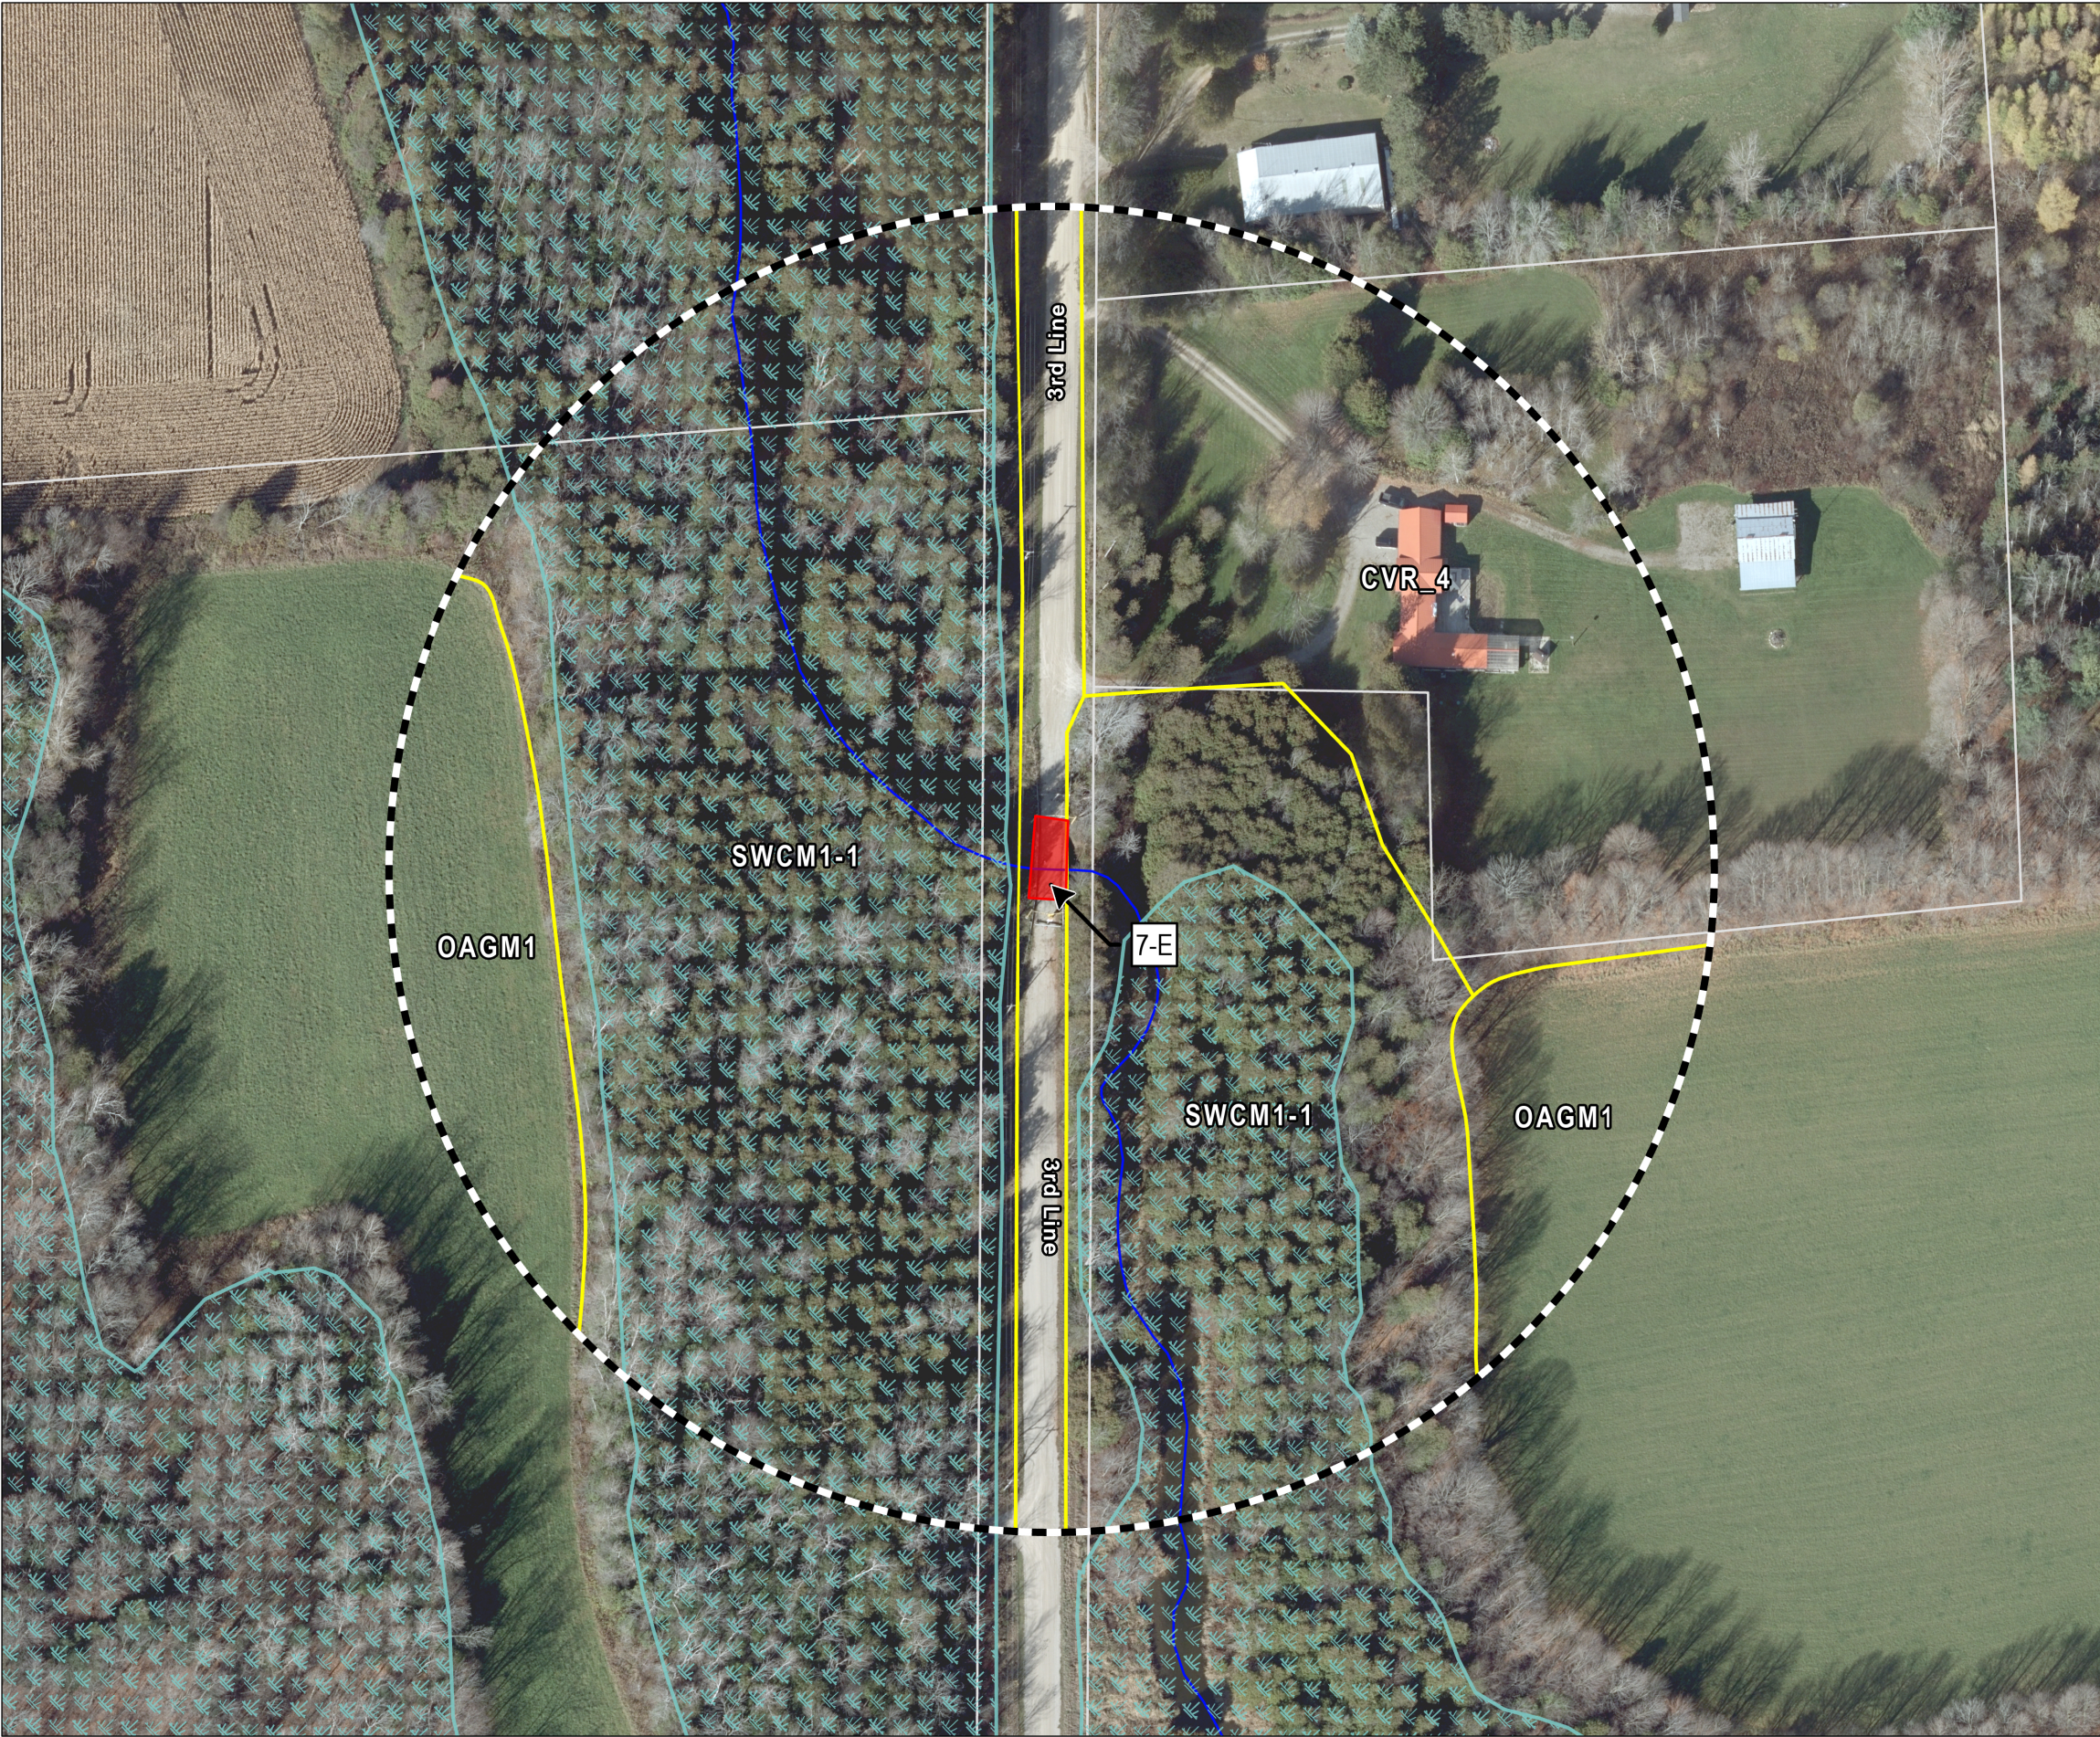
The majority of the land around this crossing within the Study Area is identified as White Cedar Mineral Coniferous Swamp that extends throughout the riparian corridor that is associated with the evaluated wetland. These forested lands connect with upland and riparian forested communities (forests, swamps and plantations) on both sides of the road. Rural property and annual row crop lands are also found within the Study Area of this site.

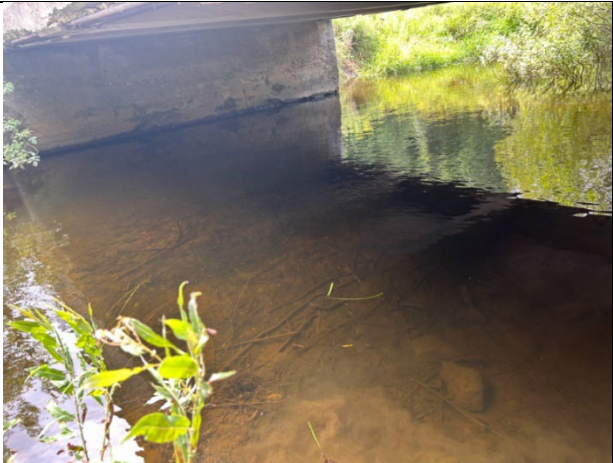
Photo 5 Inlet of the structure. Facing east.

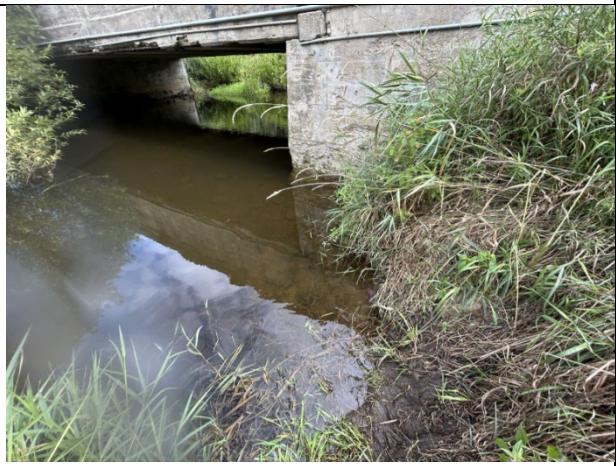
Photo 8: Erosion on the downstream's east bank, small patches were present on the west as well. Facing west.

The surrounding riparian habitat was similar to that observed upstream. However, the downstream reach was noticeably more exposed to sunlight (~30% coverage) as there were no large trees, just overhanging shrubs, willows, and grasses. The pool observed upstream continues under the structure and into the downstream area (8.4 m width, 0.6 m depth; Photos 5, 6, & 7). The pool quickly narrows to 2.0 m but maintains the depth. The aquatic habitat was similar to upstream's habitat, except there were more woody debris, including a few large branches (25% cover), cobbles (5% cover), and boulders (5% cover). Undercut banks were observed in small patches on the east and west sides of the structure, but they appear to result from footpaths (Photo 8).

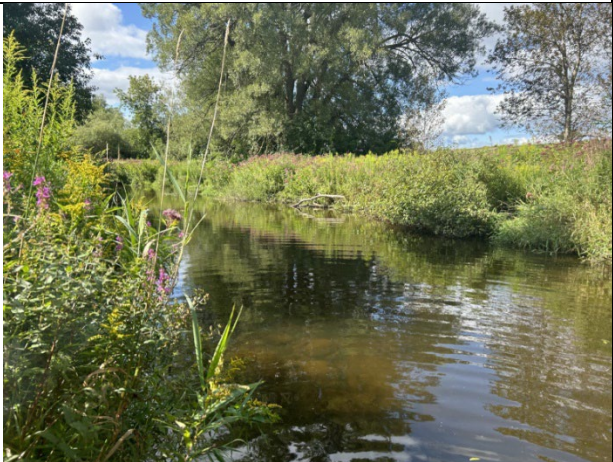
Photo 11: Downstream section. Facing south.

The watercourse remains a pool nearly unchanged from the upstream, except for narrowing slightly as the pool leaves the observed area (Photos 11 & 12). The substrate was still dominated by muck (~50%), but there was noticeably more cobble than upstream (30%). The downstream riparian area has fewer trees, more shrubs, and tall grasses, resulting in the watercourse being more exposed than upstream (30% cover). The well-vegetated banks showed no signs of erosion. Despite the riparian vegetation, there was no instream vegetation.

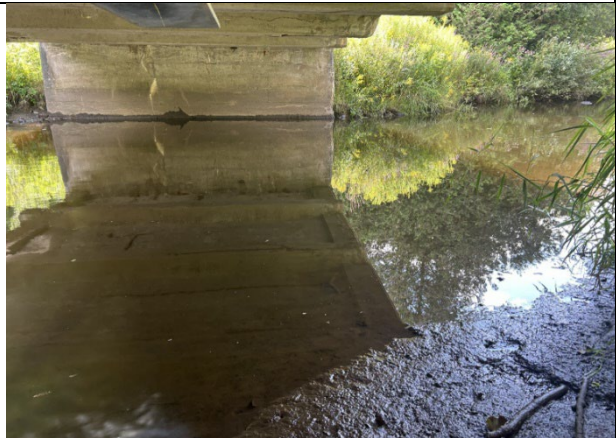
Photo: 12 Downstream section. Facing east.

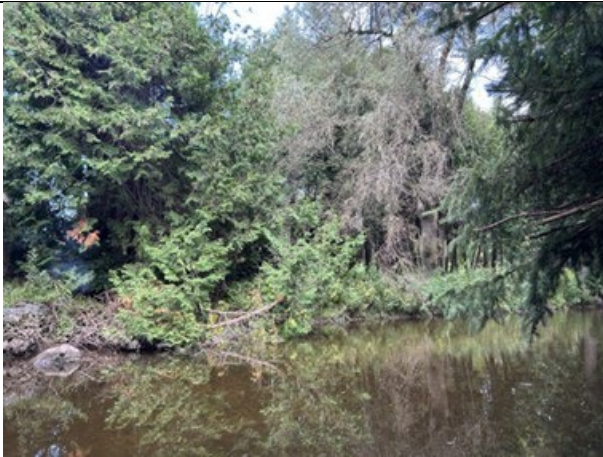
Photo 13: Upstream section. Facing north.

The upstream reach flowed north to south and was surrounded by riparian woodland with small grass-dominated banks (Photo 13). The watercourse was a flat (6.6 m width, 0.23 m width) with a substrate dominated by cobbles (60% cover) interspaced by sand and gravel (10% cover). Large patches of muck (20% cover) were present along the shorelines. There were minimal aquatic habitat features besides several boulders (10% cover) as there were neither aquatic plants nor woody debris in the observed area. The rocky banks and shorelines showed no signs of erosion. There was a small patch of watercress (*Nasturtium officinale*) found along the east bank, indicating a minor amount of groundwater upwelling (Photo 14). There were no aquatic habitat features underneath the structure (Photo 15).

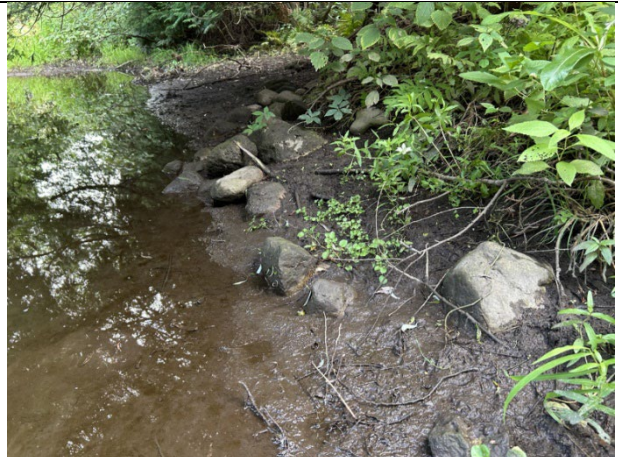
*Photo 14: The east bank of the upstream section. Watercress (*Nasturtium officinale*) present. Facing north.*

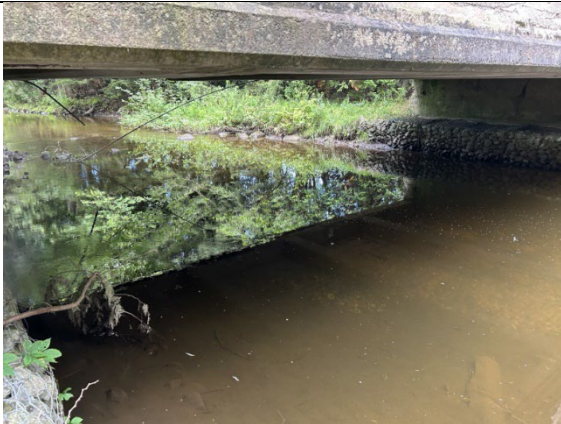
Photo 15: The inlet of the structure. Facing south.

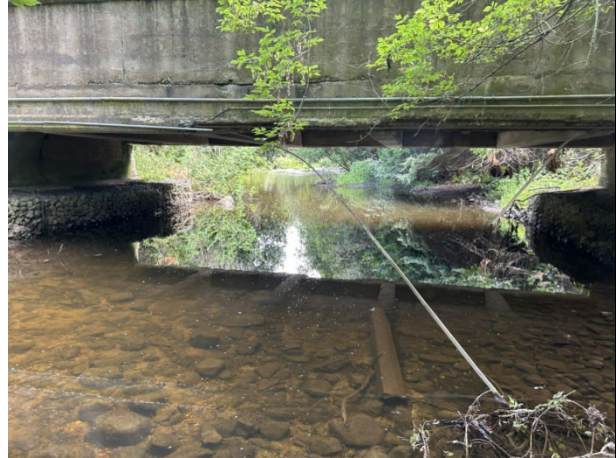
Photo 18: Structure's outlet. Facing north.

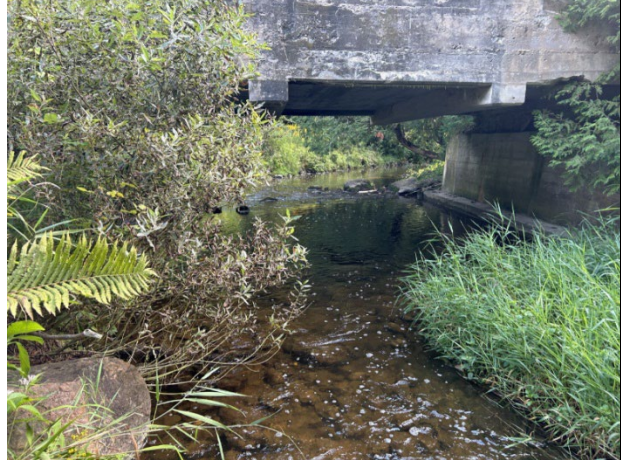
Photo 21: Inlet of the structure. Facing east.

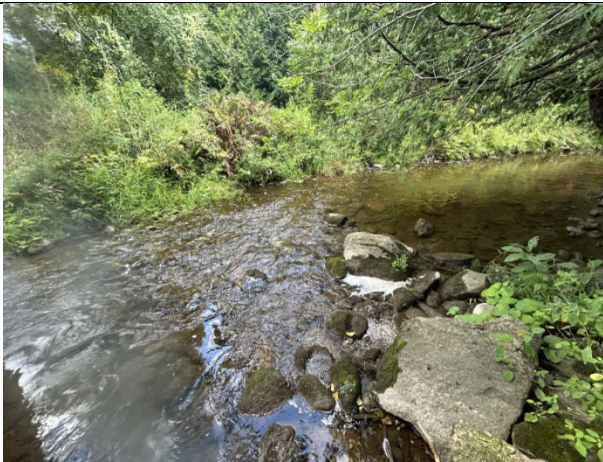
Photo 22: Downstream riffle. Facing east.
