**Municipal Class Environmental
Assessment of 5 Bridges in Former
Pilkington Township**

**Township of Centre Wellington
1 MacDonald Square
Elora Ontario N0B 1S0**

**R.J. Burnside & Associates Limited
292 Speedvale Avenue West Unit 20
Guelph ON N1H 1C4 CANADA**

**February 24, 2025
300056693.0000**

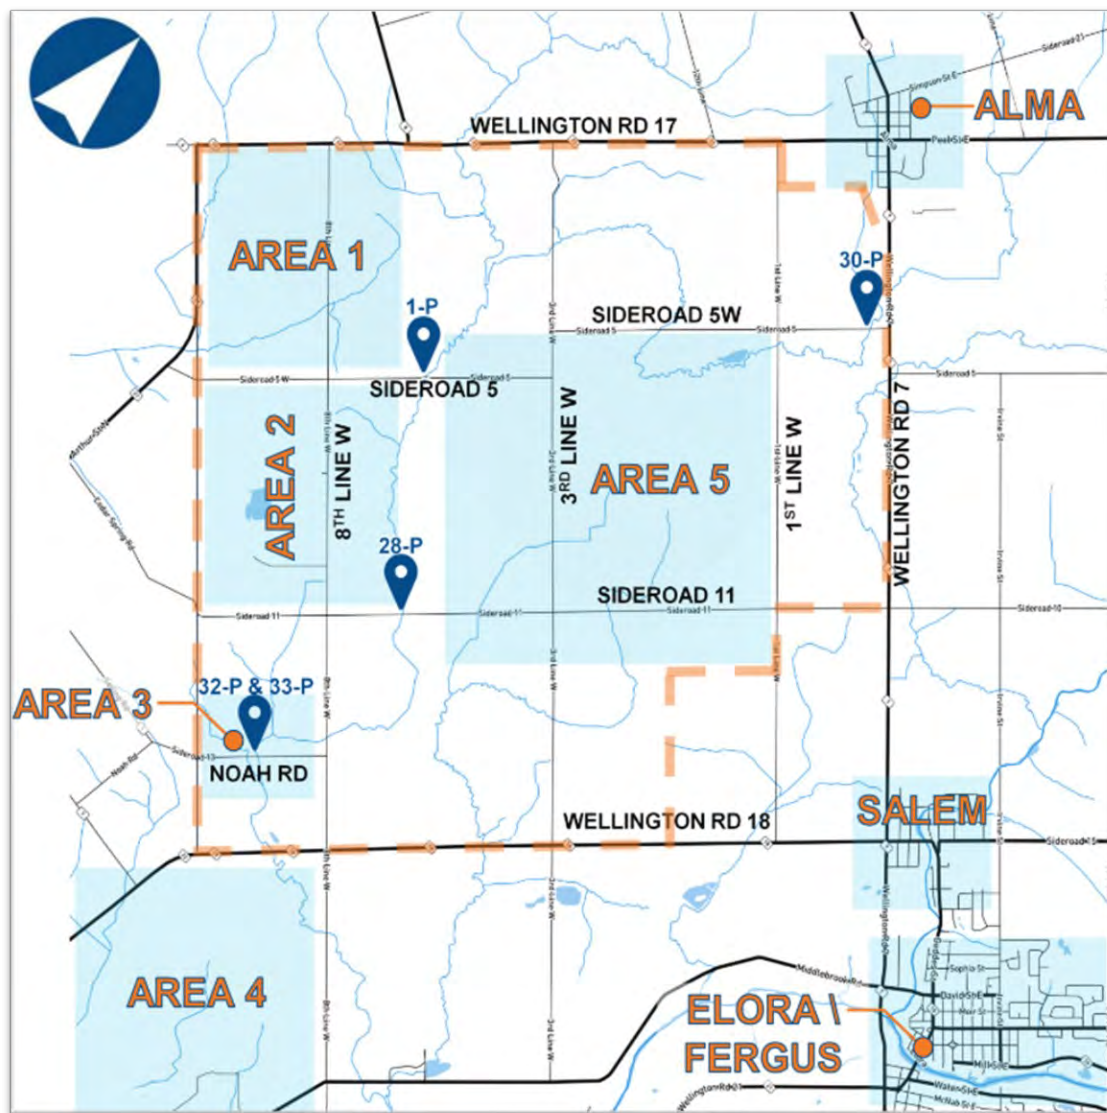
Figure 3: Cross-Community Connectivity Screening Areas

To analyse travel within the Study Area, the area was subdivided into four parcels (Areas 1, 2, 3, and 5) separated by points of discontinuity resulting from the bridge closures. Additionally, points of interest in surrounding areas outside the Study Area (Area 4, Alma, Salem, Elora & Fergus) were also investigated for considerations of commuting traffic. These areas are illustrated in Figure 3.

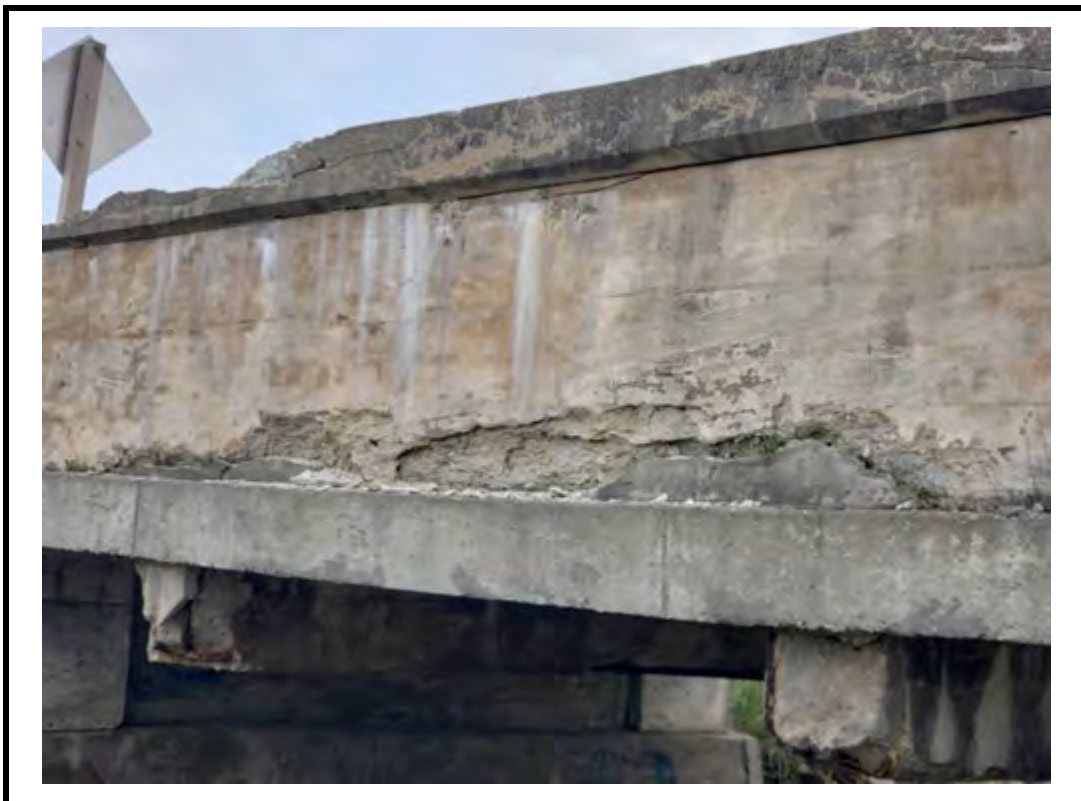
Photo 9 Spalls with exposed corroded reinforcement and efflorescence on north soffit

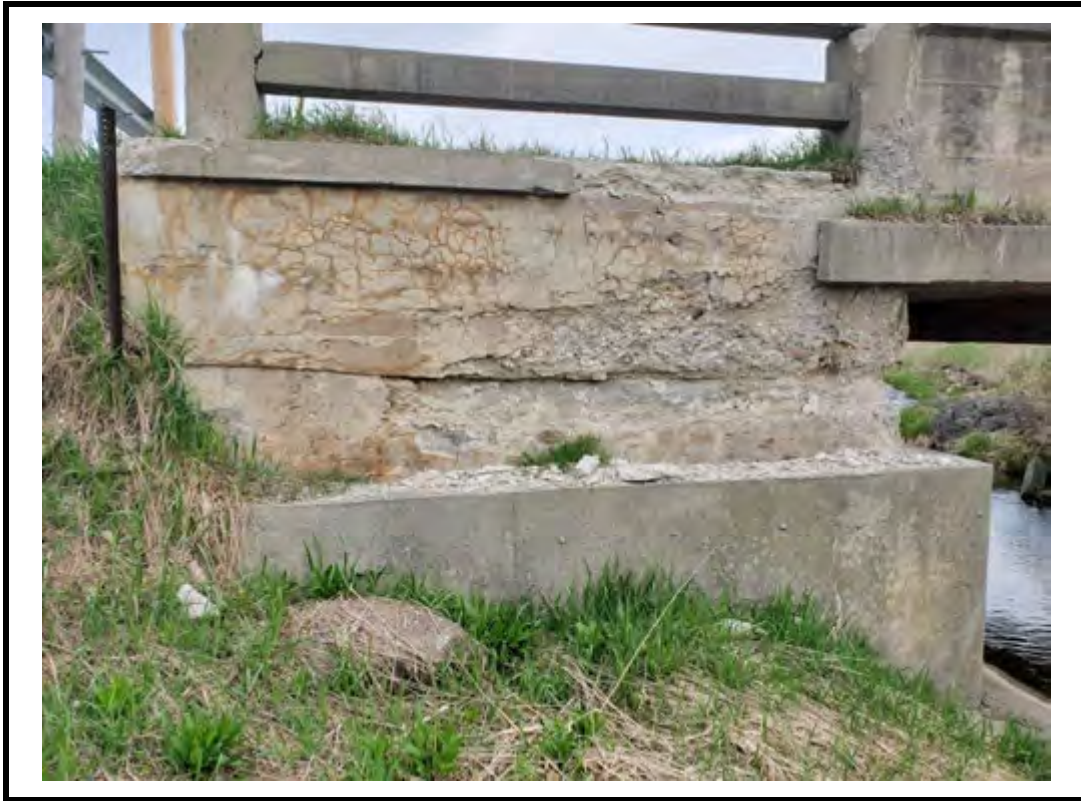
Photo 10 Spalls with exposed corroded reinforcement on north end of floor beam

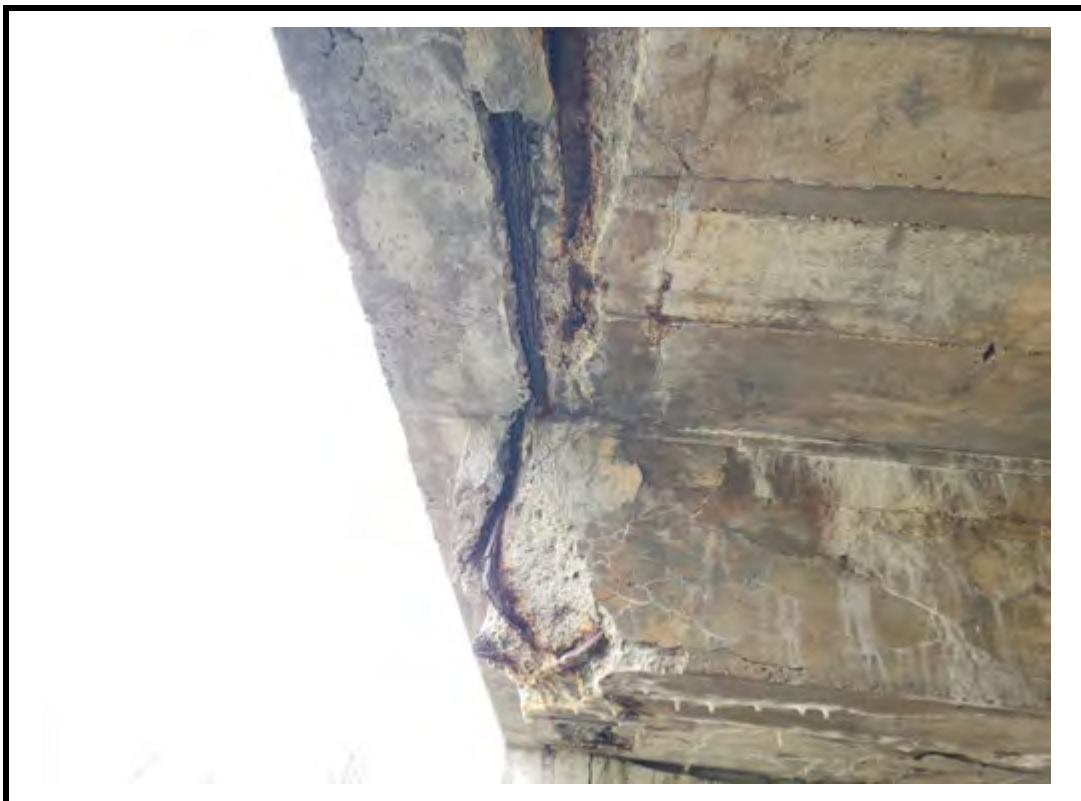
Photo 13 Large spall with exposed corroded reinforcement at concrete beams.

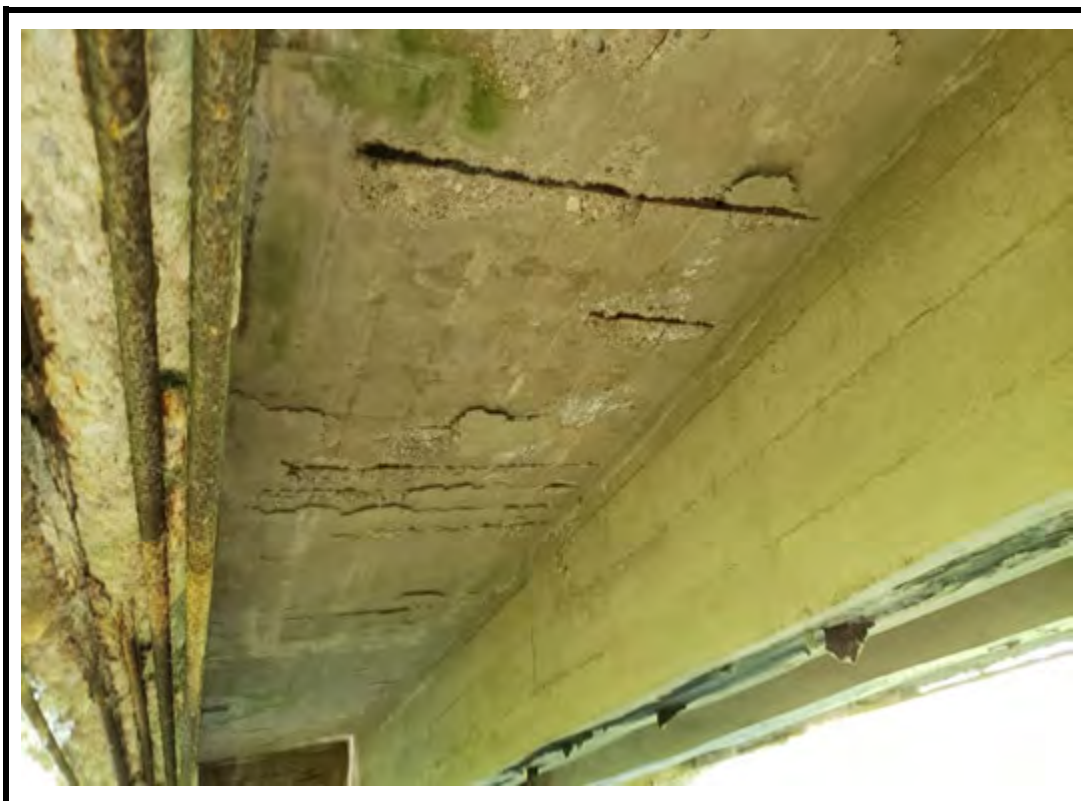
Photo 7 Large spalls with exposed corroded reinforcement noted on curbs

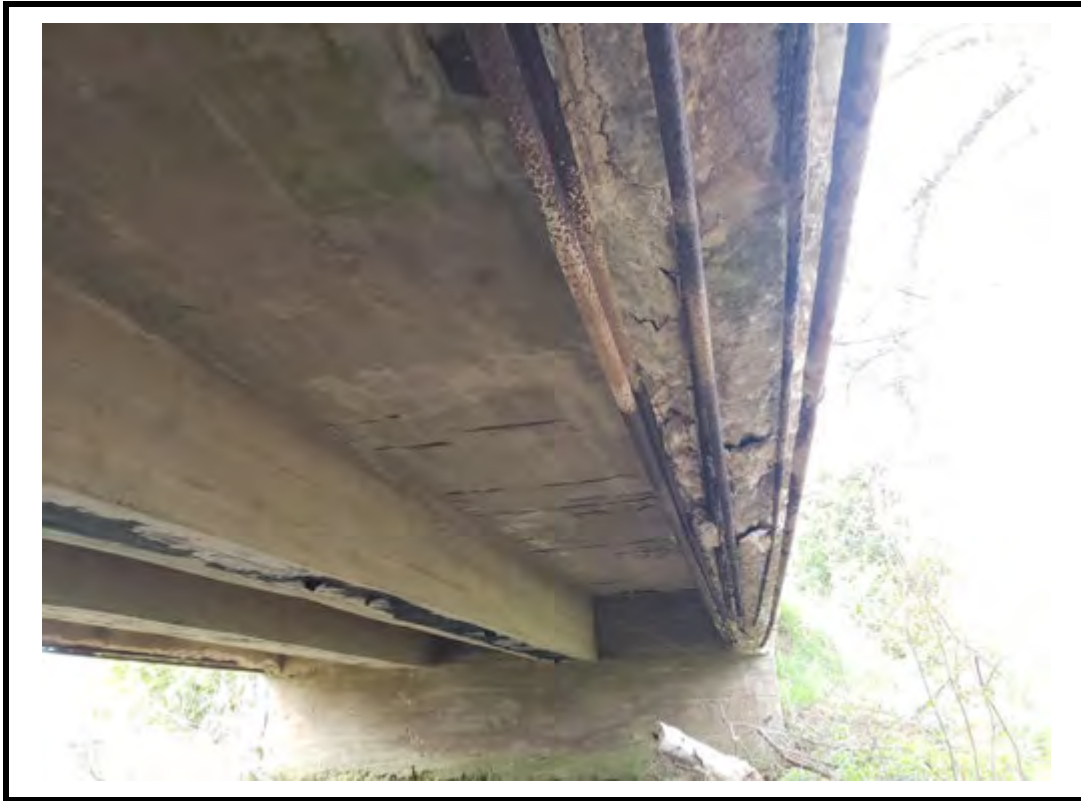
Photo 8 Large spalls with exposed corroded reinforcement on soffit and girder

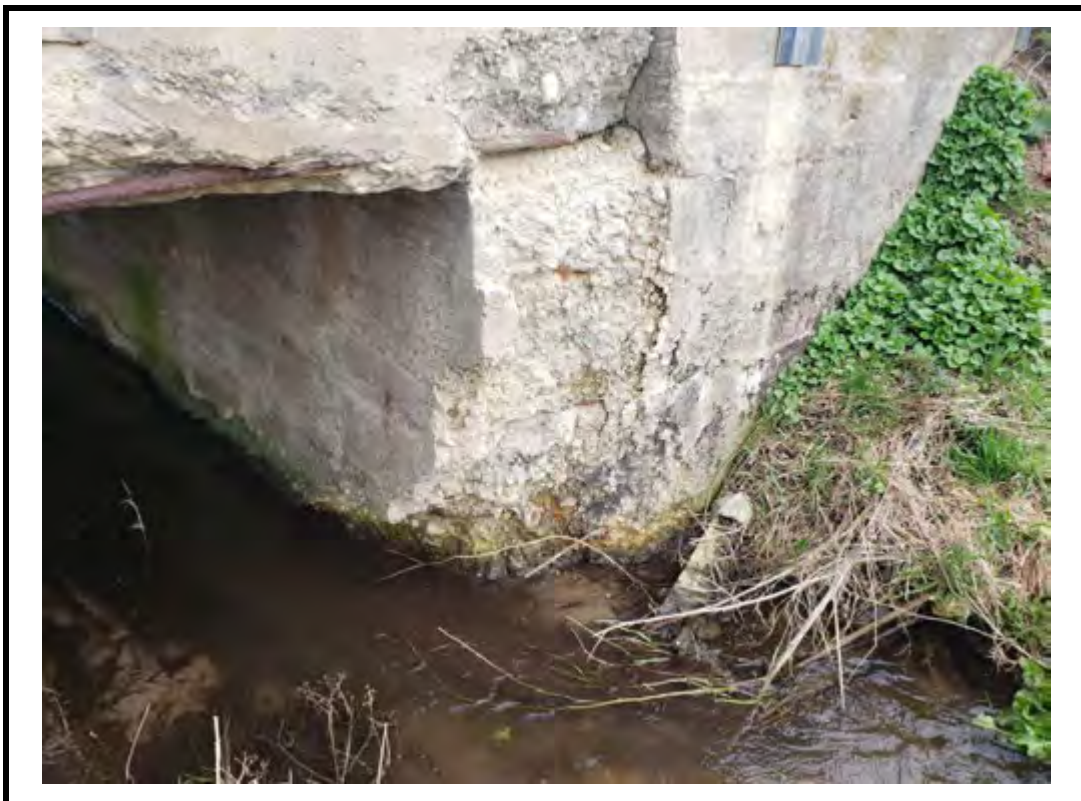
Photo 9 Large spall with exposed corroded reinforcement on underside of exterior girder

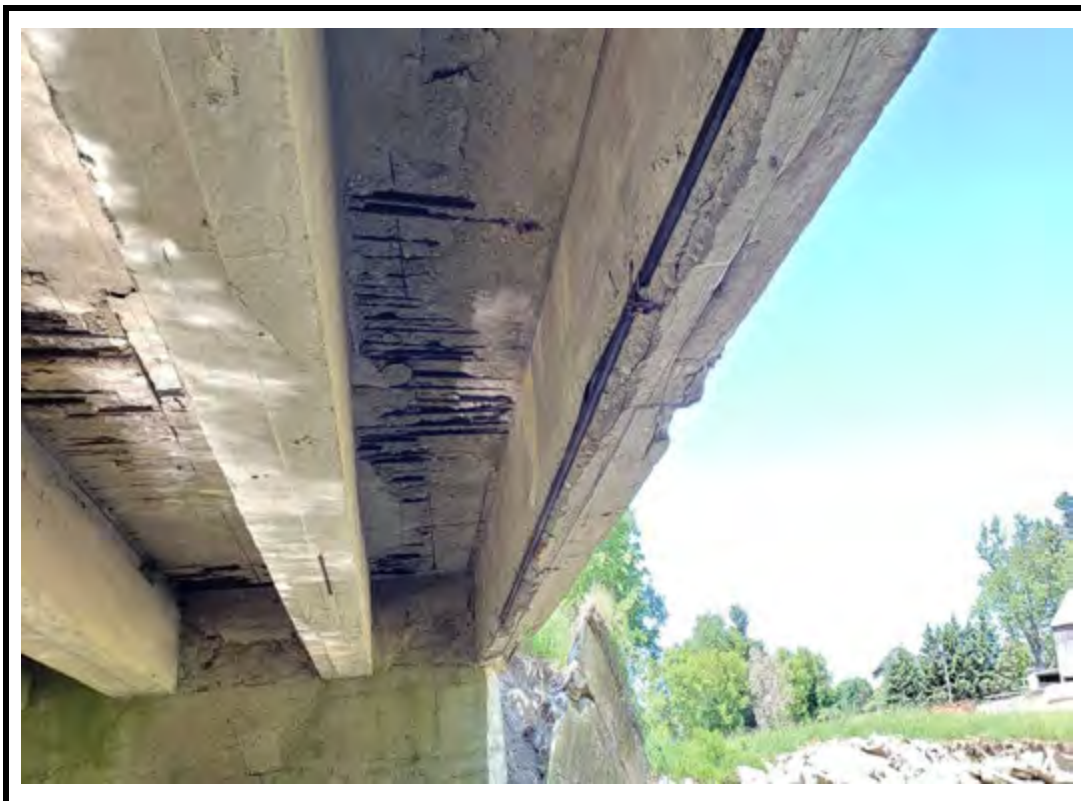
Photo 9 Spalls and delaminations with exposed corroded reinforcement on east deck soffit

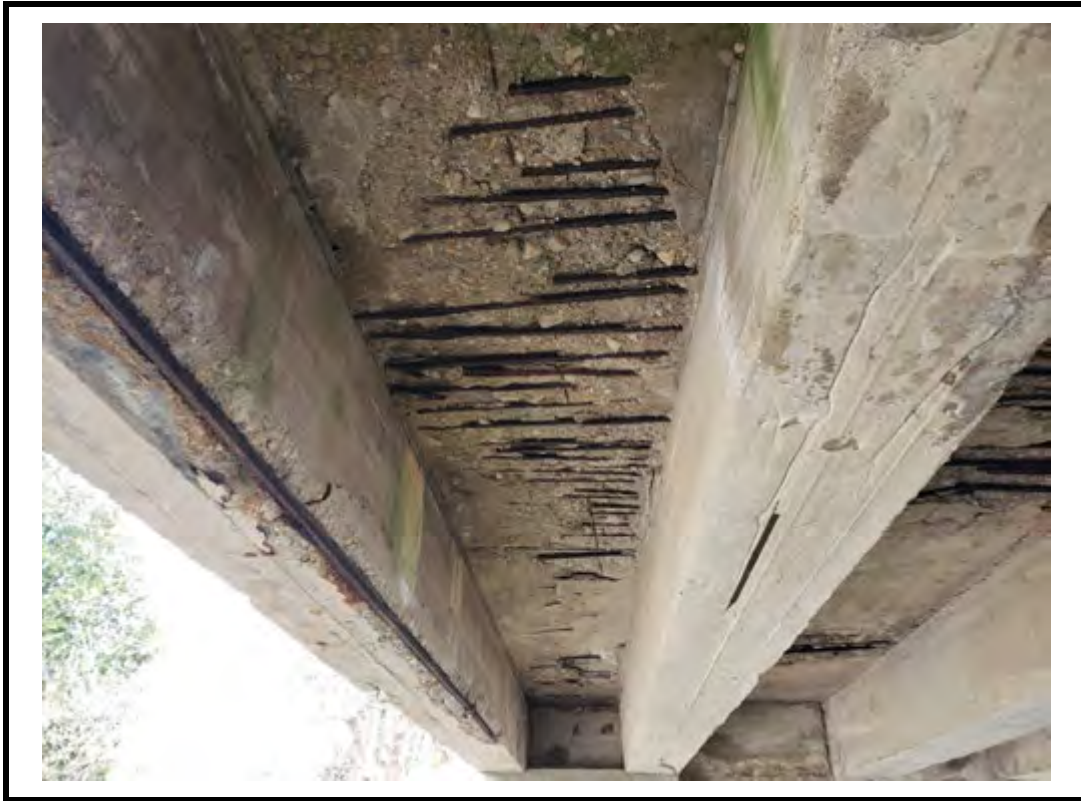
Photo 10 Spall with exposed corroded reinforcement on south exterior girder

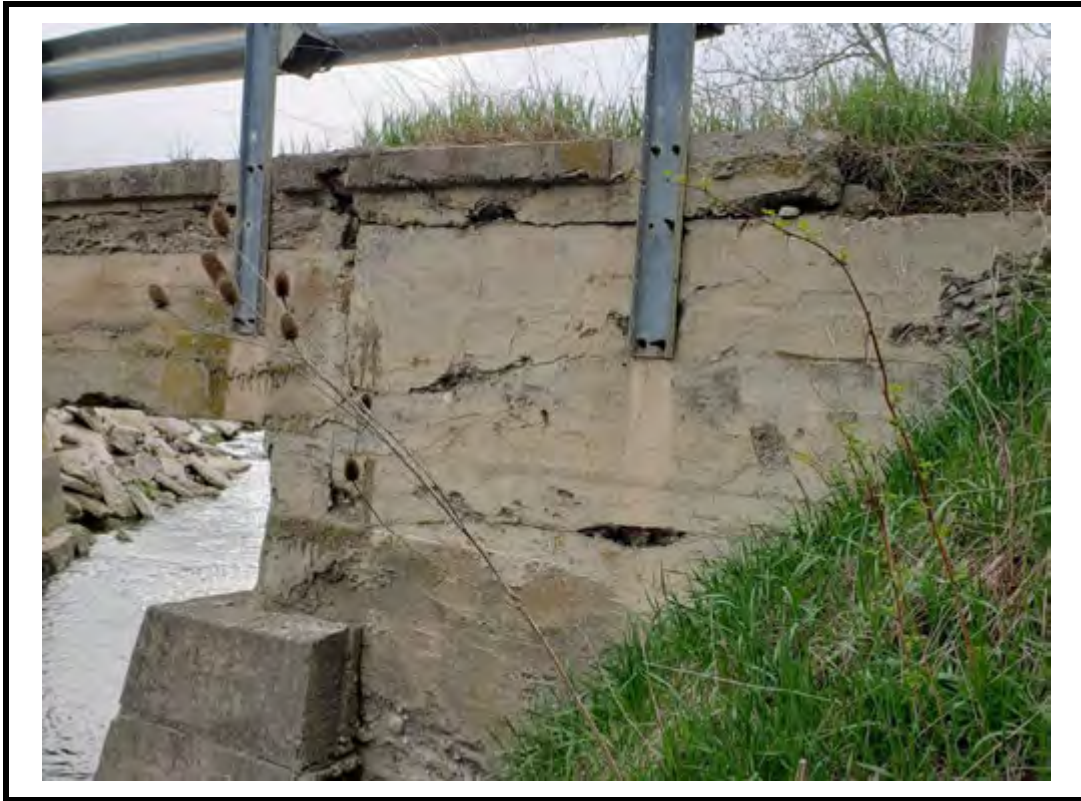
Photo 12 Northwest wingwall collapse and disconnected from abutment

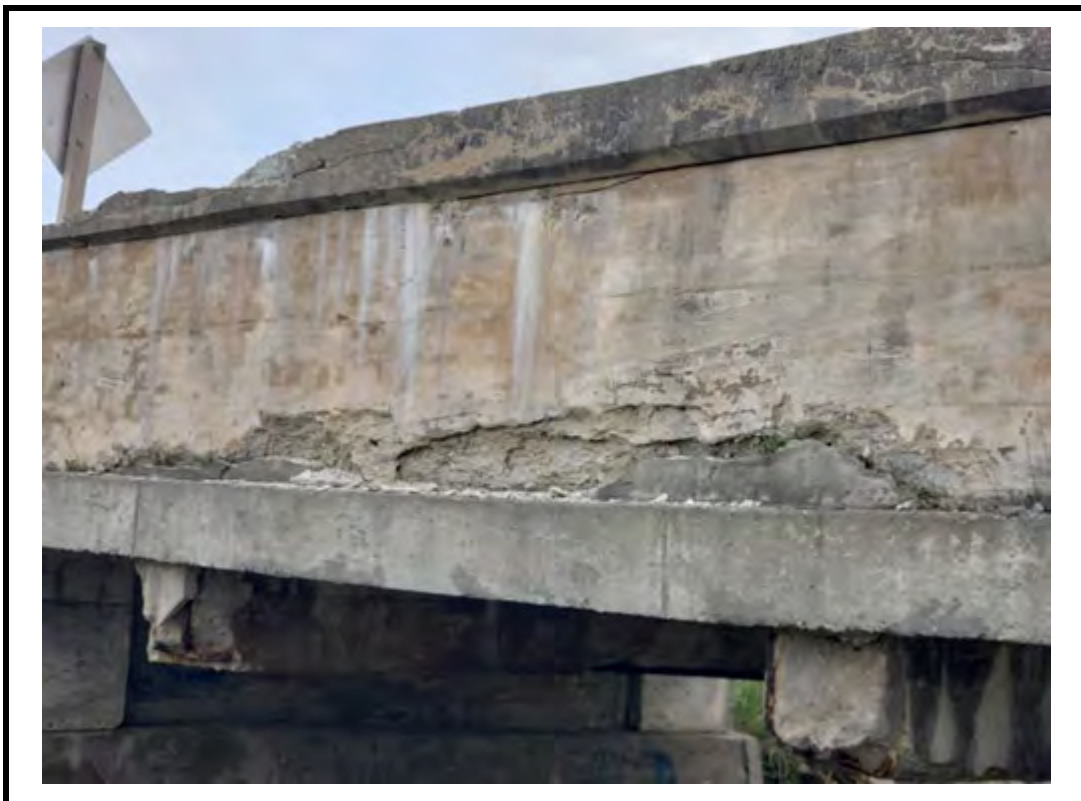
Photo 9 Spalls with exposed corroded reinforcement and efflorescence on north soffit

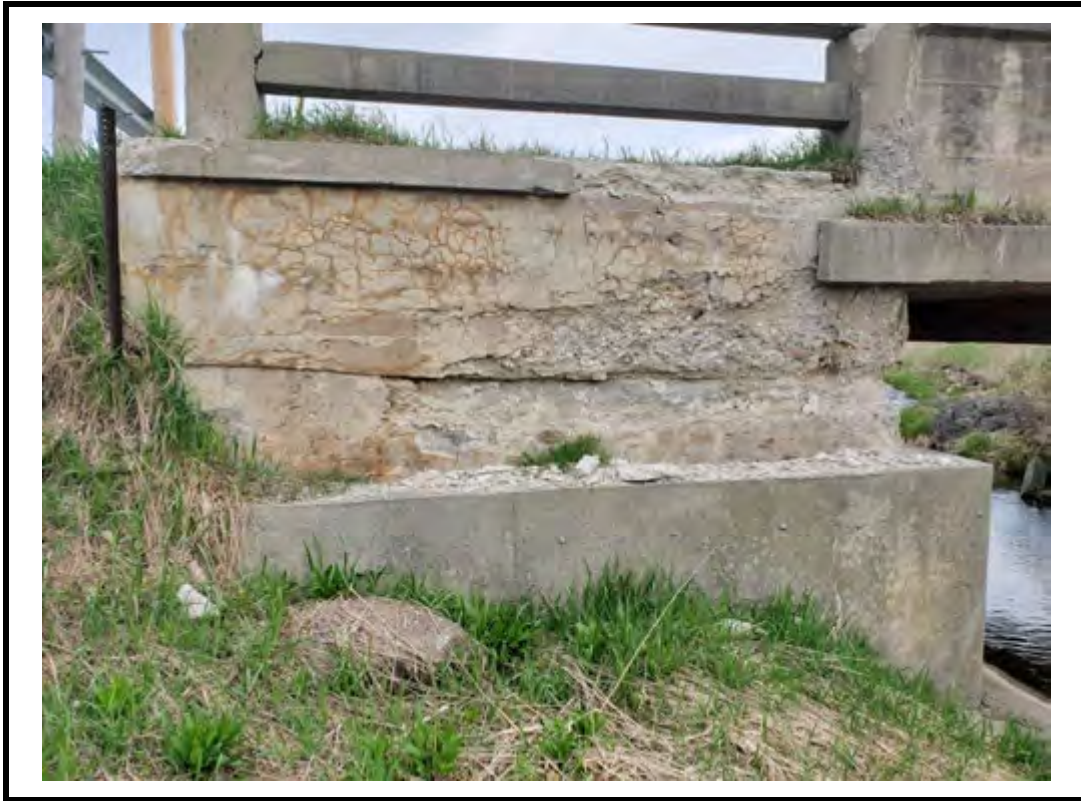
Photo 10 Spalls with exposed corroded reinforcement on north end of floor beam

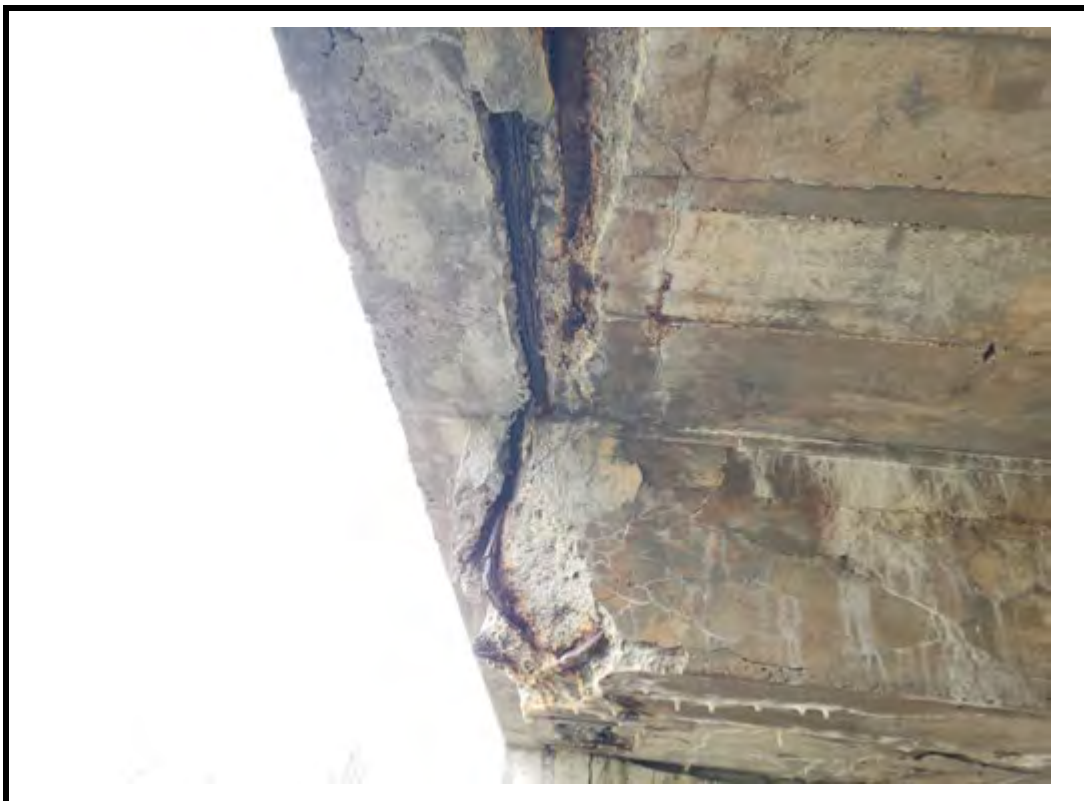
Photo 13 Large spall with exposed corroded reinforcement at concrete beams.

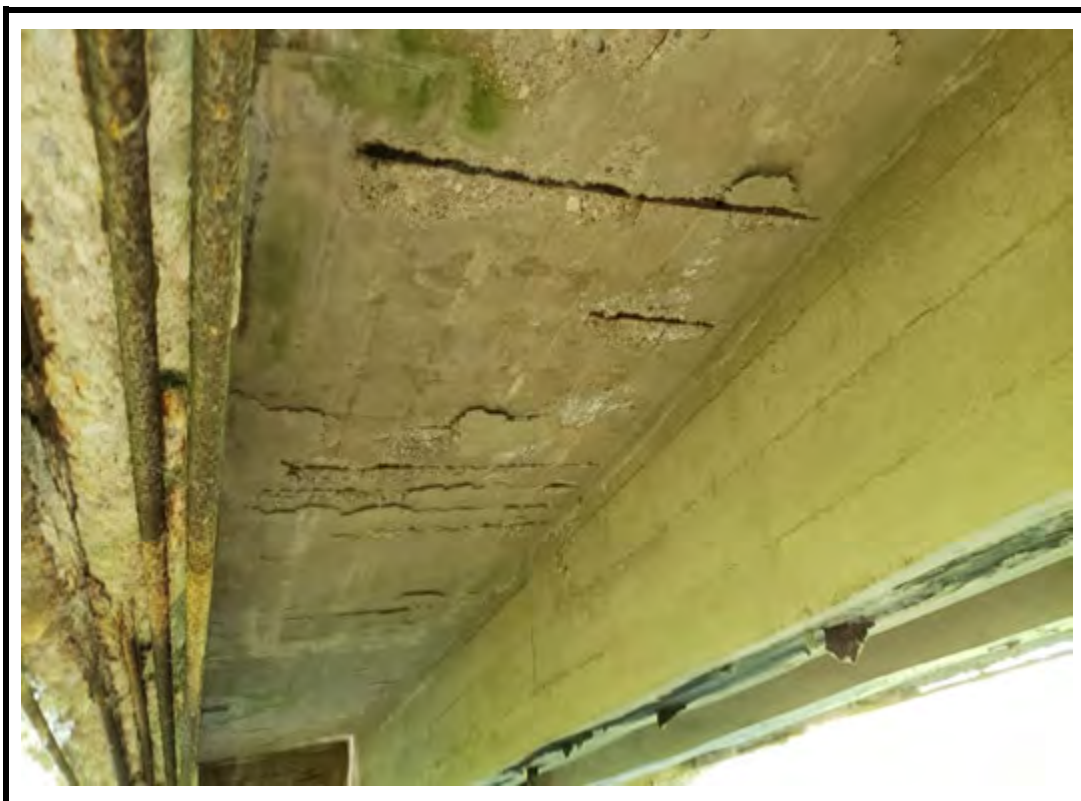
Photo 7 Large spalls with exposed corroded reinforcement noted on curbs

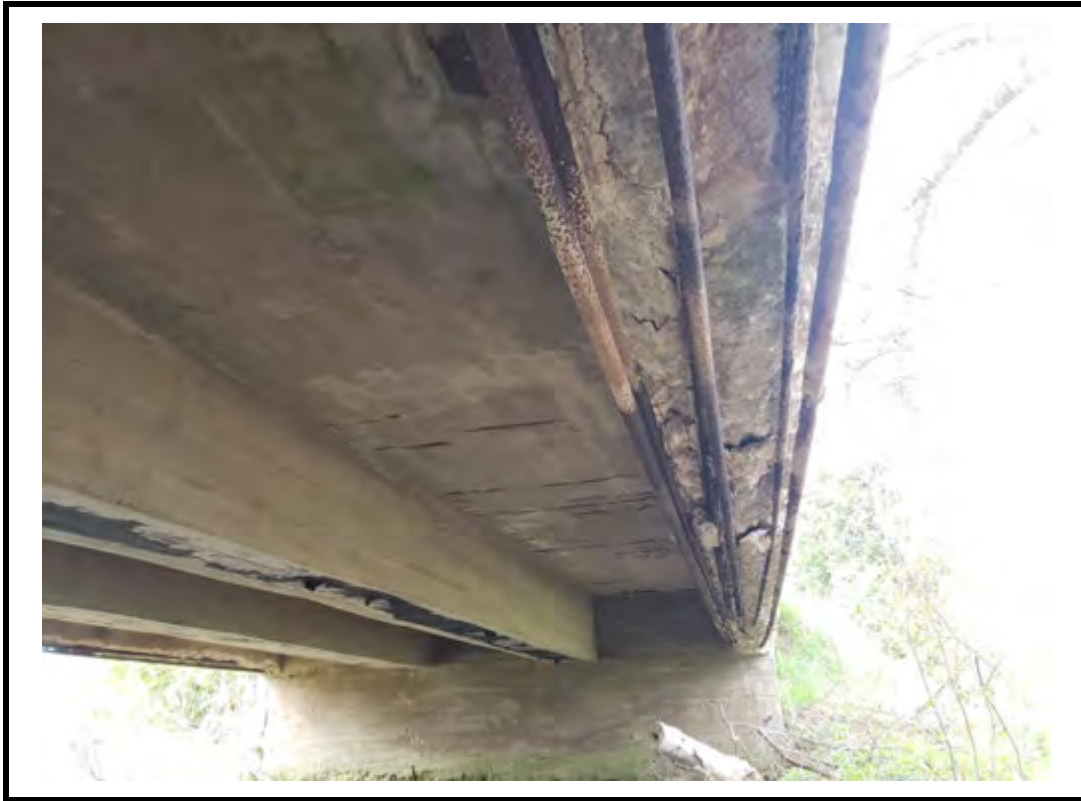
Photo 8 Large spalls with exposed corroded reinforcement on soffit and girder

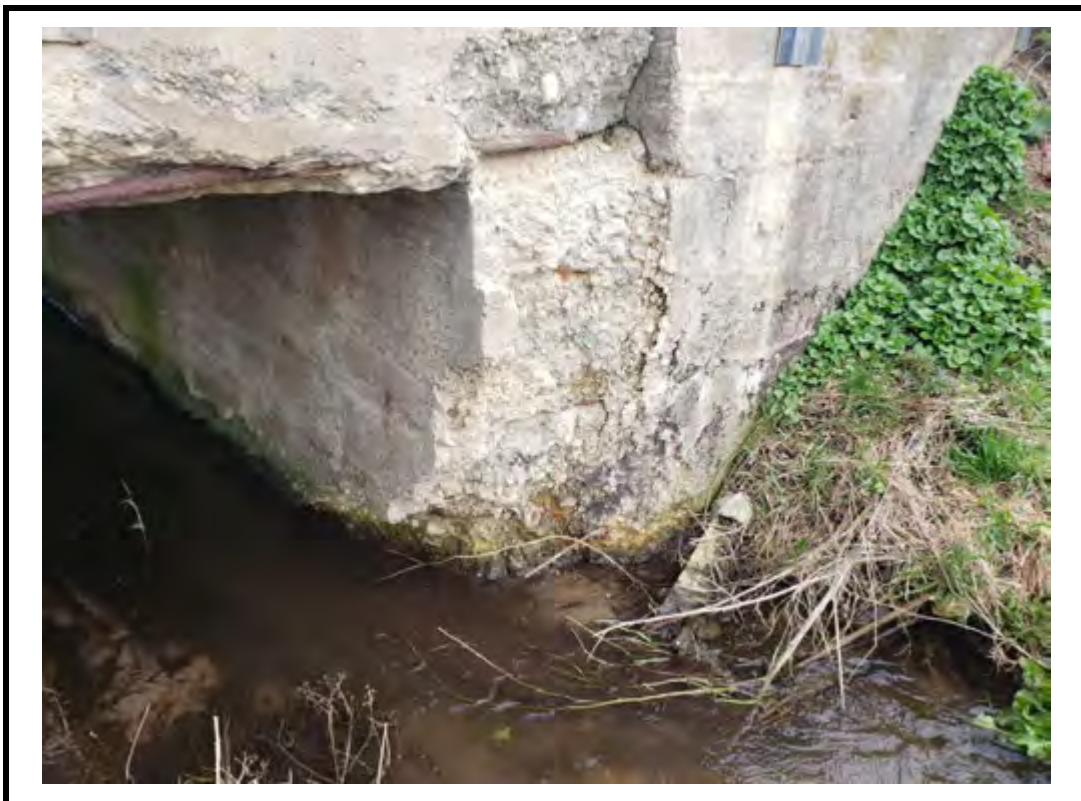
Photo 9 Large spall with exposed corroded reinforcement on underside of exterior girder

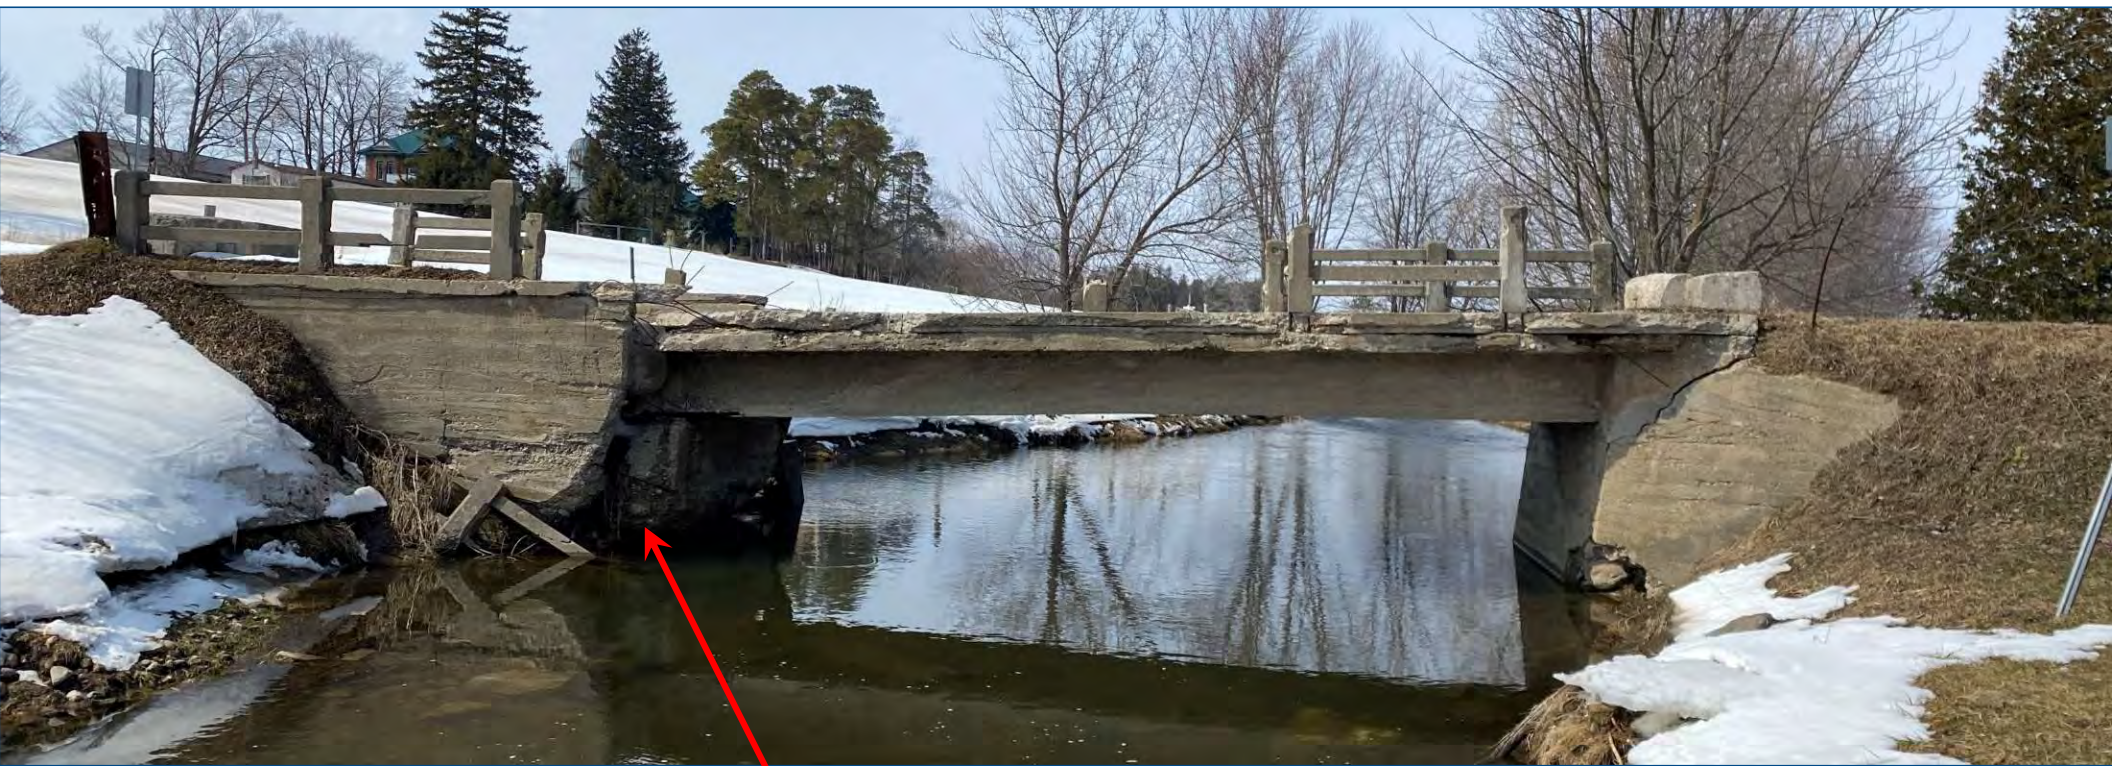
Span increasing from 10.7m to 14m for
better watercourse alignment

Existing bridge span narrower
than natural watercourse

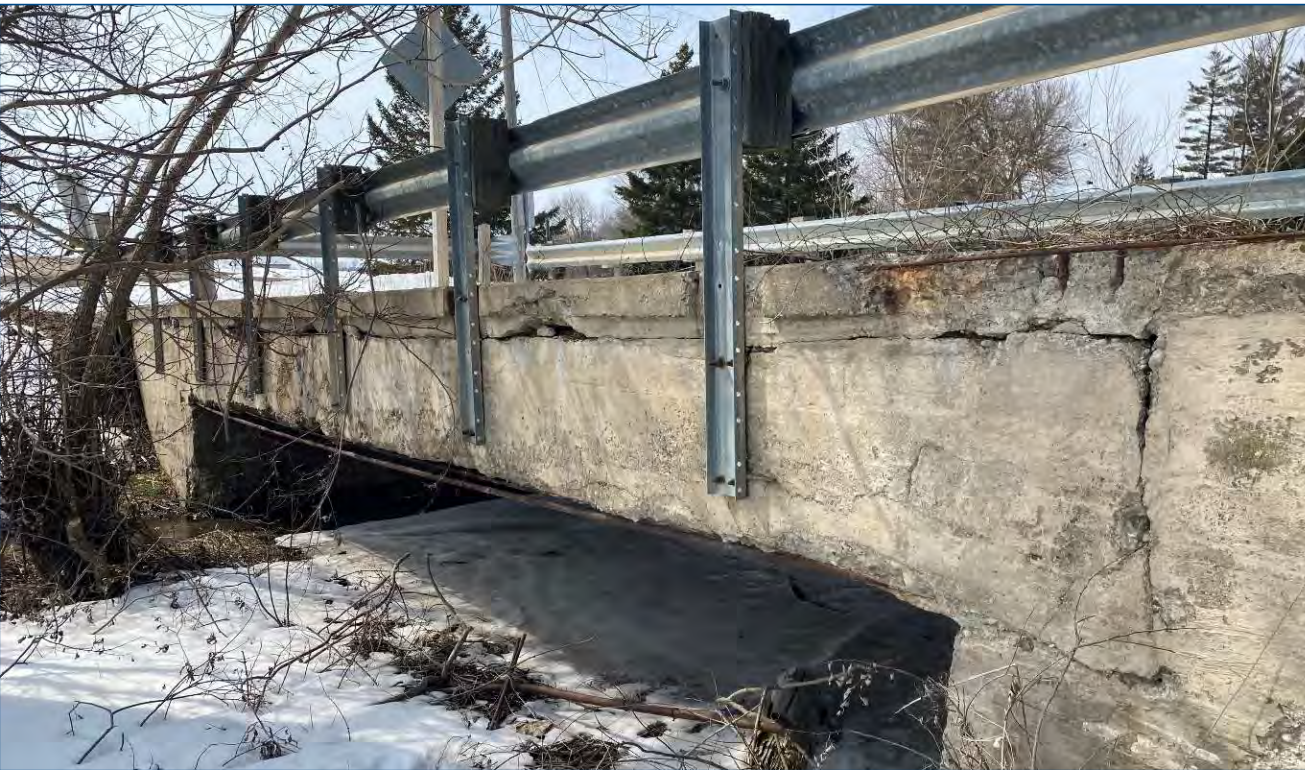
Replace bridge with 2.4 m span x 2.0 m rise Precast Box Culvert. Existing bridge is oversized for small tributary

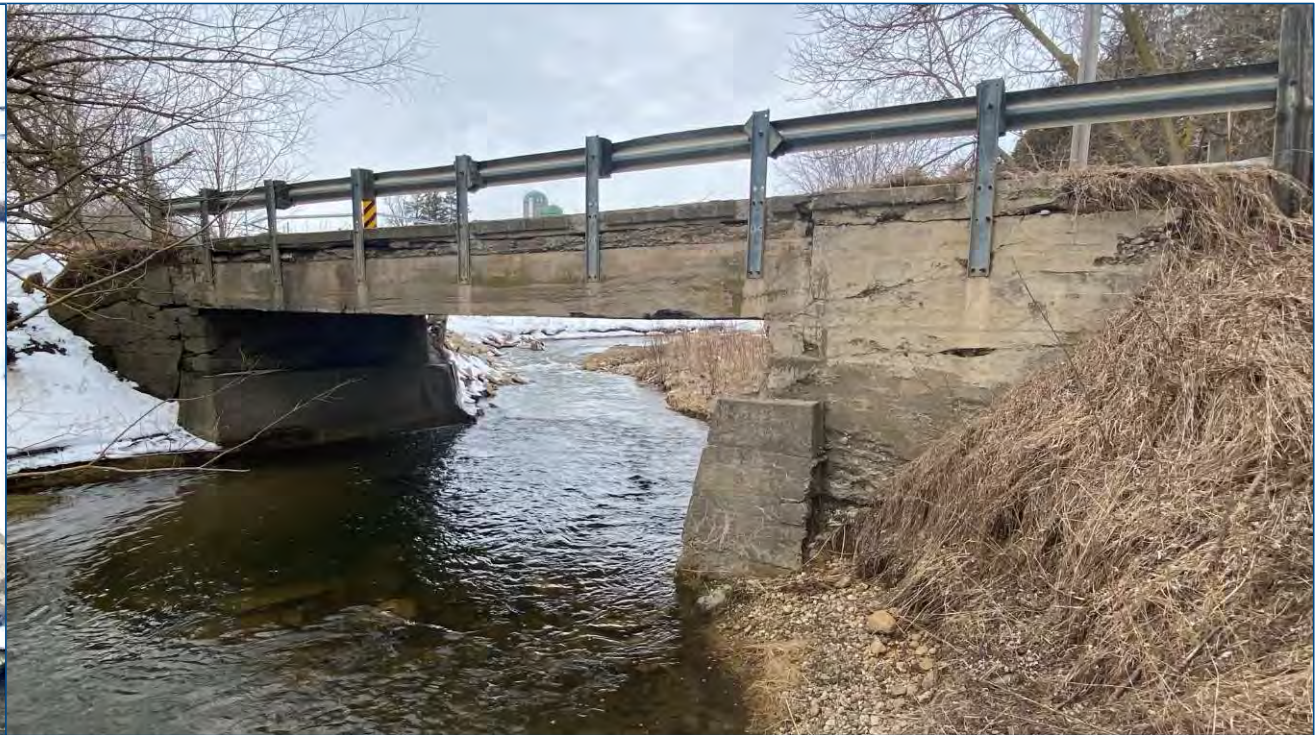
Span increasing from 9.8m to 22m for
better watercourse alignment and
opportunity for wildlife passage
